2003 C230 Sports Coupe

Facts - Sequence of Events

Addendum C.

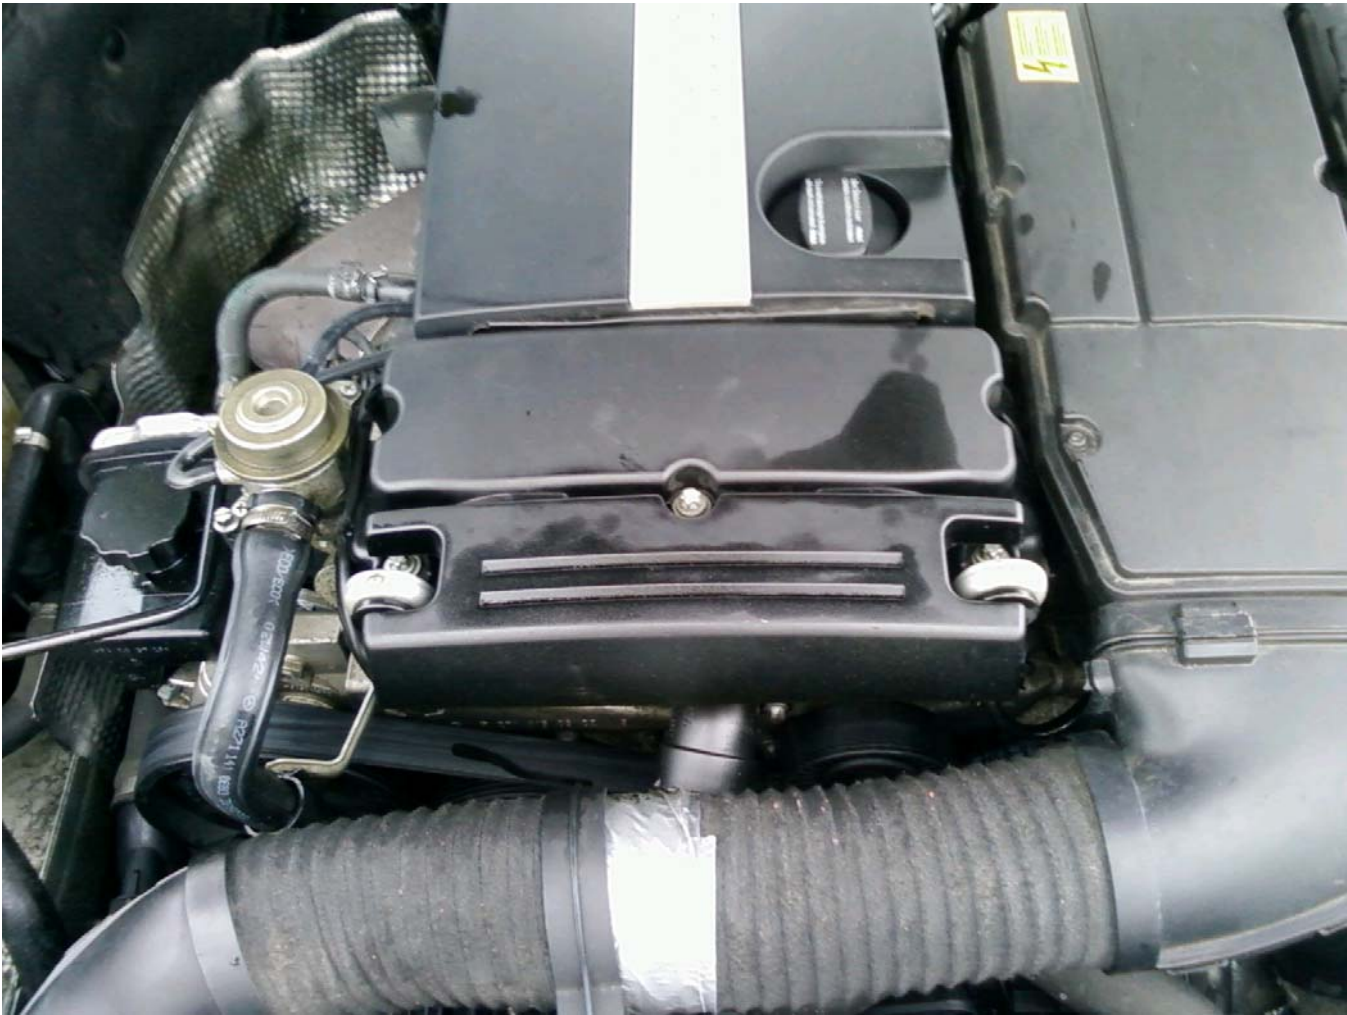
4/21 – Heard severe engine tapping. Decided to look under hood and check service performed. Discovered oil covering the entire engine bay (see pictures attached). Dash computer verified 3 qts of oil low. Technician failed to install a plug in the cam sensor essentially leaving two holes in the engine for oil to spray out. Also, discovered the isolating wires (part 271-150-27-33 in Addendum A provided to SA/technician) were not installed even though was told so on 4/16 by technician and 4/17 from SA.

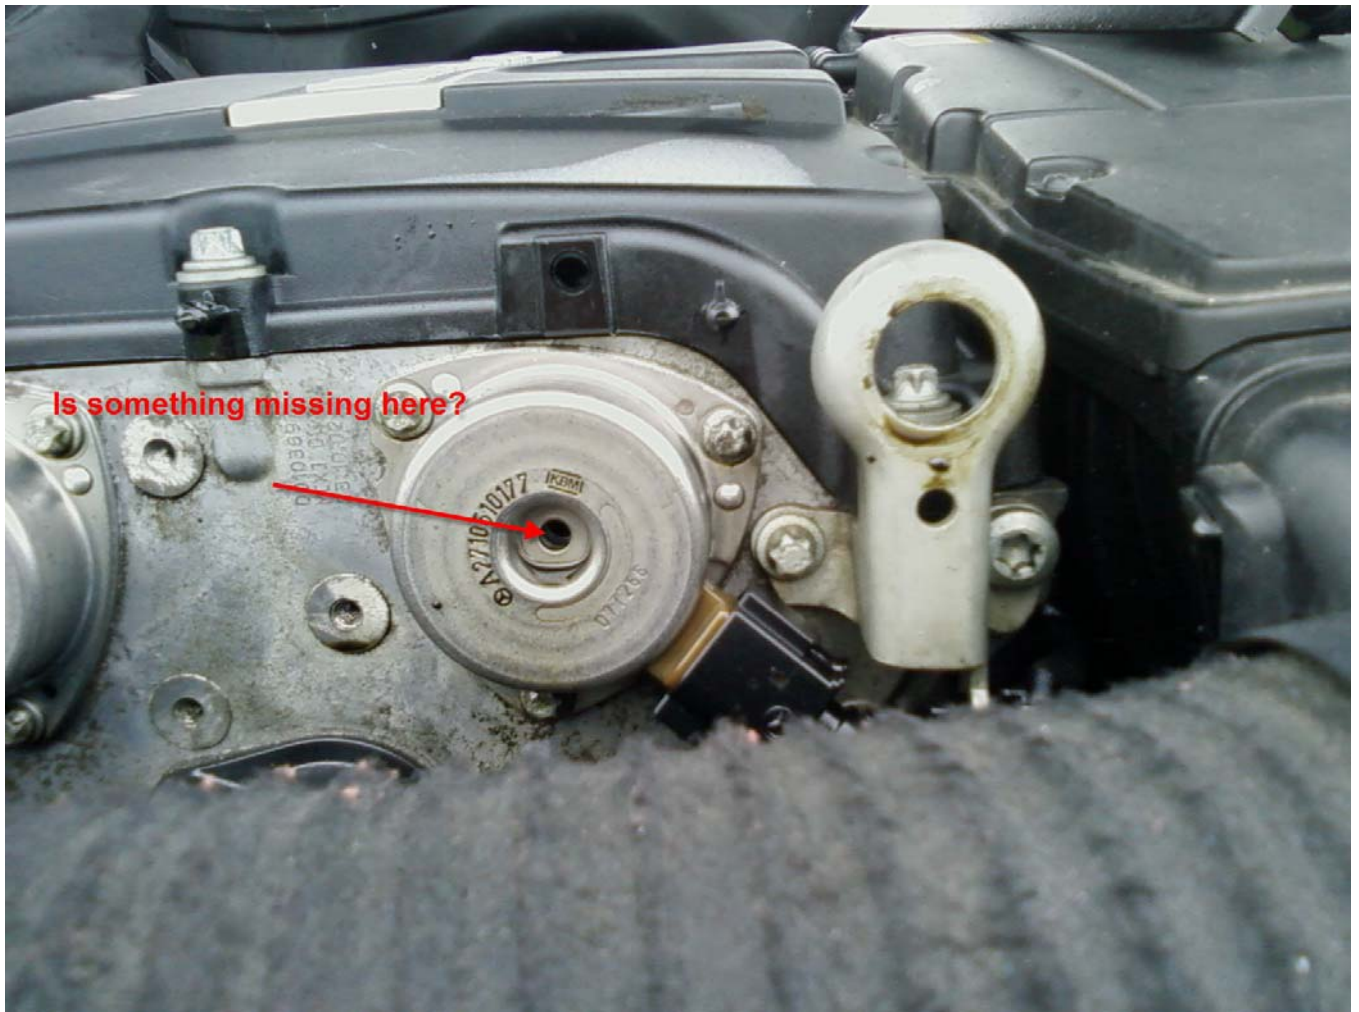
Is something missing here?

- Repair of the leak be performed properly.
- Engine bay *thoroughly* cleaned (will not tolerate any trace of a grimy/oil sodden engine bay).
- The isolating wire actually be installed.
- A (1) compression test, (2) leak down test, and (3) oil analysis be performed and provided results.

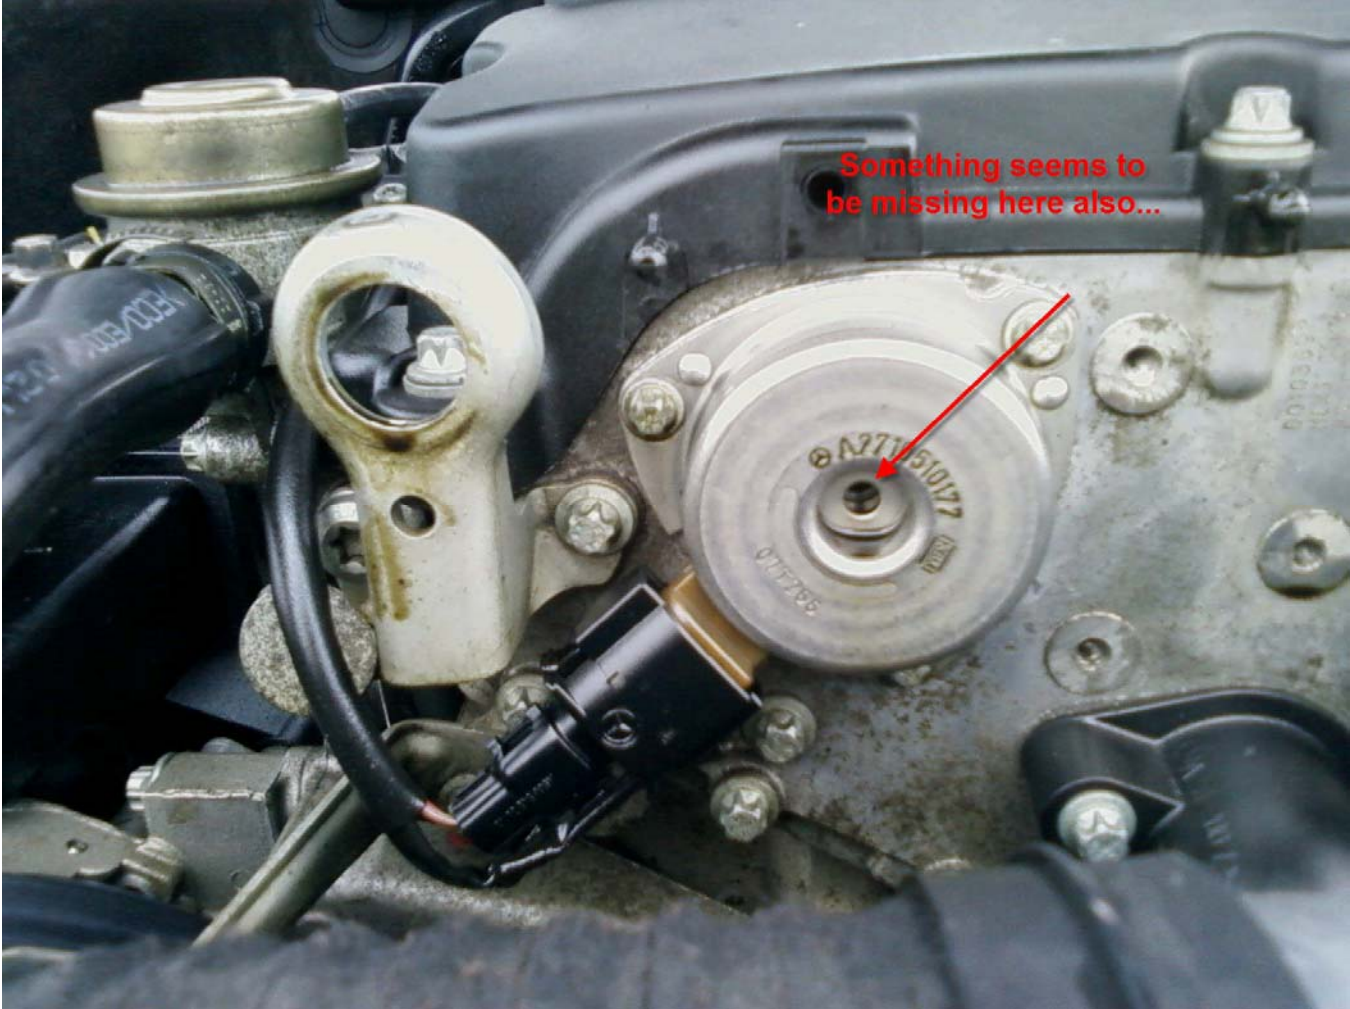
Something seems to be missing here also...
