Date: April 7, 2004
Order No.: P-B-33.10/11
Supersedes:
Group: 33

**SUBJECT: Model 203.040/061/064/065/261/264/740/764
Rumbling Noises While Driving Over Bumps or On Bad Roads**

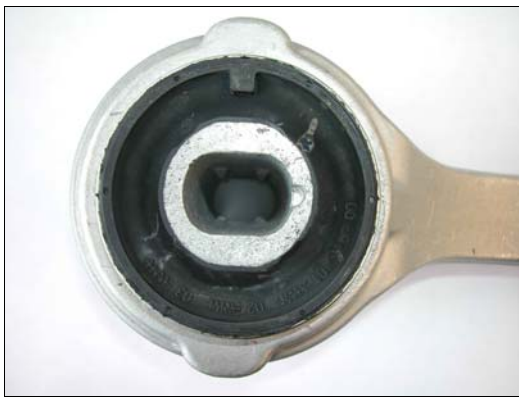
Figure 1 P-B-33.10/11
Good Bushing

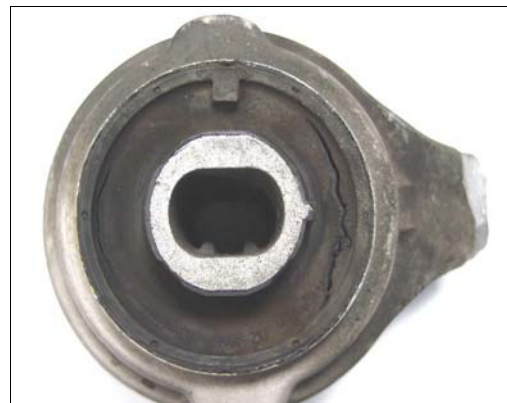
Cause 1: The rubber mount on the torque strut is cracked and losing fluid. Affected vehicles are up to VIN A436252 and F339810.

Figure 2 P-B-33.10/11
Torn Bushing

Remedy: Replace the rubber bushing only. Refer to WIS document AF33.15-P-1120BG.
