**star bulletin**

**Service Campaigns**

Date: March 2006
Campaign No 2006020008
Supersedes:
Group: 27

**SUBJECT: MODEL 203
MODEL YEAR 2004-05
Inspect transmission pilot bushing at electrohydraulic unit and replace if necessary**

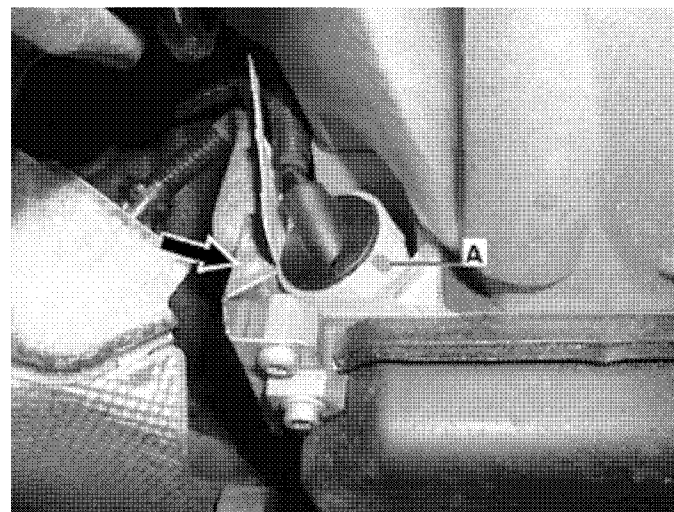
Figure 1

1. Inspect pilot bushing for green color coding(A, Figure 1).
 - If green dot is present, this campaign has been completed.
 - If green dot is not present, proceed to **SUBJECT B**.

1. Remove heat shield (arrow, Figure 1).
2. Disconnect electrical connector at transmission.
3. Remove pilot bushing mounting bolt (Figure 2); remove pilot bushing.

5. Mark new pilot bushing with a permanent green dot at location visible with heat shield in place (as shown in Figure 1).
