**DTB**

Date: August 29, 2008
Order No.: P-B-82.10/376e
Supersedes: P-B-82.10/376d dated May 23, 2008
Group: 82

SUBJECT: Model 203.040/061/064/065/076/081/084/261/264/281/284/740/747/764

Xenon or Bi-Xenon Headlamps not Functioning

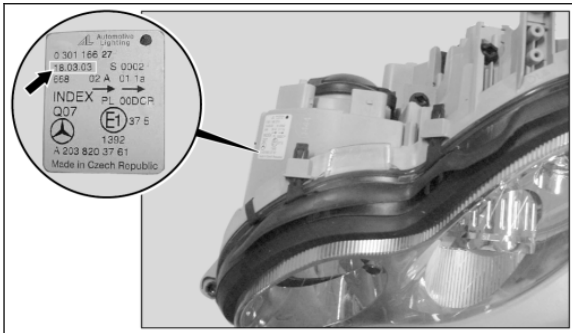
Figure 1 P-B-82.10/376a

1. Check voltage at headlamps.
 - a. Check plug (1) of low beam (E1e2, E2e2) in lamp units (E1, E2) for voltage.
 - b. If no voltage is present, continue with test step 5.
 - c. If voltage is present, continue with test step 2.
2. Check burners by swapping across (right to left).
 - a. If the fault changes sides with the xenon burner, replace xenon burner. Refer to WIS document AR82.10-P-1201P (203), AR82.10-A-1201QB (209) or AR82.10-P-1201R (230).
 - b. If the fault does not change sides, continue diagnosis with test step 3.
3. Check ignition module.
 - a. Check manufacture date of ignition module found on a printed label (Figure 1, arrow) on the headlamp housing.

- b. If the ignition module is later than the specified manufacture date, continue with test step 4.
 - c. If the ignition module is earlier than the specified manufacture date, continue with test step 6 for the 230, test step 7 for the 203.0 and 203.2 and test step 8 for the 203.7 and 209.
