star bulletin

Date: December 6, 2007
 Order No.: P-B-13.22/01b
 Supersedes: P-B-13.22/01a dated Nov. 6, 2007
 Group: 13

**SUBJECT: All Passenger Models Equipped with Engine M272 or M273
 Whining / High Pitch Whistle Noise Coming From Front of Engine**

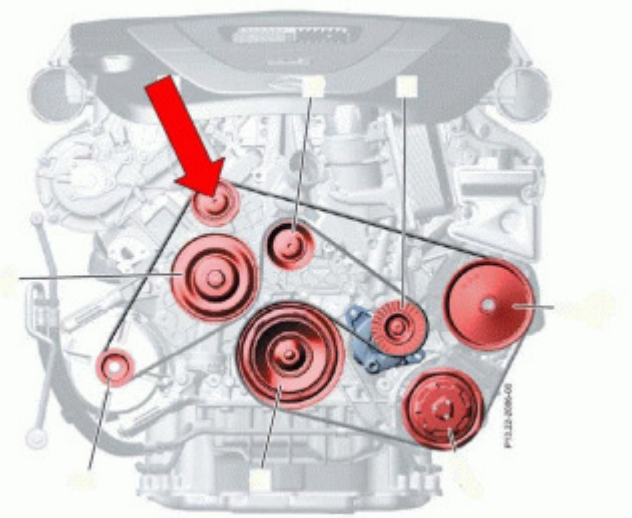
If you receive customer reports in the above model vehicles of a whining or high pitch whistle noise coming from the engine, this noise maybe caused by a faulty upper idler pulley. To resolve, replace the upper idler pulley with (Figure 1). The pulley is supplied as a package containing mounting bolt, dust cover and spacer. Fit the spacer between the case cover and guide pulley.

i Note: The new pulley comes packaged with a black plastic spacer which is used to hold the pulley assembly together. This bushing is to be removed and discarded before installation.
