AF54.21-P-2003P	Taillamps come on when ignition is switched on	18.11.02
-----------------	--	----------

MODEL 203

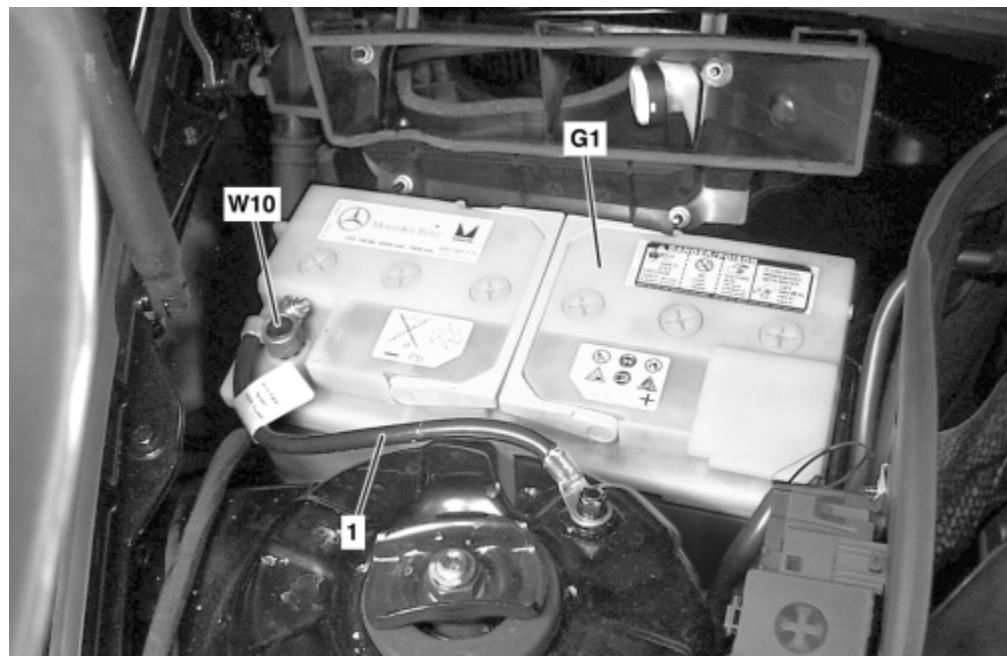
P54.10-2060-06

Damage code	Cause	Remedy	
54 590	Malfunction in signal acquisition and actuation module (SAM) with fuse and relay box.	Reset rear SAM control module with fuse and relay box (N10/2), see Steps 1-5	
		1 Perform short test, read out DTC memory.	
			AD00.00-P-2000-04A
		2 Remove dust filter housing.	
			AP83.00-P-8381P
		3 Disconnect ground line (1) from ground connection on battery (W10) and leave disconnected for 15 min.	
		4 Connect ground line (1) to battery ground point (W10).	
		5 Check parking lamps for proper operation.

1 Ground cable
W10 Ground (battery)

Steps 6-8	
		i Problem not eliminated: Perform Step 9.	
		6 Install dust filter housing.	
			AP83.00-P-8381P
		7 Perform short test, read out DTC memory.	
			AD00.00-P-2000-04A
		8 Perform basic programming	AR00.19-P-0200P
		9 Remove and replace rear SAM control module (N10/2).	
		Model 203.0	AR54.21-P-1259P
		Model 203.2	AR54.21-P-1259PC
		Model 203.7	AR54.21-P-1259PS
