DTB

Date: January 7, 2009
 Order No.: P-B-82.70/616e
 Supersedes: P-B-82.70/616d dated August 11, 2008
 Group: 82

**SUBJECT: Model 204.054/056/081
 As of Model Year 2008 Equipped with COMAND Head Unit (Code 512 , 527)
 Blue Tooth Hands-free Telephone Conversation Choppy, Echo/Distortion Detected
 Especially By The Land-line Caller**

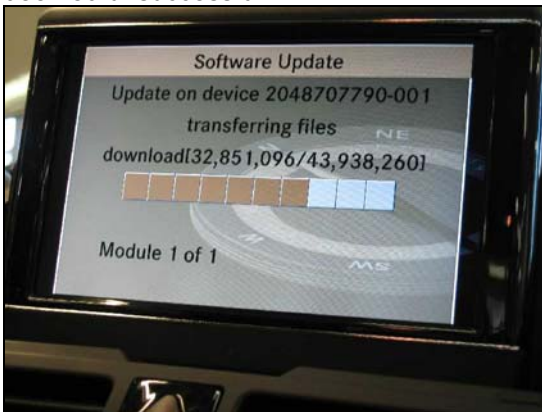
Figure 1 P-B-82.70/616

Do NOT turn head unit OFF during the update process. See Figure 1 showing what the COMAND screen looks like during the normal update process.
