Date: January 15, 2009
Order No.: S-B-82.85/597a
Supersedes: P-B-82.85/597 dated October 5, 2007
Group: 82

**SUBJECT: Model 204.054/056, as of Model Year 08
Model 204.987, as of Model Year 2010
Equipped with iPod Interface Kit and Audio 20 Head Unit (Option Code 523)
iPod Volume Too Low**

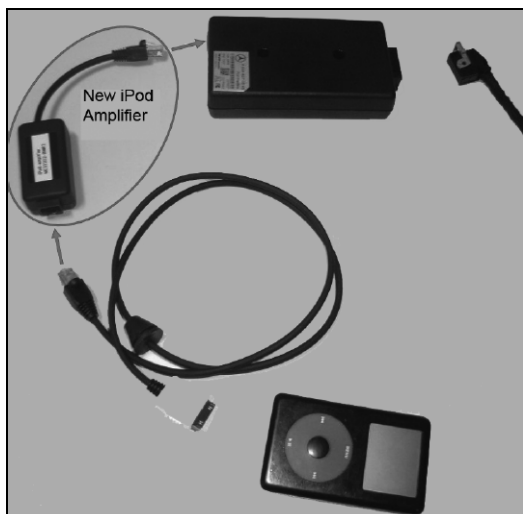
Figure 1 P-B-82.85/597

in-line Amplifier connection

If you receive customer reports in the above model vehicles that the iPod volume is too low in comparison to other audio sources (Example: audio from the CD player or FM), this may be due to a hardware condition in the iPod Interface Module. To remedy, install the iPod amplifier (A204 870 39 94) in line with the iPod Interface kit (Figure 1). Refer to WIS document AZ82.60-P-0014CW (W204) or AZ82.60-P-0014CY (X204).
