DTB

Date: April 17, 2009
 Order No.: S-B-82.85/615b
 Supersedes: P-B-82.85/615a dated March 18, 2009
 Group: 82

SUBJECT: Model 164.122/172/175/177/186, up to Model Year 2008
Model 203.052/054/056/076/087/092, up to Model Year 2007
Model 204.054/056/081, up to Model Year 2008
Model 209.356/372/377/456/472/477, up to Model Year 2008
Model 251.122/156/165/175/177, up to Model Year 2008
Equipped with COMAND Head Unit (Code 512, 527, 530, 528)
Central Display Opening/Closing Errors or Inoperative, Voice Control Does Not Respond To User's Commands (Hands-free Conversation) and/or Other Party May Not Hear Driver's Conversation

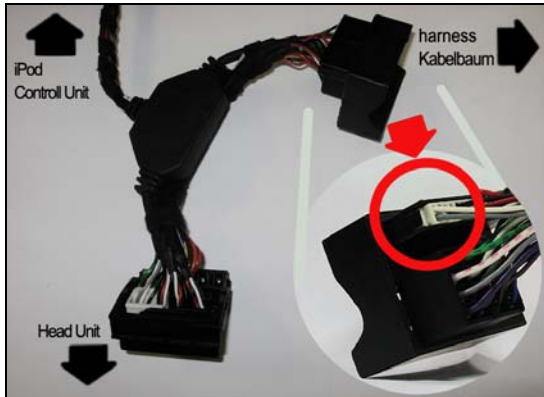
Figure 1 - iPod connector of weak contacts

If you receive customer reports in the above model vehicles having any of the conditions below, it may be due to an incorrect installation/mating/contact of the iPod Interface Cable (see Figures 1-4) with the COMAND head unit connector. To remedy, replace the iPod Interface Cable. Refer to the appropriate section of WIS Documents:

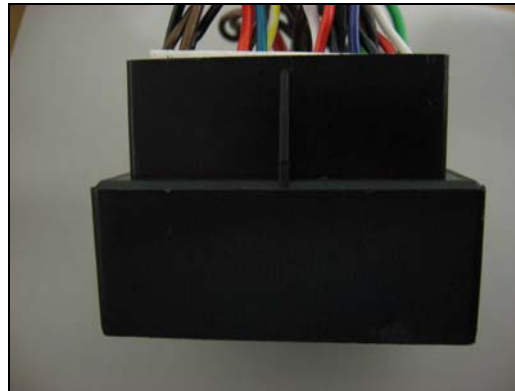
Figure 2 - Inner connector not mating securely

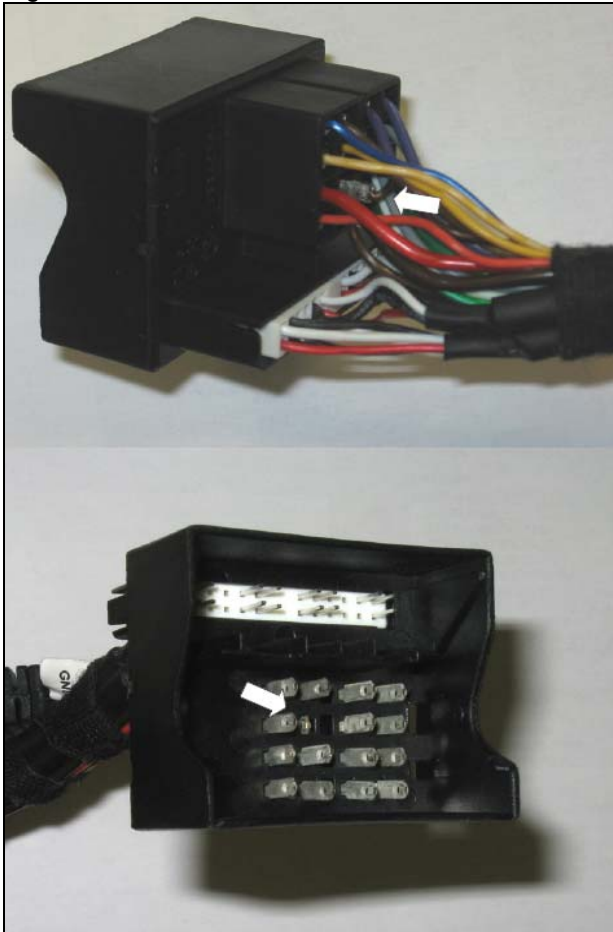
Figure 3 - Brown pin shown displaced

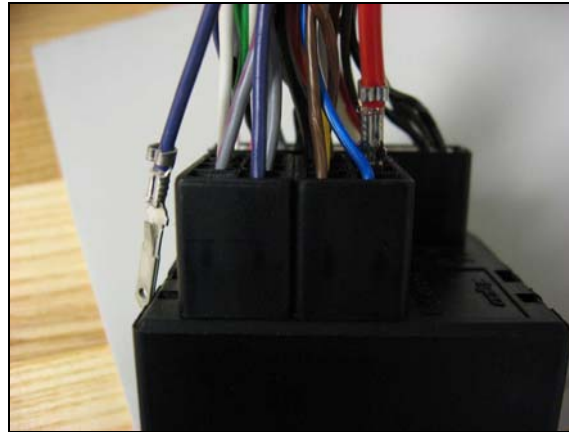
Figure 4 - Pin completely unplugged
