PREM AIR SENSOR Replaced // AIR Intake Manifold Replaced (Used Parts)

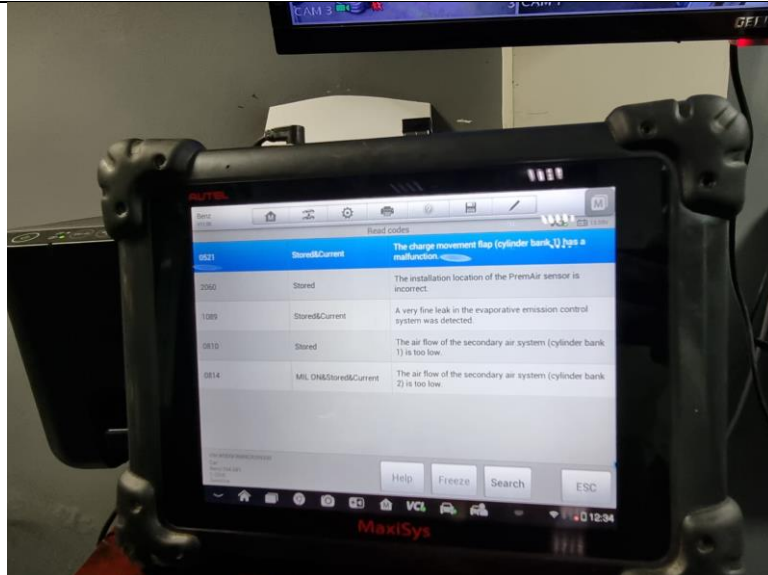
Charge Movement Flap at Intake Broken // Replace Intake Manifold again with Used Parts

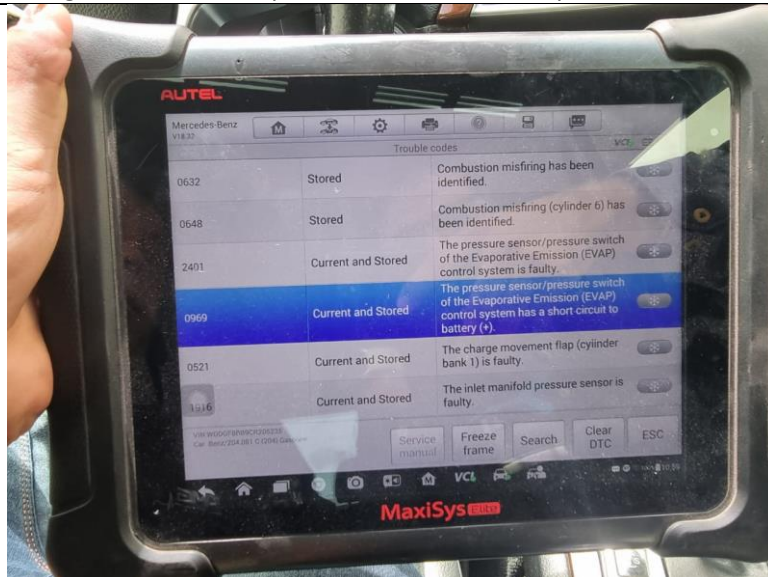
After fixing twice, It started showing EVAP control errors, Intake charge movement flap is broken again, (Replaced Intake, checked vacuum lines, replaced all lines)

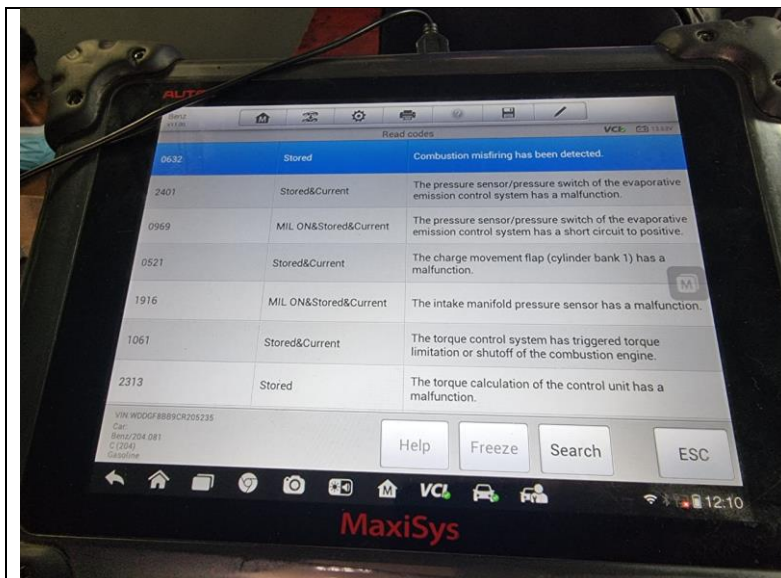
While cruising, vehicle jerked twice and engine shutdown, charge movement flap is broken again. Replace vacuum switches at this stage.

Checked all vacuum lines, RPM issue is still the same.

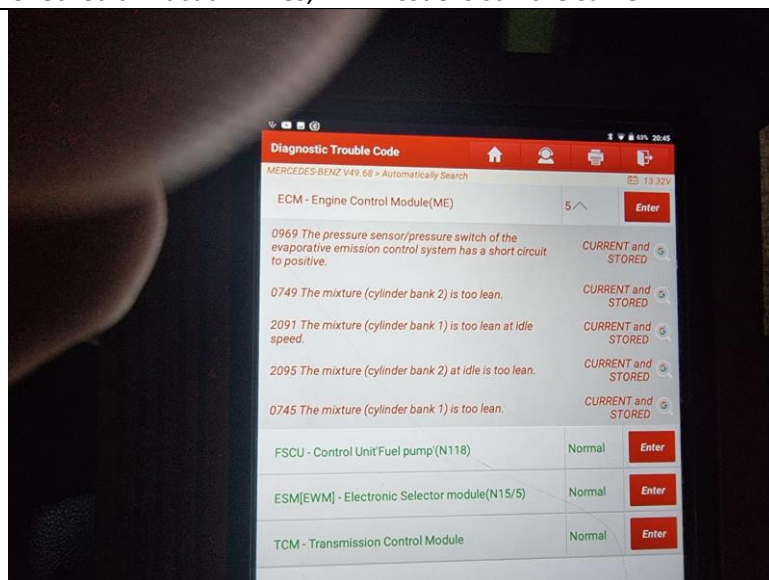
Now car started to show errors with EVAP system. Went to a guy, he mentioned that intake manifold and Fuel pressure sensors on fuel tank reservoir and filter needs to be replaced.

Issue remains the same, RPM fluctuates, no changes in the car.

Replaced ECU, reprogrammed, replace intake manifold with OEM new, replaced fuel pressure sensors.

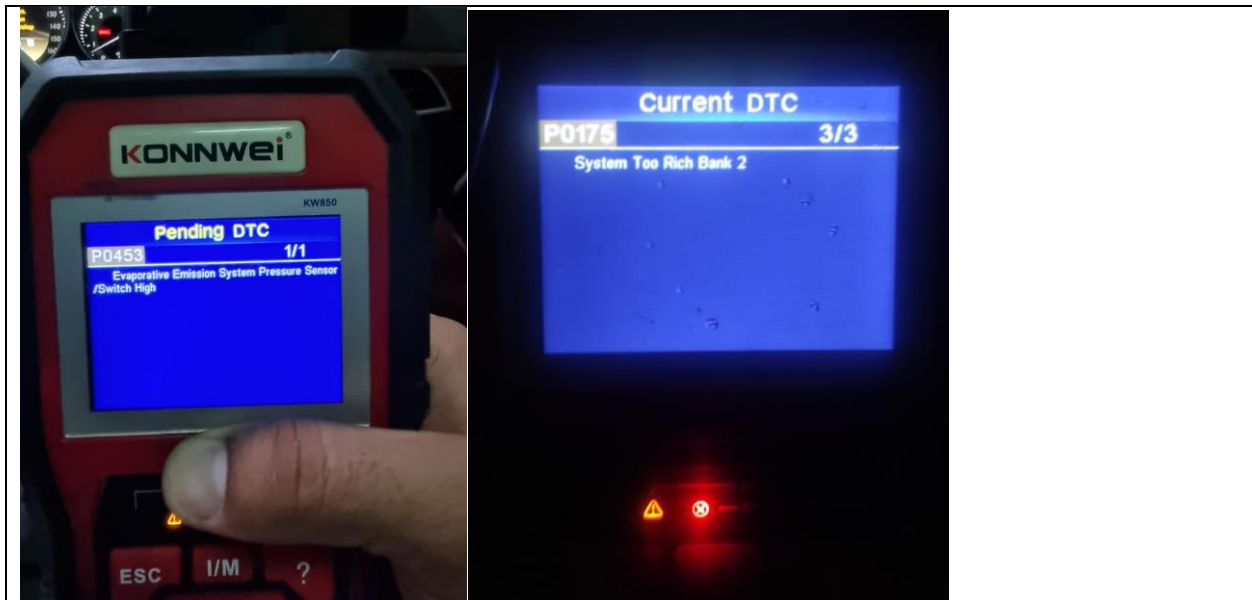
Errors of P0453 Evaporative Emission System Pressure Sensor/Switch High /// P0175 System too Rich Bank 2 ///

P0712 System too Rich Bank 1 remains.
