Campaign No. 2015020003, February 2015

SUBJECT: **Model 205 (C-Class), Model Year 2015
Retrofit Headlamp Adjustment Screw Caps**

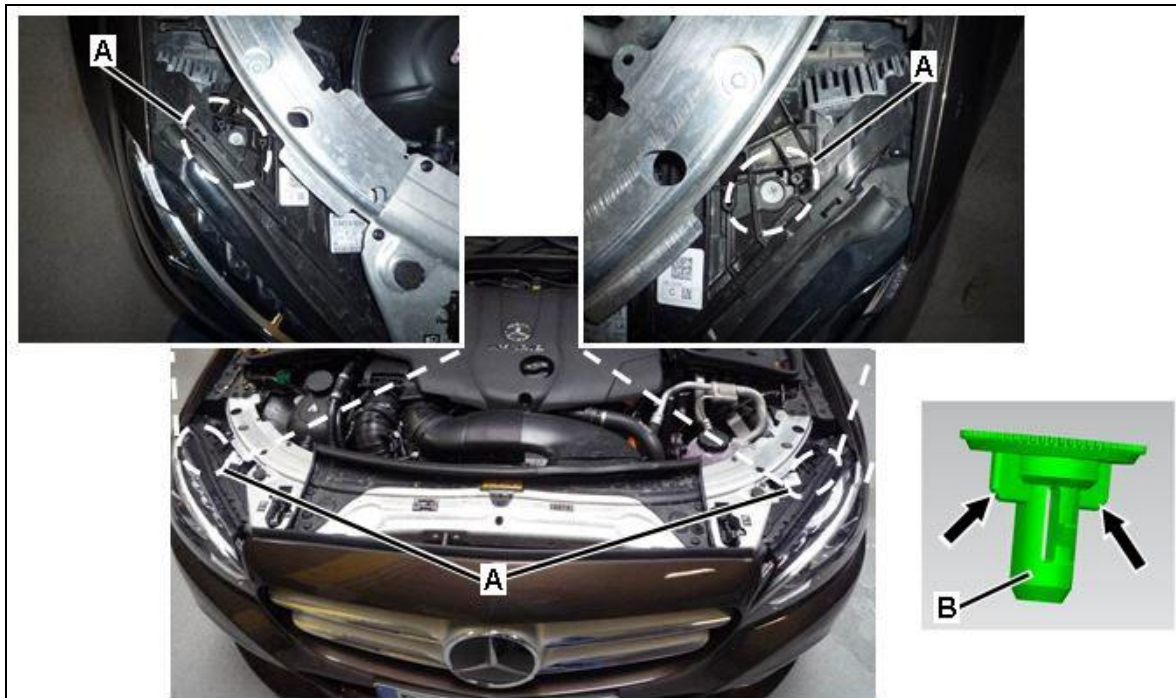
Figure 1

Daimler AG (DAG), the manufacturer of Mercedes-Benz vehicles, has determined that the headlamps might not meet the requirements of Federal Motor Vehicle Safety Standard (FMVSS) 108, which requires that headlamps with low beams must not have a horizontal adjustment mechanism. The subject vehicles are designed to meet this requirement by sealing off the headlamp horizontal adjustment screw with a non-removable sealing cap after initial adjustment in the manufacturing plant. The sealing cap may not have been installed on these vehicles. An authorized Mercedes-Benz dealer will retrofit the two sealing caps. **This recall affects dealer inventory only. Affected vehicles must be repaired prior to sale or lease.**

1. Open hood.
2. Retrofit cap (B, Figure 1) for headlamp adjustment screws (A) at left and right:
 - Position cap (B, Figure 1) on headlamp adjuster (A) so that the tabs (arrows) on the cap (B) align with the grooves in the adjuster (A).
 - Press the cap (B) into adjuster (A) by hand until it locks into position.

An audible click will be heard when the cap (B) is properly seated into the adjuster (A).
