Model 203.040/061/064/065/081/084/261/264/740/747/764

Model 203.281/284, without Sport [Suspension](#) (code 486)

Knocking or Rumbling Noise From the Front Axle Area on Rough Roads

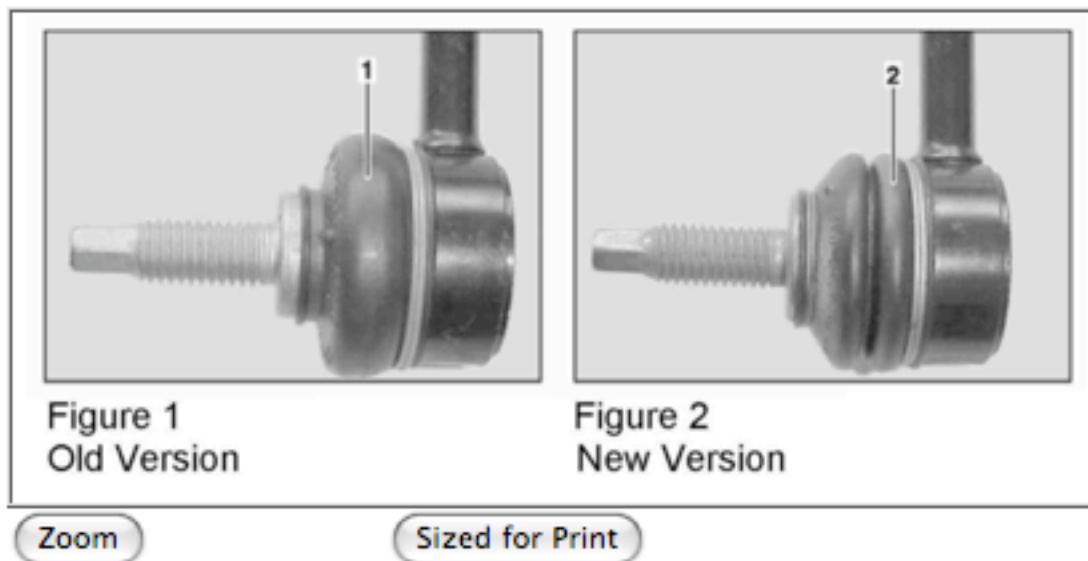
If you receive customer reports in the above model vehicles of a knocking or rumbling noise from the front axle area when driving on rough roads, check the [ball joints](#) for the front [torsion bar](#) links for excessive wear. The excessive wear can be caused by moisture entering through the sealing bellows. In this case, there will be noticeable play in the ball joint. To resolve, install new torsion bar links. As of October 2002 production, the rod ends have been redesigned (new part number) (Figure 1 and 2). If the ball joints for the front torsion bar links are OK, refer to WIS document no. AR32.00-P-2000A for additional diagnostic assistance. Repair procedure, refer to WIS document no. AR32.20-P-0300P.
