Suspension - Front End Thumping Noise on Bumps

Order No.: P-B-32.25/07a

Model 203.040/061/064/065/081/084/261/264/740/747/764

Thumping Noise from Front Axle Area While Driving Over Bumpy Road

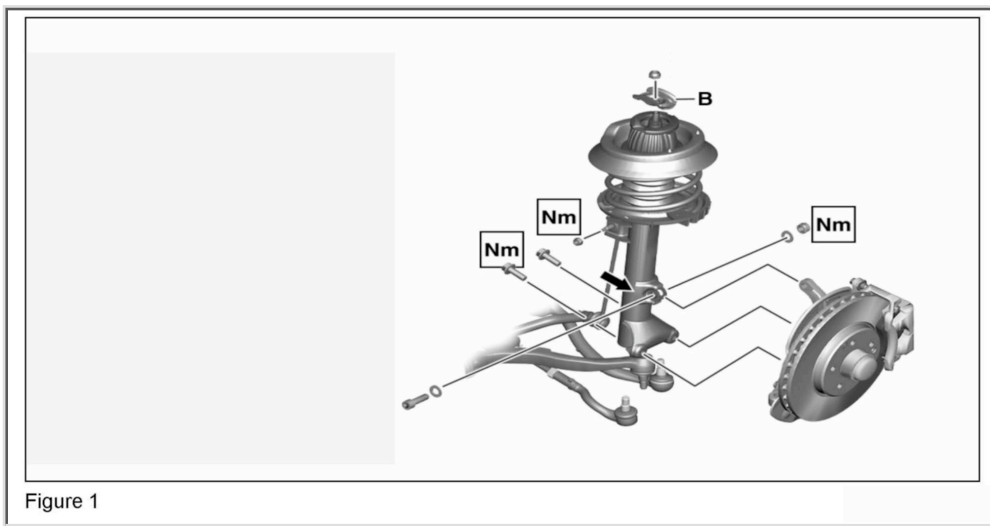
Figure 1

If you receive customer reports in the above model vehicles of a thumping noise occurring from the front axle area while driving over bumpy roads, it is possible that the clearance between the rebound stop (Figure 1, B) and the rubber ring on the top of the front damper strut is too small.

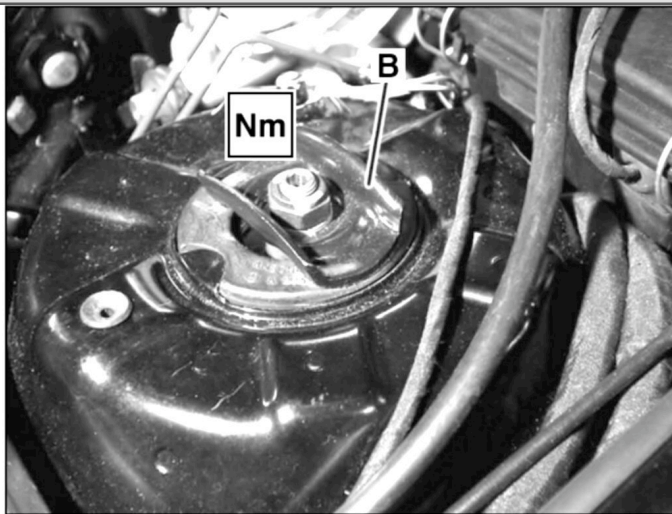
Figure 2

4. Measure clearance between the rebound stop (Figure 2, B) and the Rubber ring. If the clearance is below 1 mm, then the rebound stop (Figure 2, B) must be replaced.

5. Remove the 21 mm nut which secures the rebound stop to the damper strut assembly.
- Note:** It is not necessary to remove the damper strut assembly.

6. Replace the removed rebound stop with a new rebound stop.
 7. Secure the new rebound stop with a new 21 mm nut. Refer to WIS document AR32.25-P-1018P for the torque value for the newly installed 21 mm nut.
