# Suspension - Rumbling Noises While Driving Over Bumps

Order No.: P-B-33.10/11b

Model 203.040/061/064/065/261/264/740/764

## Rumbling Noises While Driving Over Bumps or On Bad Roads

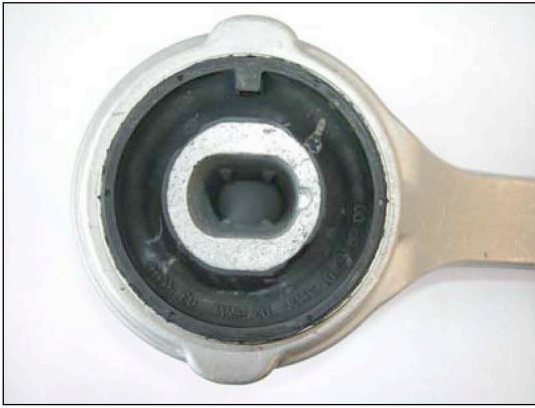
Figure 1

Good Bushing

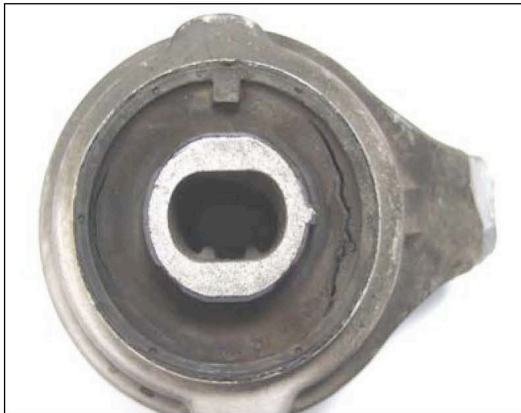
Figure 2

Torn Bushing

The rubber mount on the torque strut is cracked and losing fluid. Affected vehicles are up to VIN A436252 and F339810.

Replace the rubber bushing only. Refer to WIS document AF33.15-P-1120BG.
