2005 Mercedes Benz C 55 AMG (203.076) V8-5.5L (113.988)

Vehicle » Technical Service Bulletins » Customer Interest » Interior - Front Center Arm Rest Loose/Falls OFF

Order No.: P-B-68.20/33c

Front Center Armrest Lid

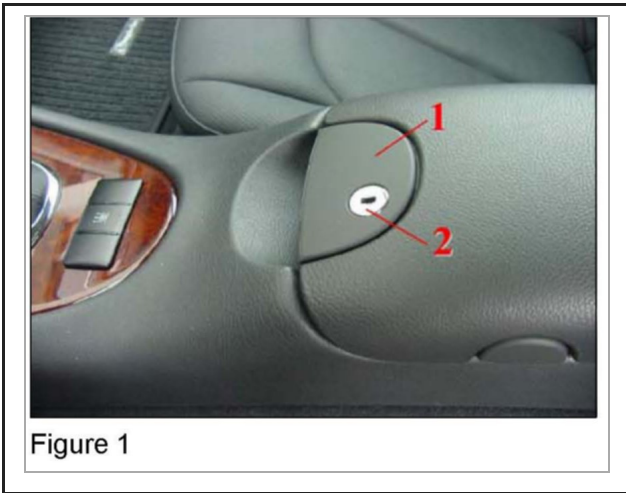
Front center armrest latch will not open or catches when opening.

This may be caused by tolerance problems in the kinematics of the latch or the latch may be broken. If this occurs, it is not necessary to replace the entire lid.

1. Replace only the latch (Figure 1, 1).
2. Remove and install the old lock cylinder (Figure 1, 2) as per WIS document AR68.20-P-2380P.

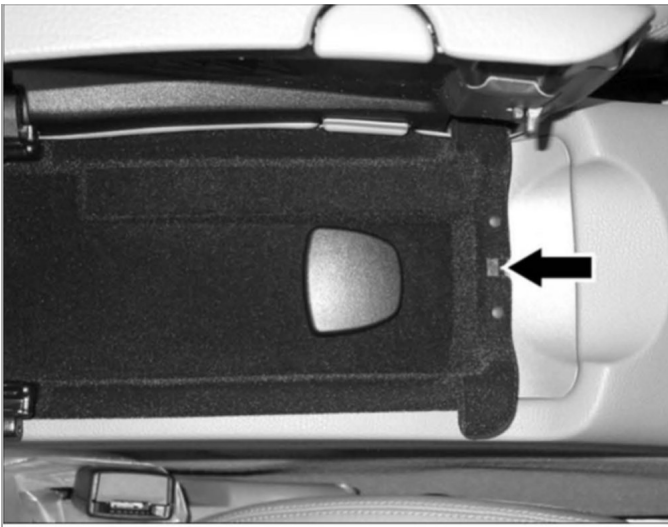
Figure 2

Rubbing noise from center armrest lid.

This may be due to the center armrest lid rubbing against the catch area when driving (Figure 2 for 209 or Figure 3 for 203, arrows). To resolve, lightly grease the catch area.
