Interior - Noise Sources on Instrument Panel BR 204

Topic number L168.10-P-055895
Version 2
Design group 68.10 Instrument panel
Date 05-01-2013
Validity Model series 204
Reason for change Part number of adhesive pad added

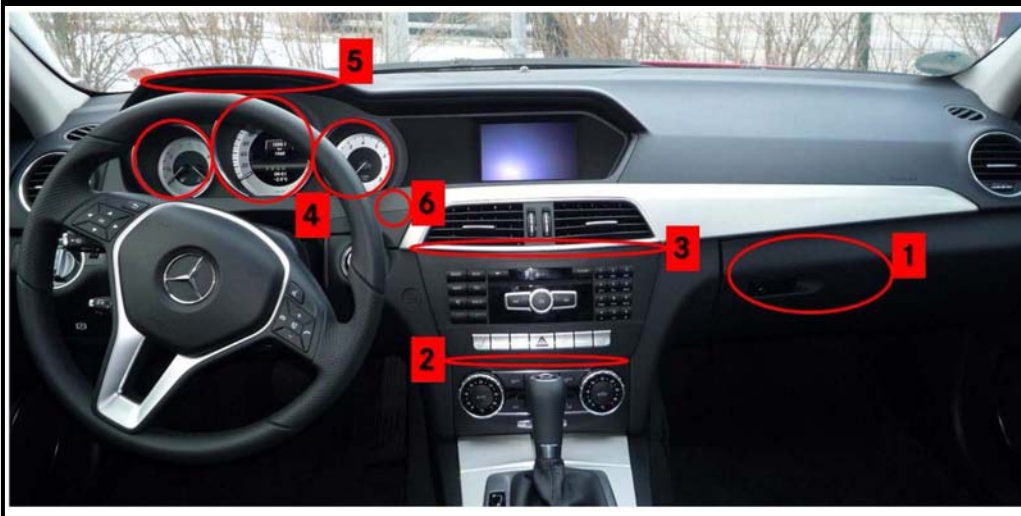
1. Glove box squeaks/rattles in top left area.
2. Creaking or friction noise in center console area at transition from lower control panel to HVAC control panel.
3. Chatter/noise in area of center air vent/head unit (as of facelift).
4. Creaking/cracking noise in area of combination cover (as of facelift).
5. Noise from upper area of instrument cluster.
6. Noise in right instrument cluster area.

File	Designation
Noise source overview.jpg	Overview of noise sources on instrument panel, BR 204

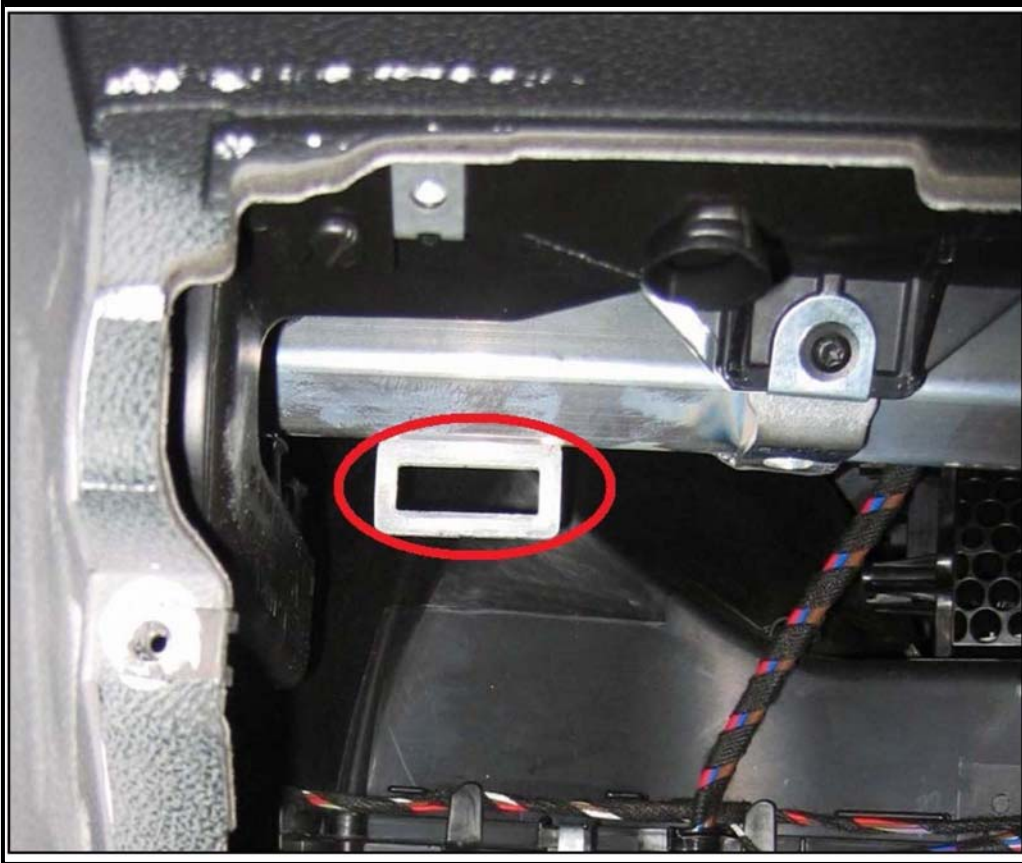
1. Breakthrough for glove box on crossmember sharp-edged (Attachment 1)

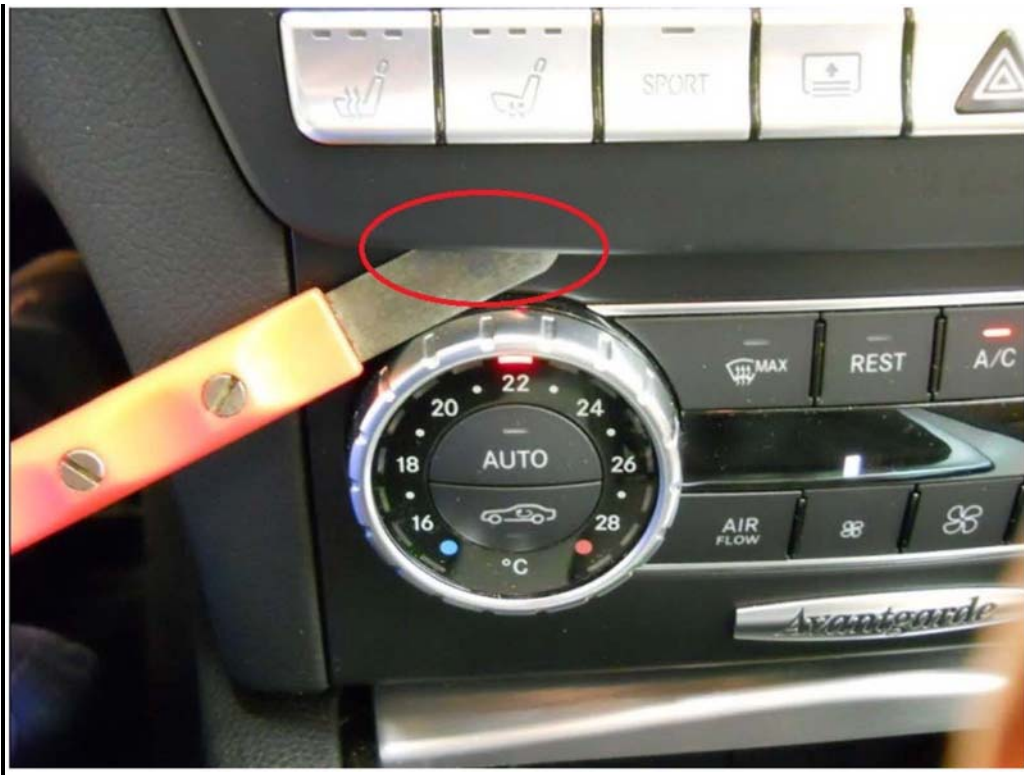
2. Cover of lower control panel makes contact on left side with cover of HVAC control panel (Attachment 2)

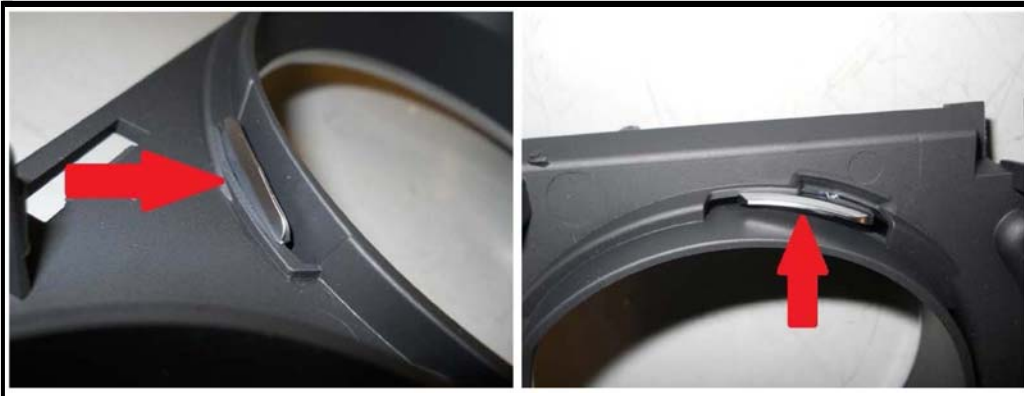
4. The material pairing between the chrome rings and the combination cover generates noise at potentially all points of contact (Attachment 4)

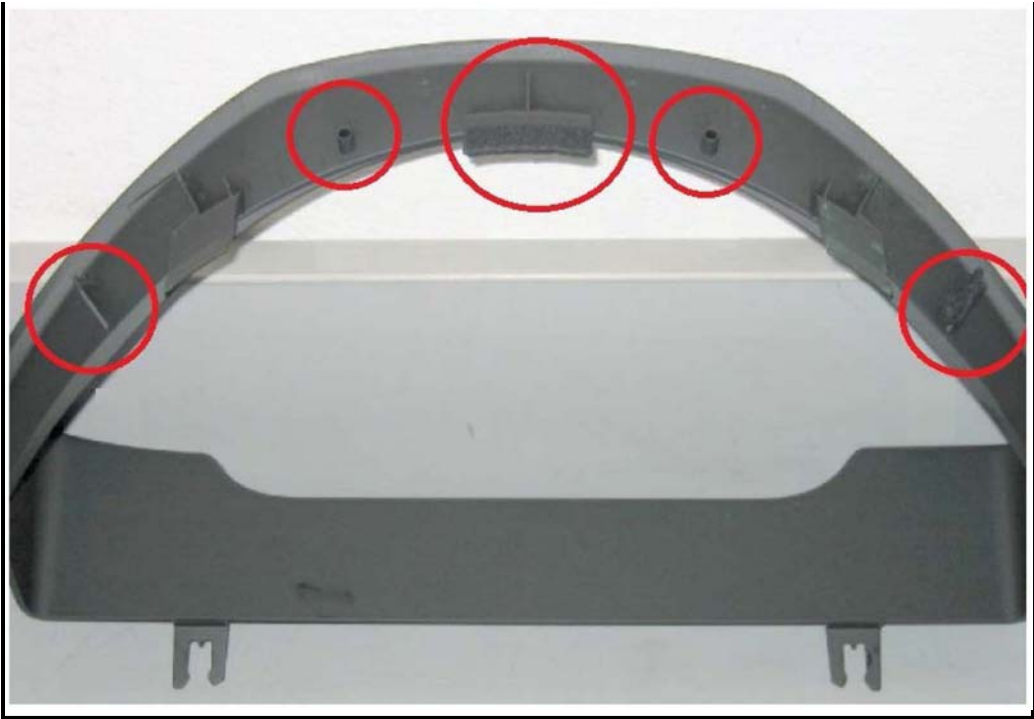
5. Relative movement of components to each other (Attachment 5)

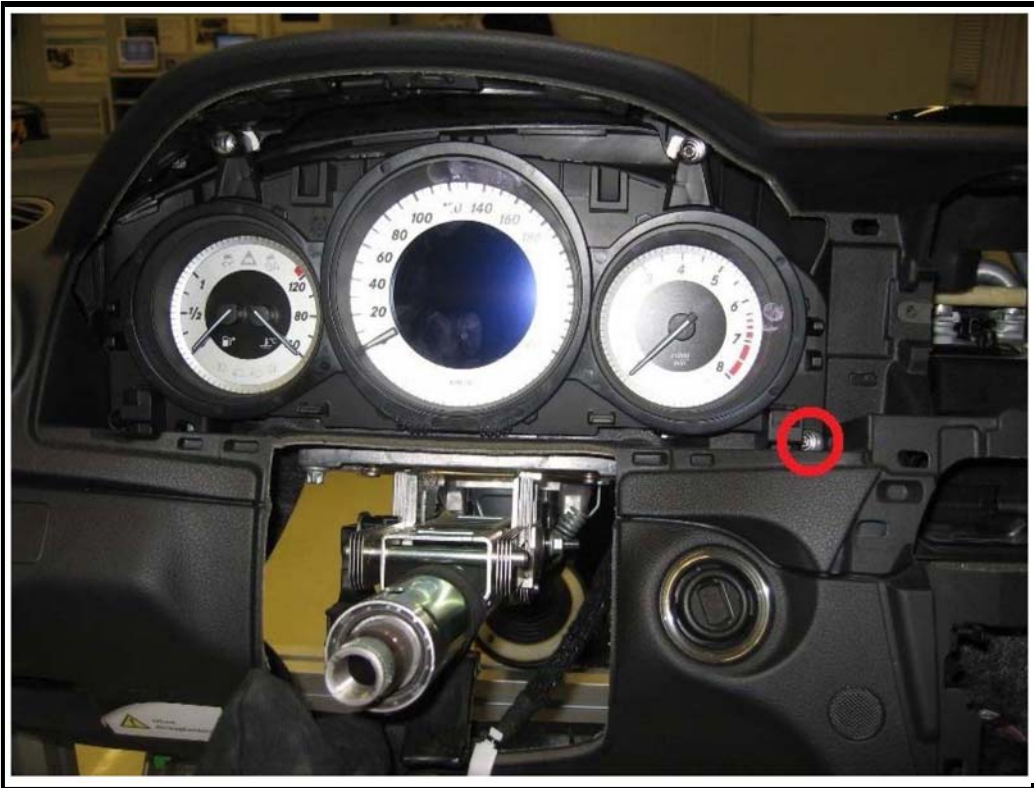
6. Improper torque of attachment bolt (Attachment 6)
