Recall Campaign Bulletin

Campaign No. 2019050008, May 2019

SUBJECT: Model 204 (C63 AMG only)

Replace Driver-Side and Front Passenger-side Airbag and install Knee Bolster

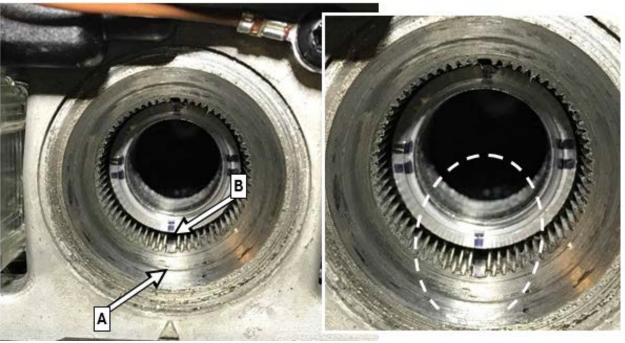
Figure 2

The serrations (A, Figure 2) on the steering wheel must be aligned with the marking (B, Figure 2) on the steering shaft.

i For basic data for models 204 see AR46.10-P-0100CW

$oxed{f L}$ Check the position carefully before removal and position identically during installation.
