June 4, 2018

Subject: Joshua Wetherson's Complaint Submission with the Attorney General's Office.
Repair Order #: 220047 – VIN# WDDSJ5CB6EN057853
ECS Reference: Complaint #: NMOAG-ECS-20180531-6529

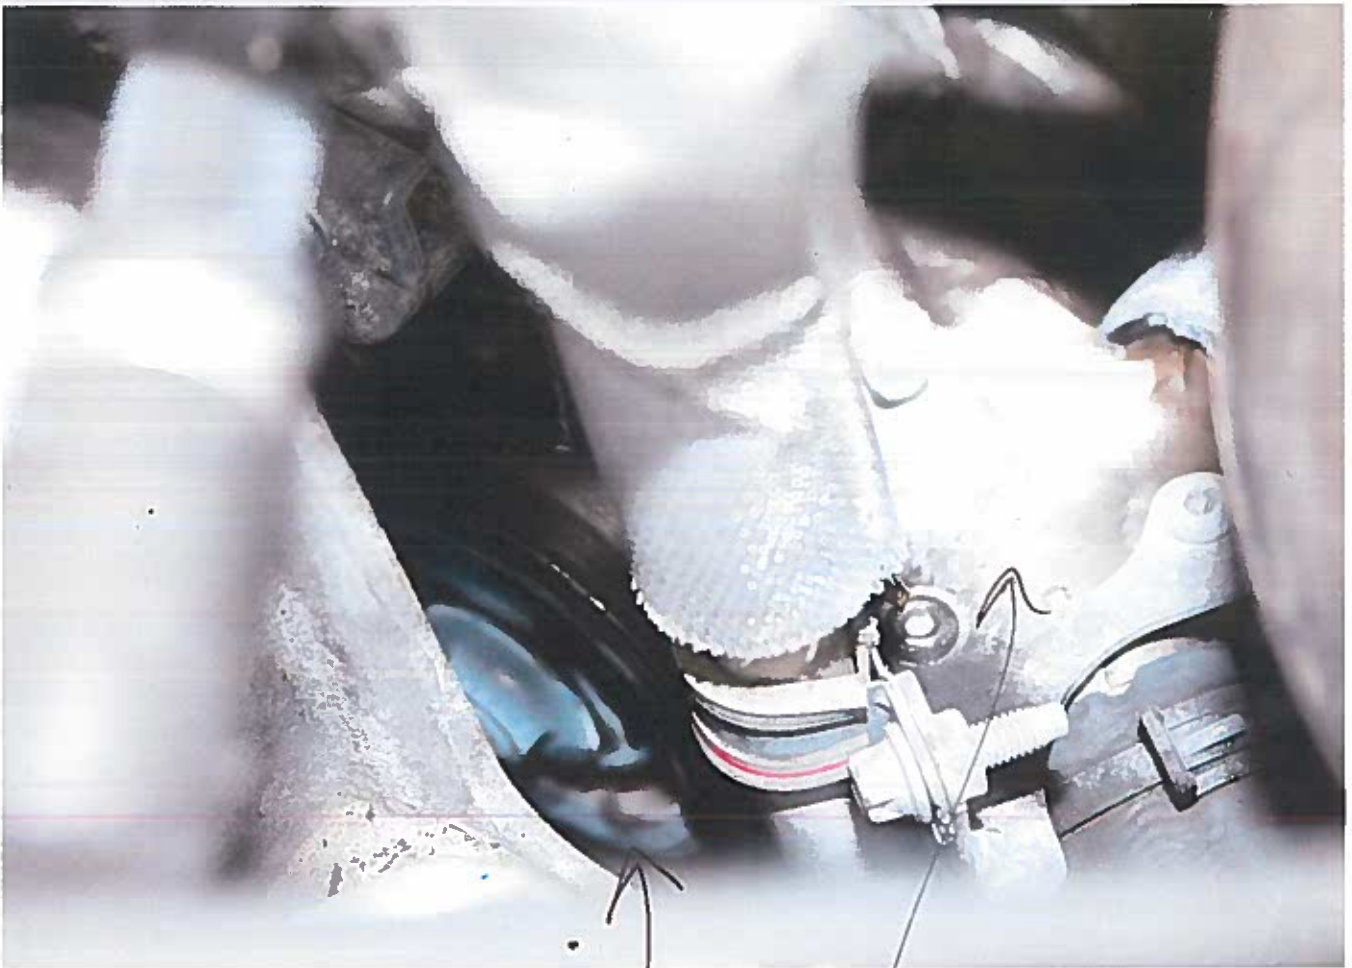
Mercedes-Benz Corporate requested this information to decide if a goodwill adjustment was warranted. The inspection came to the conclusion after downloading all the computer data supplied by the on board computers, it was determined that the alternator was overburdened, causing the alternator to overheat and the excessive heat caused the belt that turns the water pump to fail.

The excessive heat damage to the belt that runs from the crankshaft to the water pump caused the water pump to stop circulating coolant, and the engine to overheat. According to the data retrieved from the engines on board controller, the coolant light warning came on seven times prior to the engine failure. We received the vehicle with 41719 miles. The last engine warning light came on at 41716 miles. Because of the engine damage our technicians were not able to start the engine and drive the vehicle into the stall for inspection.

For clarification reasons, I should explain that the vehicle has two belts on the engine, one for all the accessories (this would be the large one that is easy to see), and the second belt for the water pump, which is run exclusively by the crankshaft (This belt is hard to see from the top of the engine). We have included photos, so you can make out what we are describing. The belt is melted to the pulley.

Engine coolant pump and pulley
turned white from excessive heat

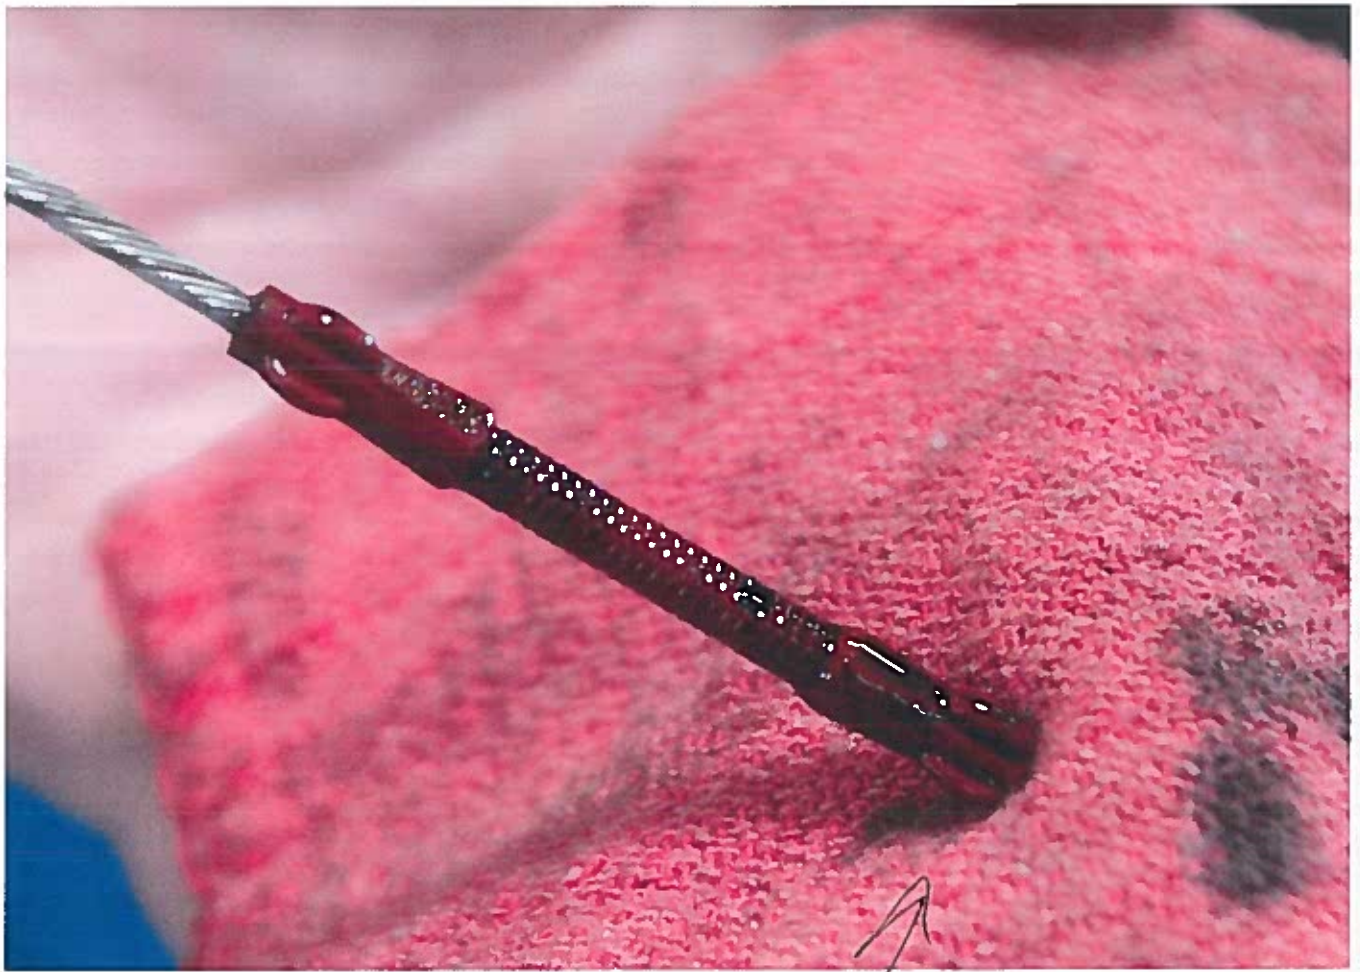
We have also included the dip stick, which clearly shows that there is oil in the engine, along with a photo of a 200 amp fuse installed in series between the battery and alternator. The alternator that is installed on this vehicle is rated at 175 amps. This is why the fuse did not blow and protect the alternator.

Engine oil on Dipstick

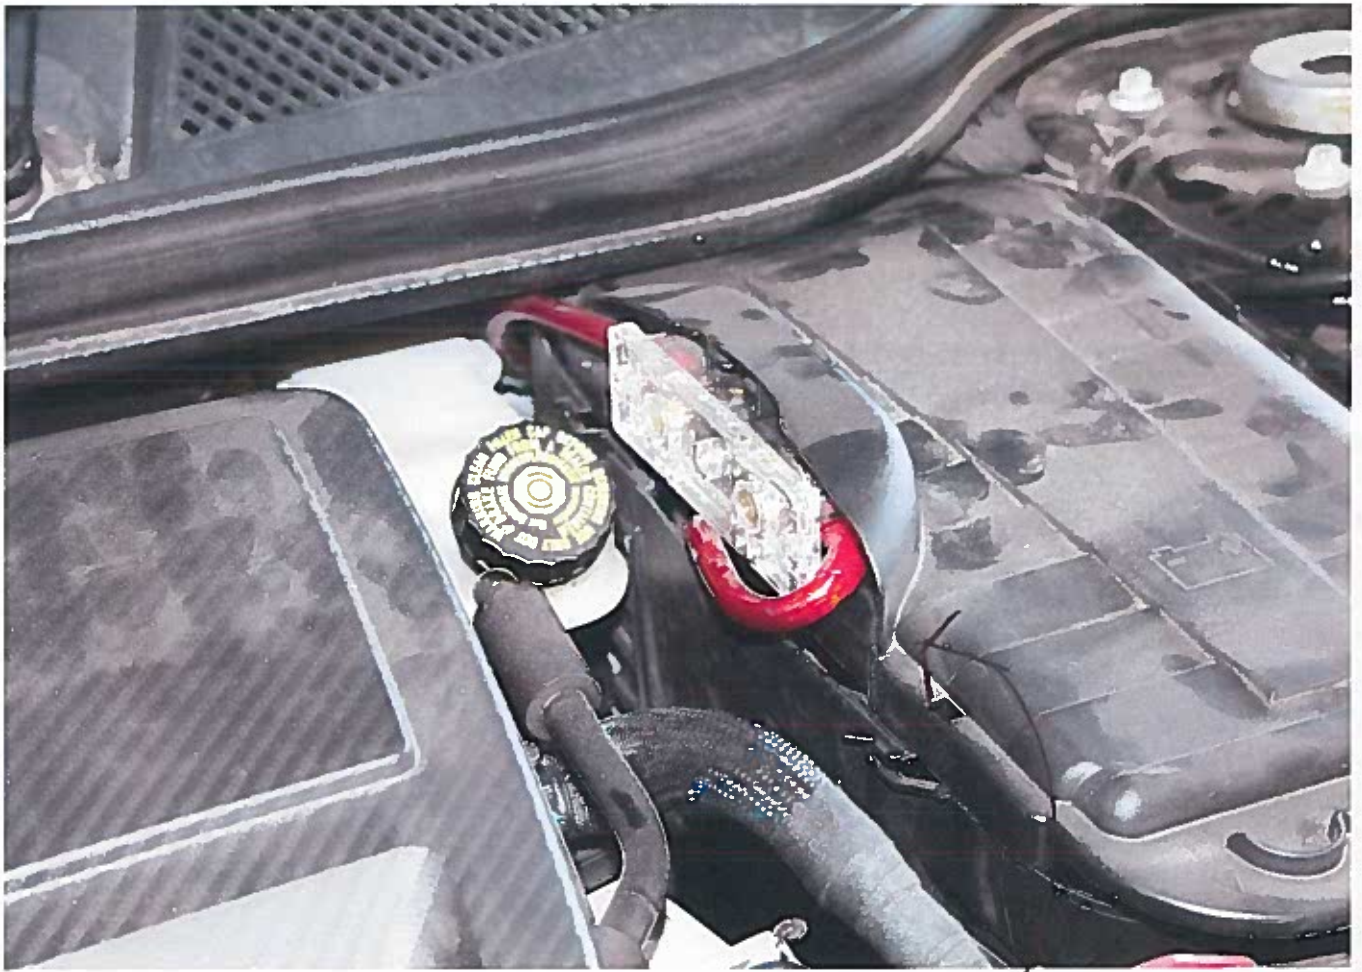
Aftermarket wiring Installed

Client's vehicle has an Alternator that is only rated at 175 Amps. Client's Aftermarket Fuse is 200 Amps. Also Client's Aftermarket Fuse is not inline from Alternator to Battery. It is from Battery to his equipment in Trunk.
