DTB

Date: April 23, 2009
 Order No.: S-B-03.30/08i
 Supersedes: S-B-03.30/08h dated October 24, 2008
 Group: 03

SUBJECT: Model 164.156/172/186/871/886
Model 171.454/456
Model 203.052/054/056/087/092
Model 204.054/056/081/987
Model 209.356/372/456/472
Model 211.056/072/087/090/256/287
Model 216.371/386
Model 219.372
Model 221.171/186
Model 230.471
Model 251.156/165
Equipped with M272 or M273 Engine
Check Engine Light On / Fault Codes Current and/or Stored in ME-SFI Control
Module / Oil Leaking at Camshaft Adjustment Solenoid

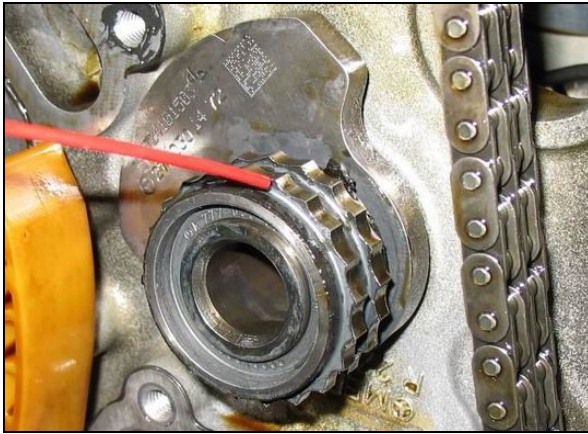
Figure 1 – Damaged/worn S-B-03.30/08a

Fault Code Scenario 1: DTC 1200 and/or 1208 is/are present in ME-SFI control module. The fault codes are recorded as current and/or stored in the fault memory. When the fault memory is erased and the engine is restarted, the fault codes reoccur immediately. This is due to the positioning of the timing chain driven camshafts relative to the crankshaft and can be caused by a worn sprocket on the balance shaft on engine M272 or by a worn guide (idler) gear for the timing chain on engine M273. Figure 1, 2 and 3 show extremely worn sprocket gears. Figure 4, for comparison, shows a new sprocket gear.

i **Note:** Refer to Figure 1 through 3 for examples of damaged / worn sprocket profile. Refer to Figure 4 for example of a new gear (for comparison).

- b) Only if worn (sprocket teeth profile damaged), replace the balance shaft on engine M272 or replace the guide (idler) gear of the chain drive on engine M273 as per WIS instructions AR03.20-P-1000* (* - applies to a specific model designation e.g. AR03.20-P-1000VA – model 171).
