TO: Mercedes-Benz Dealer Principals, General Managers, Sales Managers, Service Managers, Parts Managers	FROM: Gregory Gunther, Department Manager, Vehicle Compliance and Analysis, Engineering Services
RE: <b>Recall Campaign Launch Notification</b> <b>Check Sliding Roof Bonding – Phase 2</b> <b>MY01-11 Various Models</b>	DATE: July 10, 2020

Campaign No. 2020040011, June 2020

SUBJECT: **Models C-Class, CLK-Class, E-Class, and CLS-Class (203, 209, 211, and 219 platform)**  
**Model Years 2001-2011**  
**Sliding Roof Bonding - Phase 2**

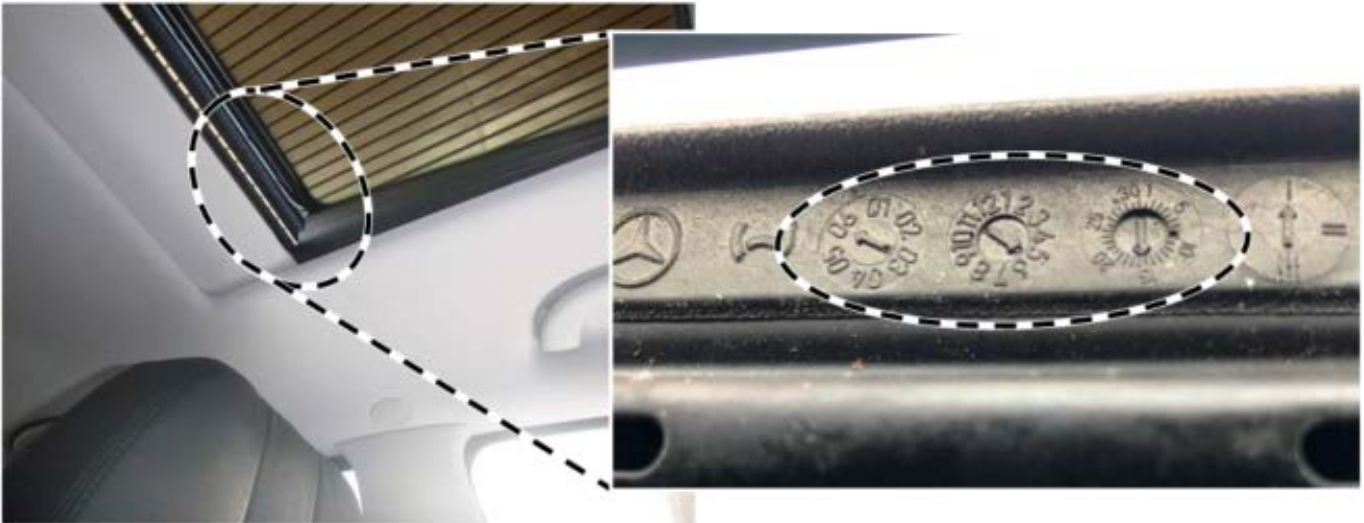
1. Move sliding sunroof to tilt position and check production date (**figure 1**).

**i** The production date **must** be on or **after 01-16-2006** or on or **before 07-09-2006**.

**Figure 1** (The production date in the sample picture is **06 year / 5 month / 15 day**)(5-15-2006)

- A.** Production date between 01-16-2006 and 07-09-2006: Carry out **check/test procedure B**.
- B.** Production date **not** between 01-16-2006 and 07-09-2006: **End measure**.

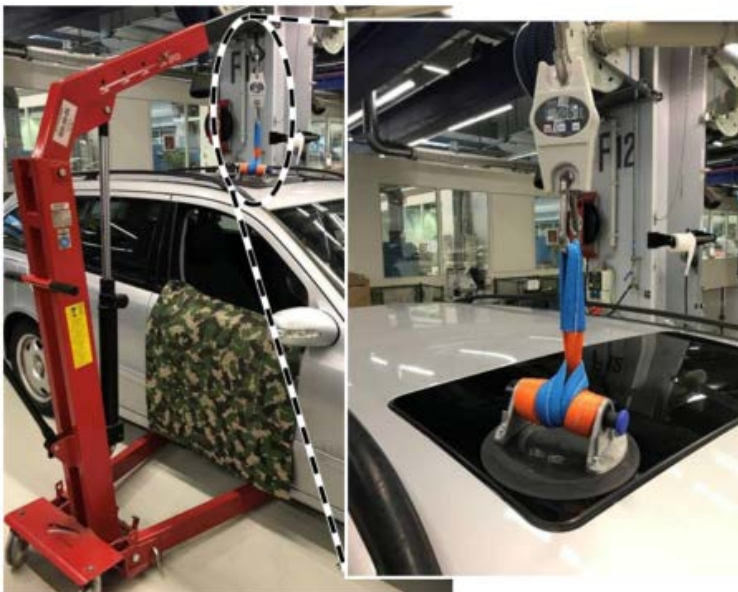
Figure 2

3. Position cup suction tool (**figure 2**) and pull as **vertically** as possible (tolerance of  $\pm 10$  degrees) using lifting tool.

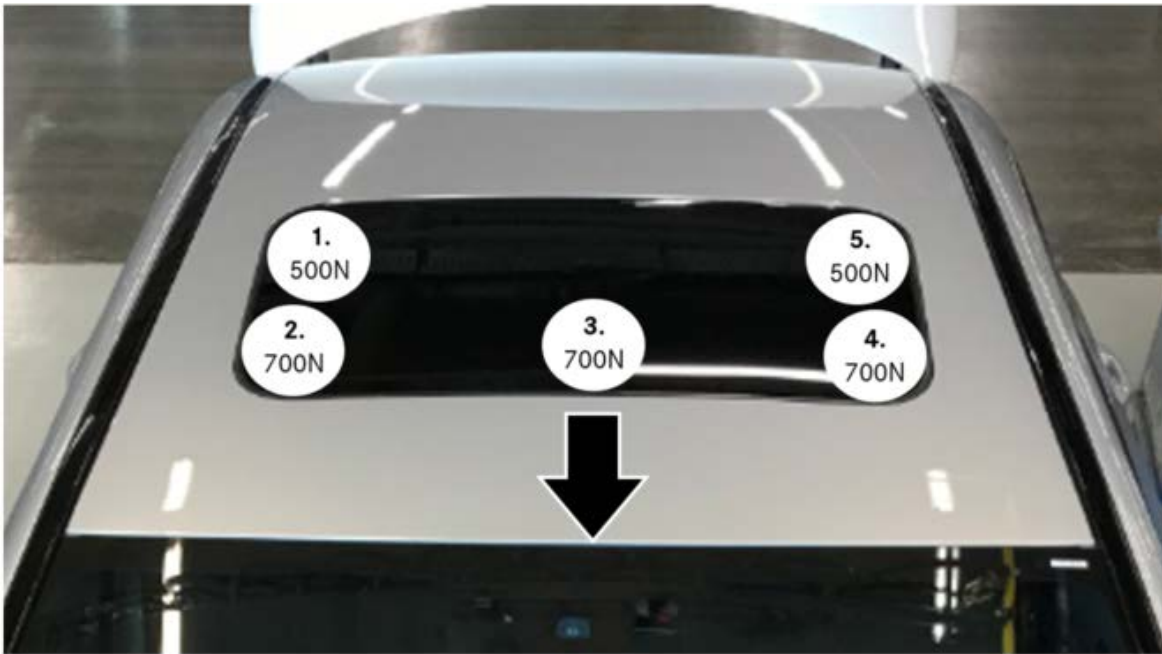
Specified force 500 N/700 N (**figure 3**).

Position cup suction at 5 positions in the sequence **1, 2, 3, 4, 5: (Figure 3)**.

**Figure 3** (test sequence 1, 2, 3, 4, 5 – arrow specifies front of vehicle)

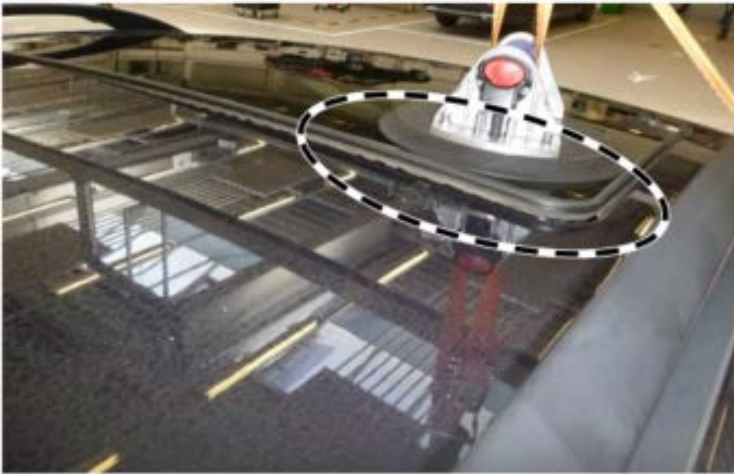
Figure 4

- i** The sliding roof panel is lifted out of the roof frame noticeably at the rear test positions 1 and 5 (**figure 4**).
- i** If the sliding roof panel detaches from the padding of the tilting/sliding roof frame at one of the test positions (see **figure 5**), the sliding roof panel must be replaced.

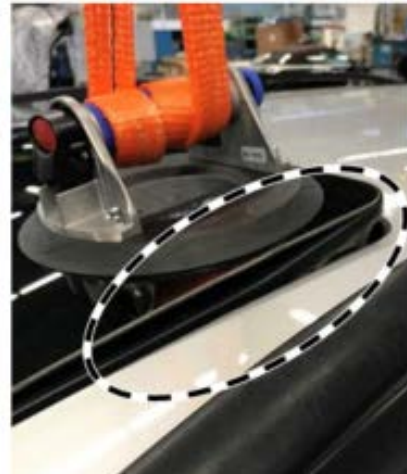
Figure 5 (**NOT OK**)

- C.** If the sliding roof panel detaches from the padding: Carry out **work procedure**.
- D.** If the sliding roof panel does **not** detach from the padding: **End measure**.
