Campaign No. 2019090019, October 2019

SUBJECT: **Model CLS-Class vehicles (257 platform)**
Model Year 2019
Wiring Harness for Electric Coolant Pump

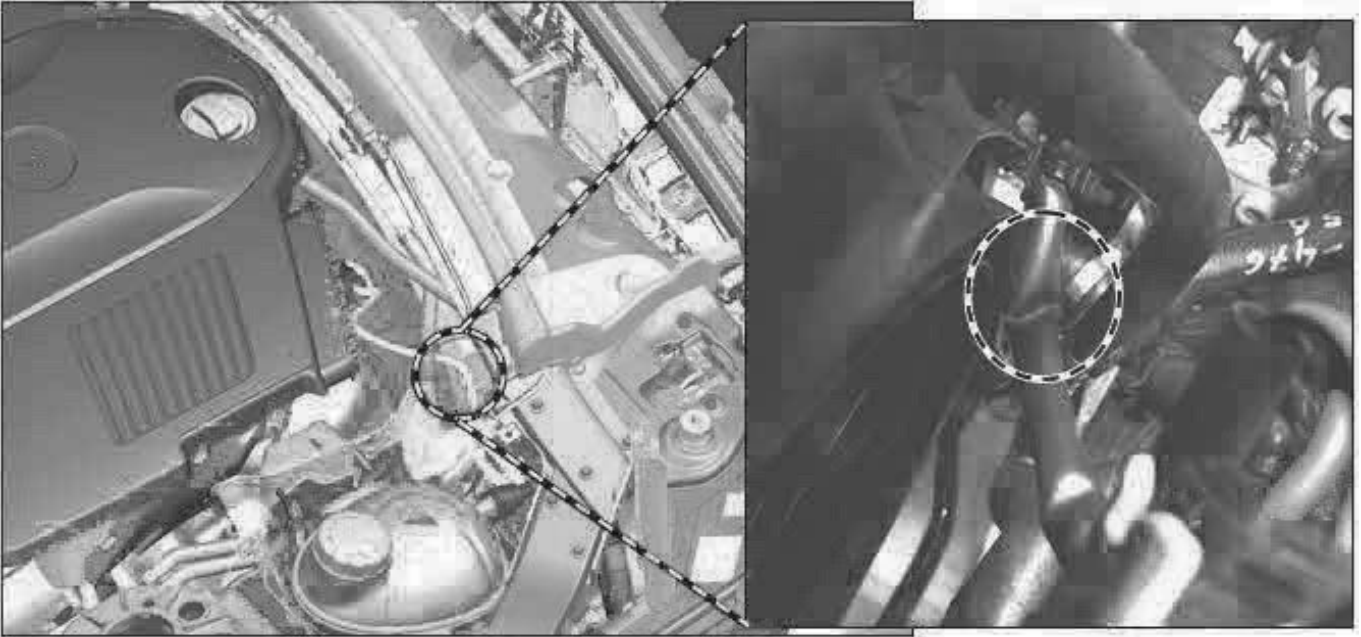
Figure 1

Daimler AG ("DAG"), the manufacturer of Mercedes-Benz vehicles, has determined that on certain Model Year ("MY") 2019 CLS-Class vehicles (257 platform) equipped with a 6-cylinder gasoline engine (M256), the electric power supply for the engine coolant pump might contact the engine fan and chafe. Chafing of the electric power supply for the engine coolant pump could lead to a malfunction of the engine coolant pump and/or a deactivation of the 48V on-board electrical system. If the engine coolant pump malfunctions, the engine coolant temperature might increase, potentially leading to an engine stall. If the 48V on-board electrical system becomes deactivated while the engine is running, the vehicle can continue to be driven. However, a restart of the engine would not be possible if the engine has been switched off by the ECO start/stop function or by the "Glide" mode functionality. In both cases, the vehicle propulsion would be lost, increasing the risk of a crash. An authorized Mercedes-Benz dealer will check for damage on the electric power supply to the coolant pump and repair it, if necessary. Additionally, the routing of the electric line will be modified in order to prevent potential contact with the engine fan.

1. Check electrical wiring harness of electric coolant pump in area of fan for damage (figure 1).

- a. **Line insulation** and **protective hose** of electrical wiring harness **damaged**:
Perform **work procedures A and B and C**.
- b. **Only Protective hose** of electrical wiring harness **damaged** and **line insulation NOT** damaged:
Perform **work procedures B and C**.
- c. **Line insulation** and **protective hose** of electrical wiring harness **Both NOT** damaged: Perform **work procedure C**.
