## **Service Campaign Bulletin**

Campaign No. 2017010006, March 2017

SUBJECT: Model 190, Model Year 2016

Check Automatic Transmission for Leaks, Replace if Necessary

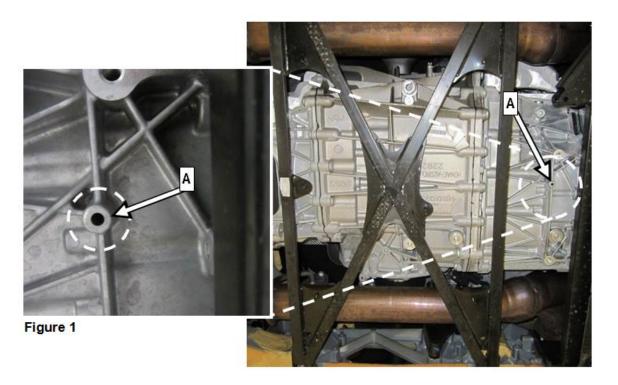
- 1. Remove underfloor paneling under automatic transmission.
- 2. Check ventilation bore (A, Figure 1) at bottom side of transmission for leaks.

- If transmission fluid is **NOT** leaking from ventilation bore (A) **(OK)**: Procedure is complete.
  - Note: Reassemble in reverse order.
- If transmission fluid **IS** leaking from ventilation bore (A) (NOT OK): Proceed to step 2.
- 2. Replace automatic transmission; refer to WIS: AR27.10-P-0502MNB.
- 3. Create PTSS case:
  - Submit pictures of old automatic transmission serial number and new transmission serial number along with VIN.

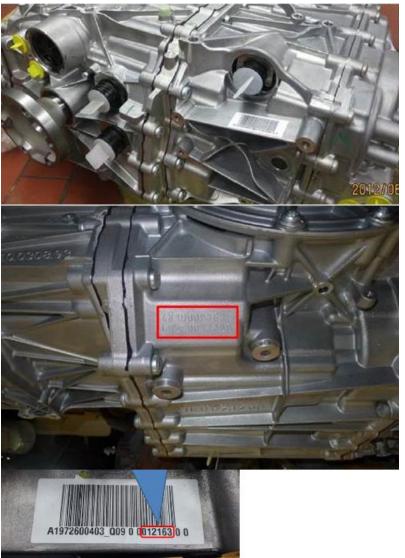
Figure 2

- Pictures submitted must be of good quality and high resolution (refer to Figure 2). Picture with bar code is preferred.
- No SDS print out is required.
- No further instructions will be provided. Do **not** select check box for information only case.
