Mercedes-Benz

Campaign No. 2016050008, September 2016

SUBJECT: **Model 190, Model Year 2016**
Check Drive Shaft, Replace if Necessary

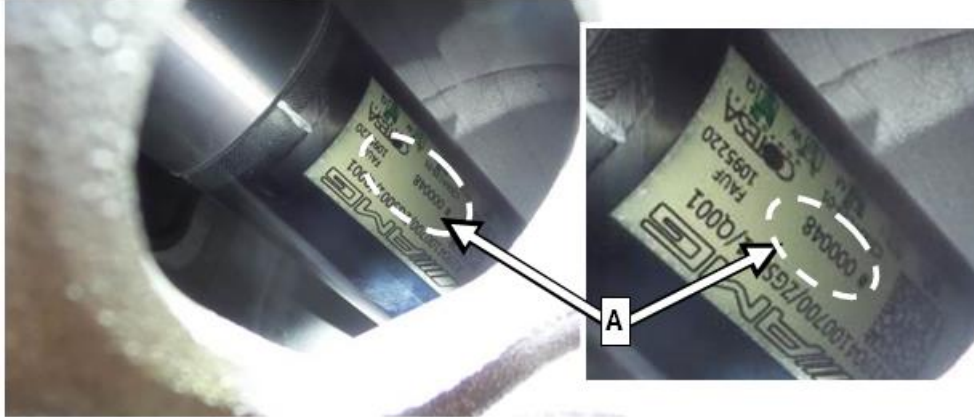
Figure 3

Check drive shaft production number (A, Figure 3).
- If production number is **greater** than **000322 (OK)**: Procedure is complete.
 - If production number is **less** than or **equal** to **000322 (NOT OK)**: Proceed to step 5 (below).

Replace drive shaft, refer to WIS: AR41.10-P-0051MNB.
-
