Gap from longitudinal member panel to front fender too large - greater than 0.65 mm

Topic number	LI88.10-P-065524
Version	1
Design group	88.10 Fenders
Date	01-11-2017
Validity	MODEL 190.3##
Reason for change	
Reason for block

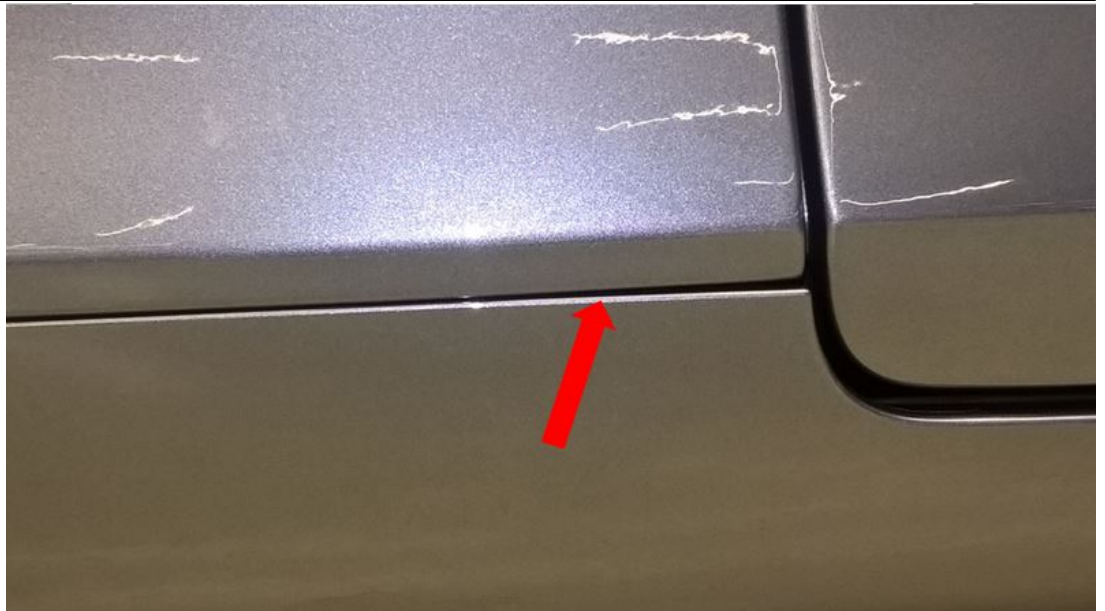
Spaltmaß LTV1.JPG:

Gap from longitudinal member panel to front fender too large - greater than 0.65 mm (Figure 1).

Adjustment of distance from front fender to longitudinal member panel.

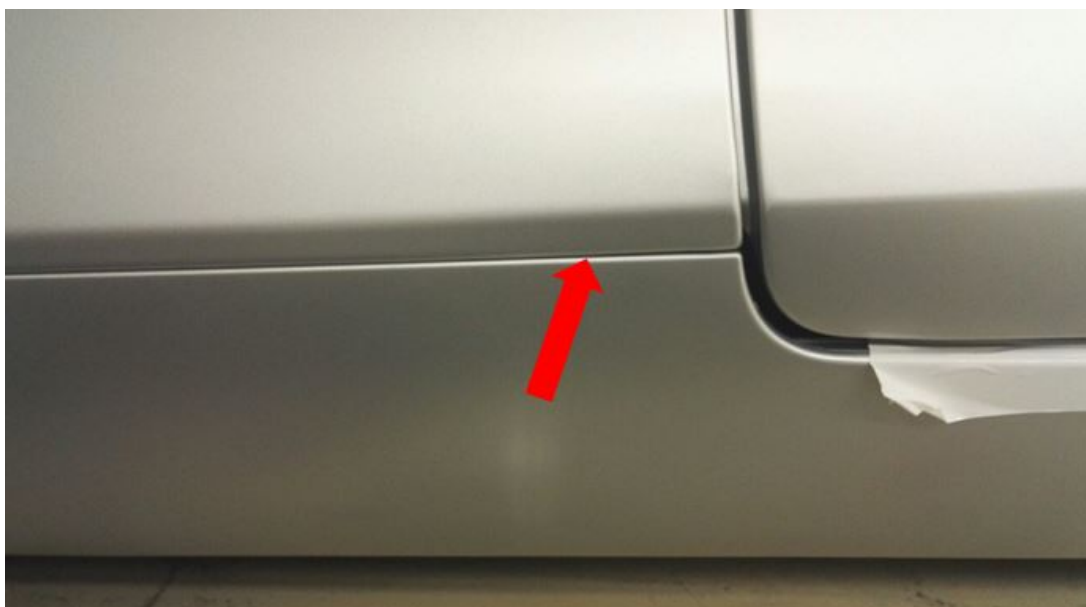
Spaltmaß LTV4.JPG:

Gap after adjustment < 0.65 mm (Figure 4).
