Article No.: TASC-TIP-06-09

Mercedes 722.6, Daimler W5, Porsche W5, Jaguar 722.6

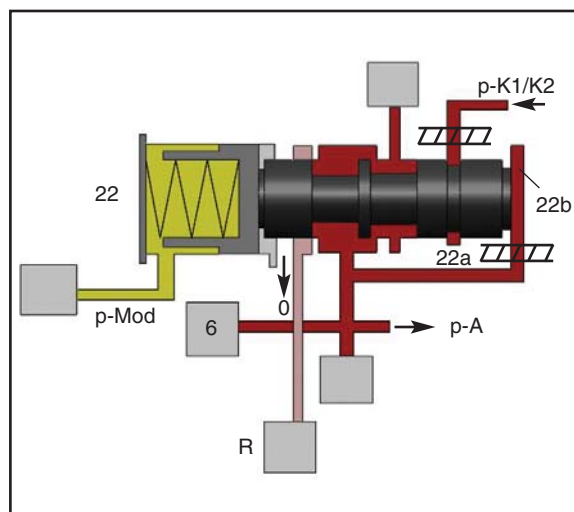
Working Pressure

wears, working pressure does not increase with engine load and the flare or loss of gear occurs.

In 1998, many of the high mileage cars we repaired under Mercedes warranty had the same problem: 2-3 flare causing the vehicle to go into limp mode. After several inspections we discovered the link between the working pressure bore wear and the shift problems. We felt that the lack of hardness of the valve body material was the cause of this common failure. We designed a bushing to correct the leakage, using a harder material that would allow it to last longer when paired with a high speed valve. The valve is a long, one-piece

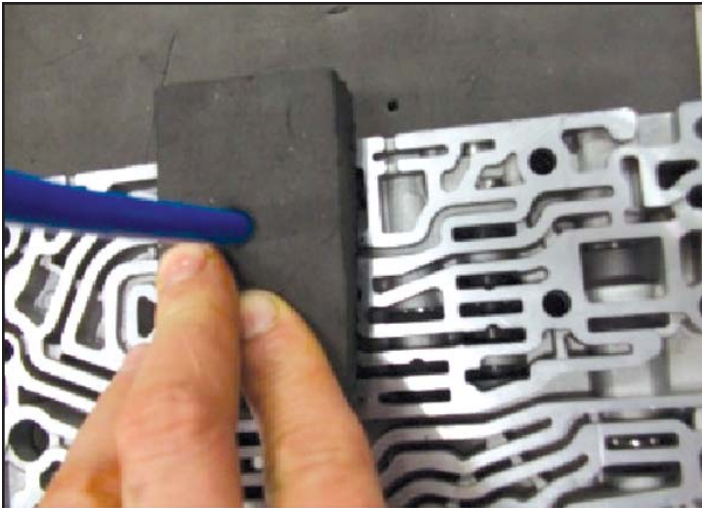
Vacuum Test for Working Pressure Valve

design, and when it is leveraged on the larger end, it also loads into the bore on the smaller inboard end. Both of these wear conditions can be discovered by either a vacuum test or a visual inspection.

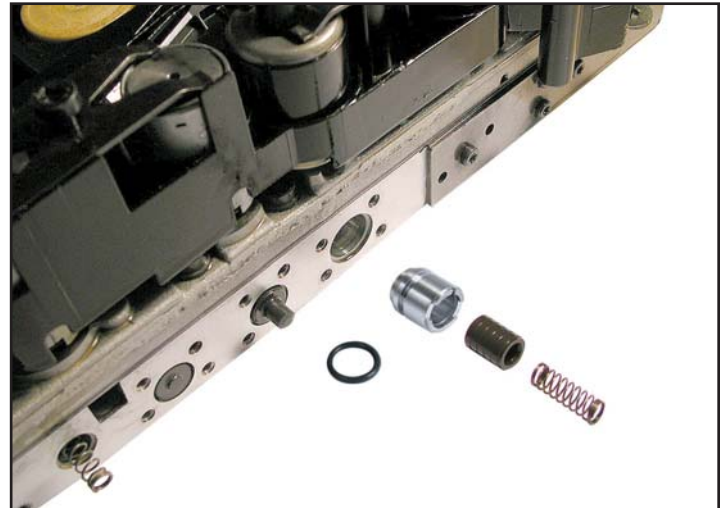
1-2/4-5 Overlap Bore Location

The 1-2 /4-5, the 2-3 and the 3-4 Overlap Sleeves are also in the pMod solenoid signal circuit. It is common for them to wear on the ID and to leak at the OD as well. Wear at any of these sleeves reduces pressure at the working pressure valve. These sleeves can be vacuum tested prior to removal or cleaned and inspected for wear.

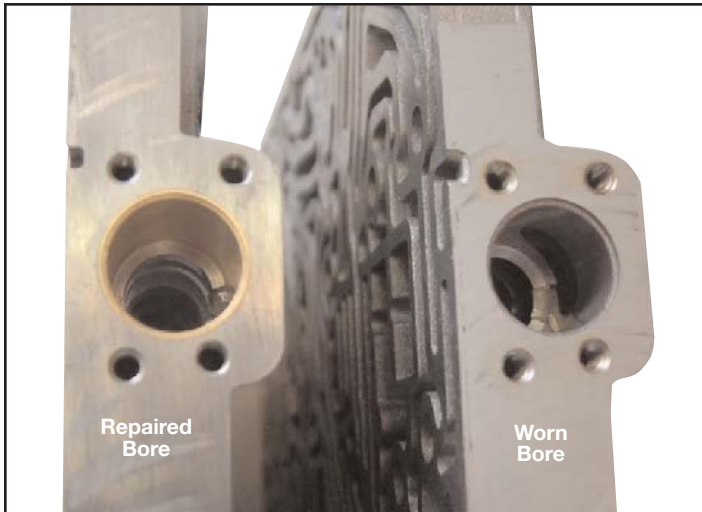
Worn Working Pressure Bore on Right. Repaired Bore on Left.
