John Dahlquist June 19, 2014 Version 3

With direct injection system for engines 157, 276, 278 (for example) the spark plug indexing is very critical as indicated in the picture and the warning information in WIS when replacing spark plugs.

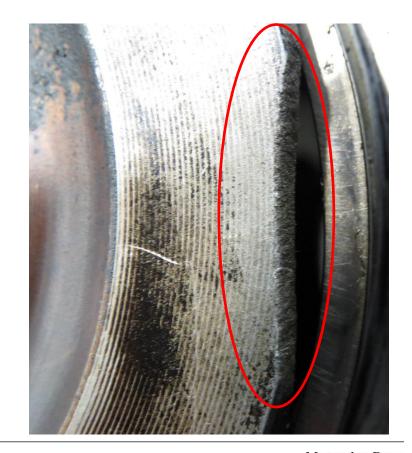
NGK Plug

In this case, the incorrect spark plug caused major engine damage (melted piston) that lead to a complete engine replacement. This is not a warrantable defect.
