Interior - Seat Cushion Rocks Makes Cracking Noises

Date: October 13, 2004

Order No.: P-B-91.10/83

Model 210.020/025/055/065/070/072/074/082/083/265/282

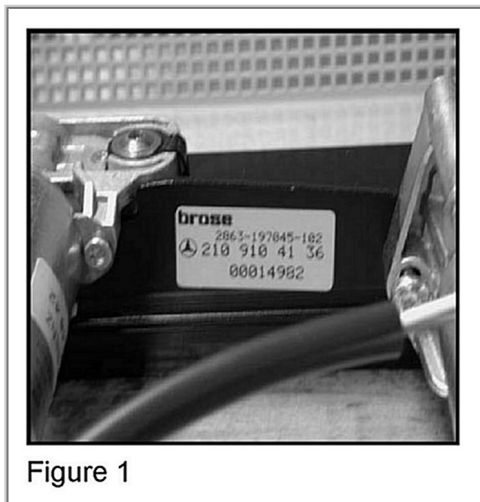
Figure 1

If you receive customer reports in the above model vehicles that the front of the seat cushion rocks when braking and accelerating or makes a cracking noise, this may be caused by excessive clearance for the stepped bolt. To resolve, install replacement bolts with an O-ring which are available as spare parts for seats with the height adjustment mechanism manufactured by Brose. A label identifying the seat height adjustment manufacturer can be found on the mechanism (Figure 1).

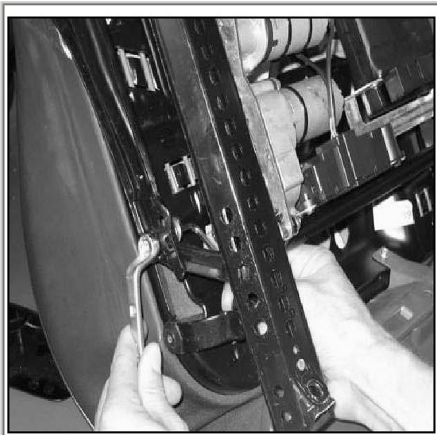
Figure 2 P-B-91.10/83

3. The stepped bolt is now visible just below the lower edge of the seat covering or upholstery near the front on both the left and right sides (Figure 2).
