W210 Intermittent Power Mirror

One-direction only fail

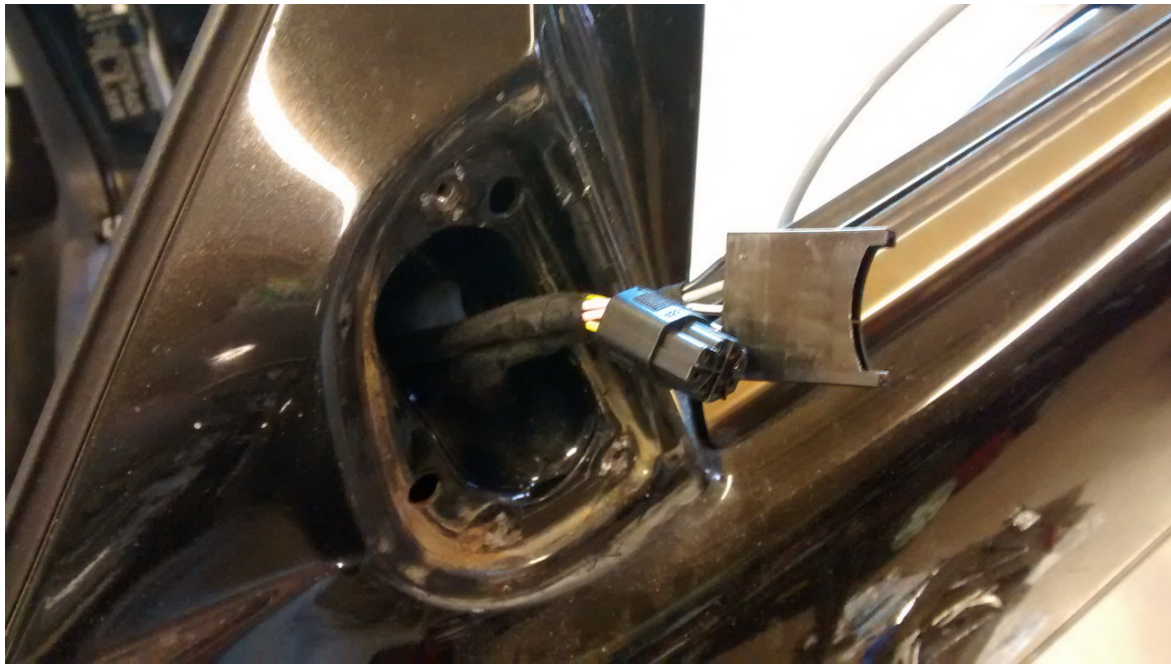
-These two connectors and their mates fit into that small enclosure in the door frame.

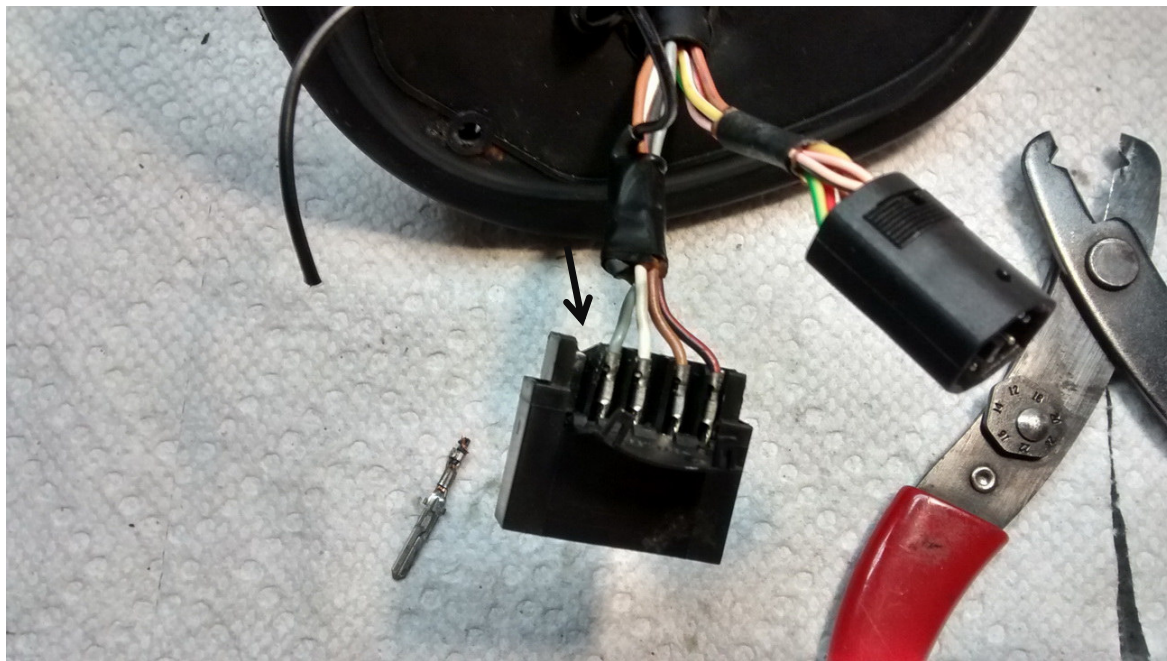
- Cause: mirror harness connector located under mirror and inside(!) the door pillar was crushed against a metal edge. Eventually, the plastic connector deformed and one of the three wires used to control the mirror motor was then forced against the metal edge. Wire insulation cold-flowed from the pressure, wire strands contacted the metal edge, and wire strands began to break.

-Arrow points to area of connector damaged by being crushed against door frame. Pressure damaged wire and head of pin being replaced in this photo.

- Solution: separate damaged wire from pin, splice new length of wire onto original wire, install new pin, insert into socket. Reassemble into door ensuring connectors have sufficient slack (not as easy as it sounds).
