1999 W210

21 May 2021

252,011 kilometers

-Passenger side front door lock assembly failed so door would not close. Replaced with new 202-720-44-35. \$237 w/tax.

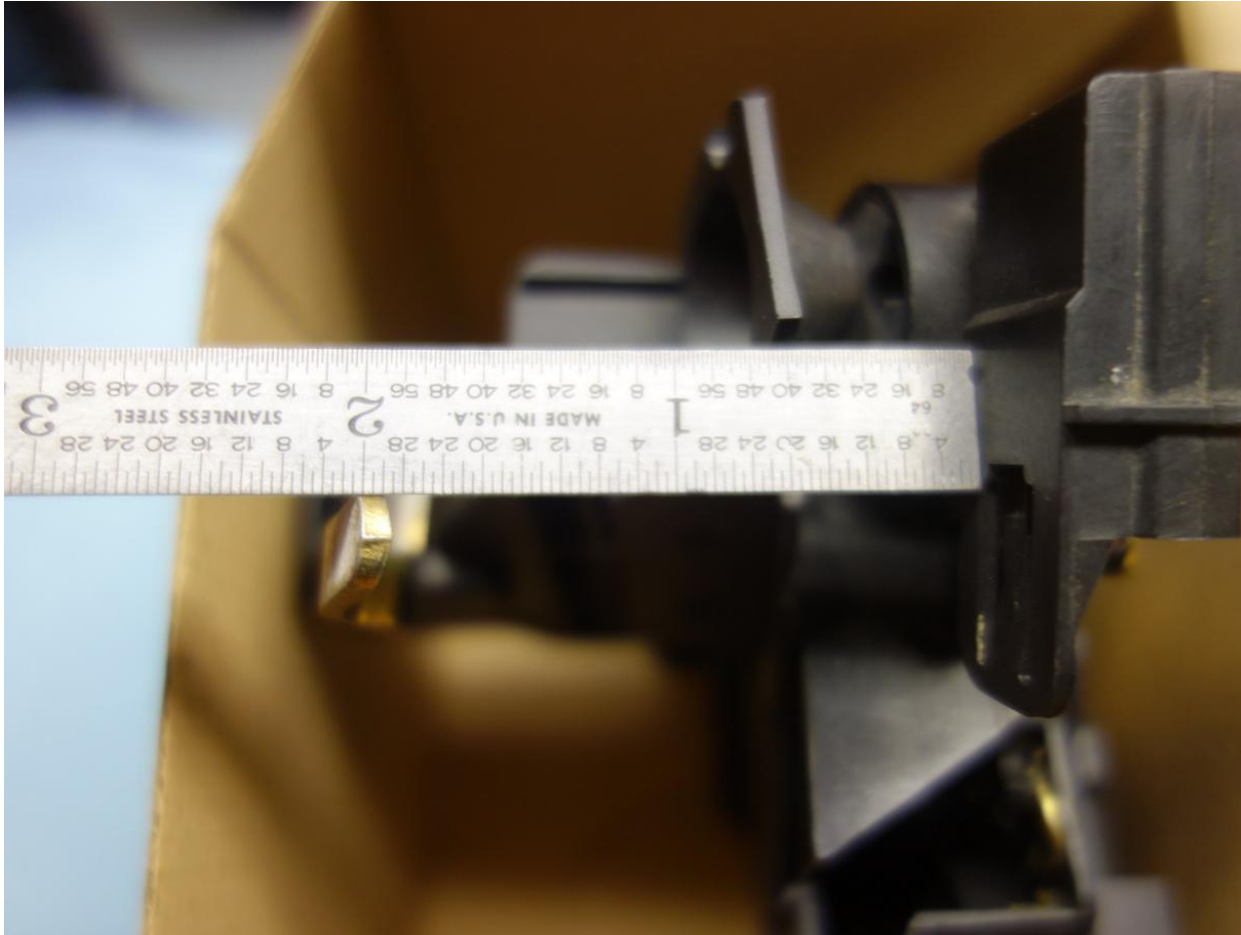
- On the old lock assembly, measure the distance of the release lever from the plastic housing. In this case, $\sim 1 \frac{7}{8}$ ths of an inch.

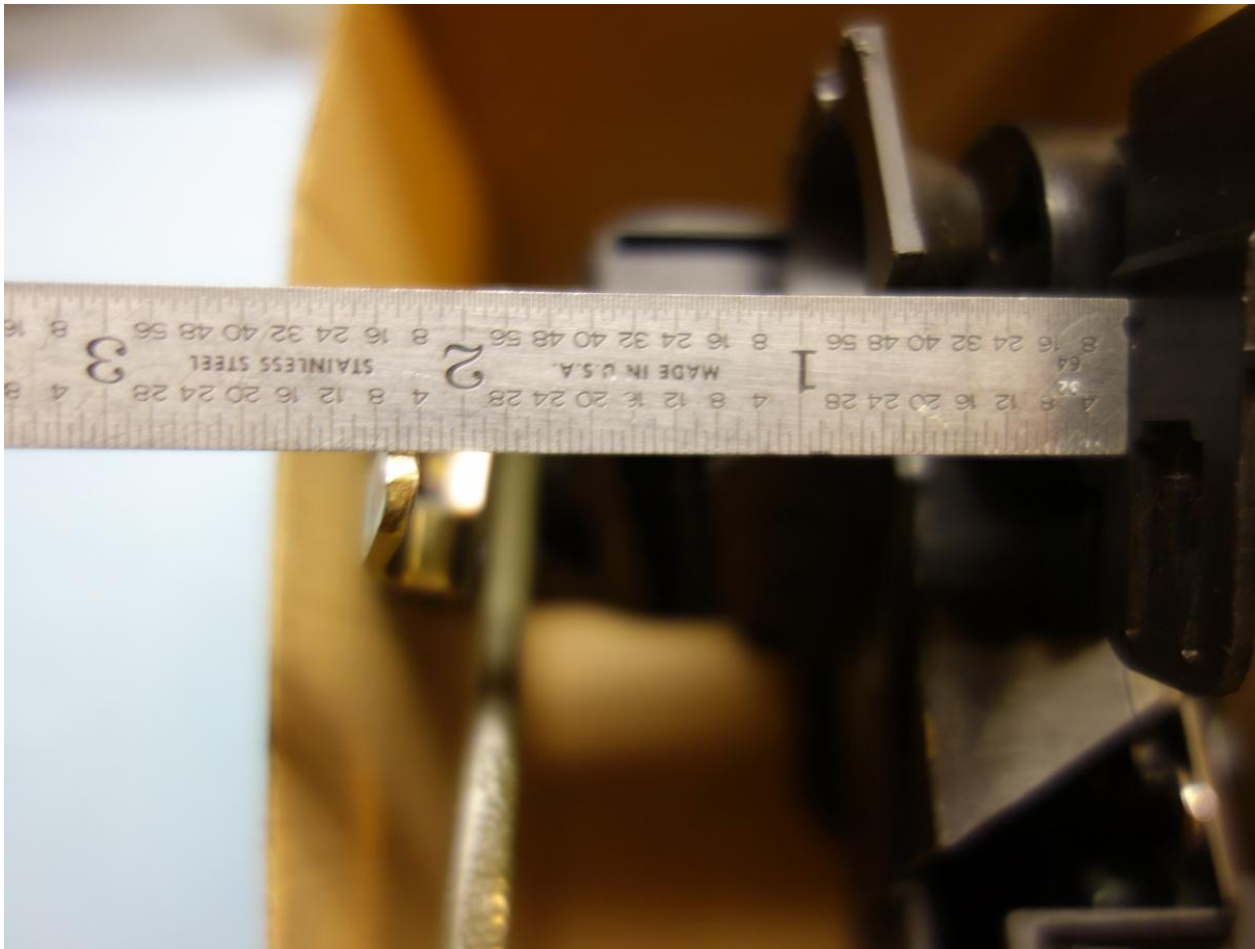
- On the new lock assembly, measure the distance of the release lever from the plastic housing. In this case, $\sim 2 \frac{1}{8}$ of an inch.
- This means the exterior door handle will not sit flush with the door but rather will stick out one-quarter inch. ($2 \frac{1}{8}$ " minus $1 \frac{7}{8}$ ")
- This can be adjusted.
