Mercedes Tech Tip: Leaks At Internal Steering Lines or Steering Gear Housing

3/11/2010

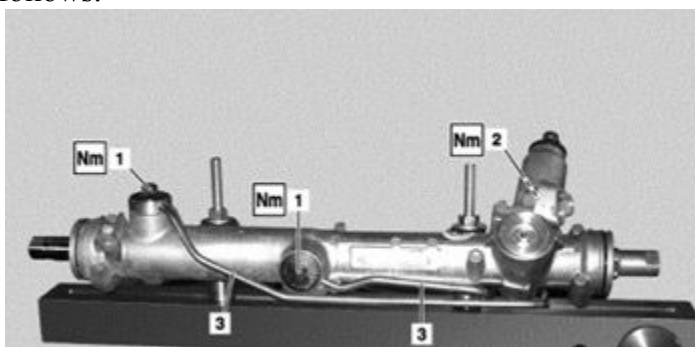
2. Mount the steering gear to the steering gear housing support (**Fig. 1 for 203/209 and Fig. 2 for 211**). Before starting the repair, clean any loose contamination from the steering gear and maintain cleanliness throughout the repair process.
