Tech Tip: Mercedes-Benz Check Engine Light with DTCs P2003, P2047, P0810 and P0814 Stored in Engine ECU

8/9/2011

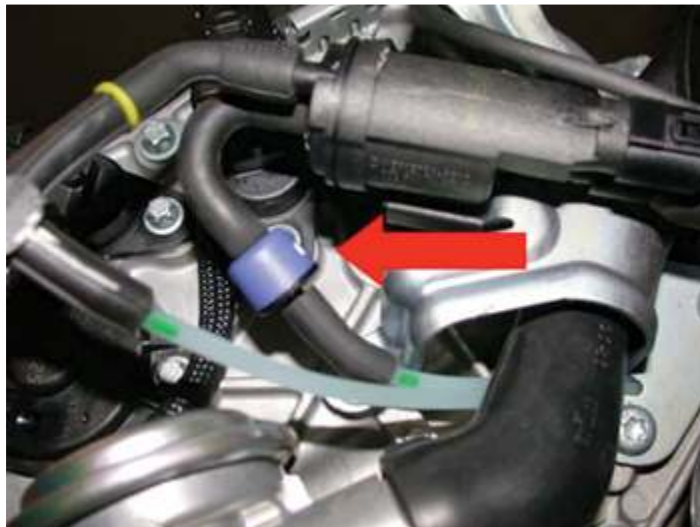
This condition may be caused by a malfunctioning check valve in the vacuum line (see **Fig. 1**) to the air pump switch-over valve. When the check valve malfunctions, vacuum flow to the diverter valve is restricted, preventing it from opening. Proceed as follows.

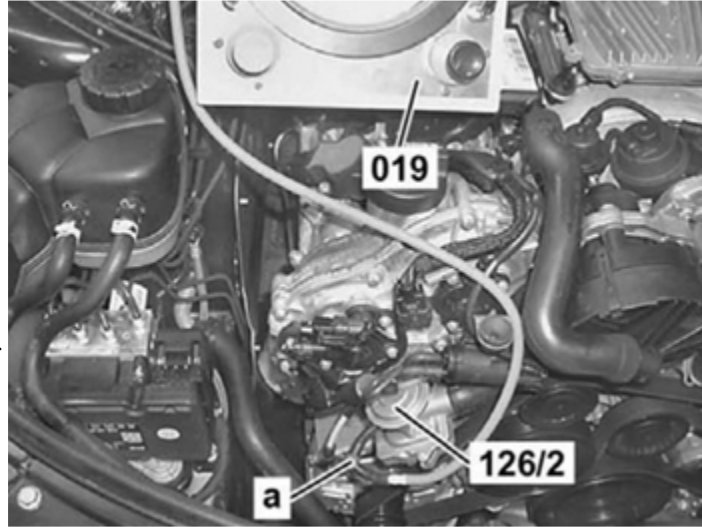
2.2. If the air pump can be activated with SDS but the function chain test fails, the vacuum flow between the air pump switchover valve and the diverter valve may be restricted, preventing the diverter valve from opening.

2.3. Check vacuum supply (see **Fig. 2**) at the diverter valve. If vacuum is < 500 mbar, change the check valve.
