**DTB**

Date: July 22, 2004  
Order No.: P-B-91.40/67a  
Supersedes: P-B-91.40/67 dated January 22, 2004  
Group: 91

**SUBJECT:** **Model 215, as of 1.12.02 Production**  
**Model 220 as of 1.9.02 Production**  
**SRS Indicator Lamp On**

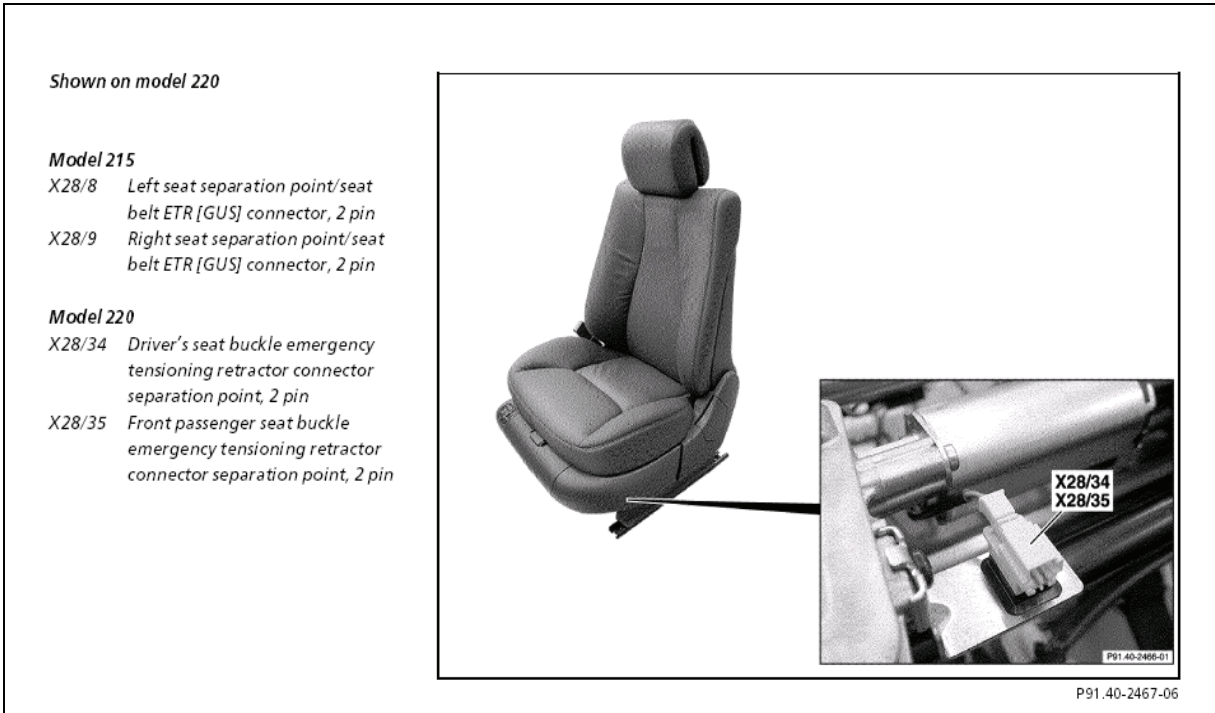
Figure 1

If you receive customer reports in the above model vehicles that the SRS light is illuminated and diagnostic fault code(s) B9183 and/or B91A3 are stored in the SRS ECU, the resistance of the circuit for the belt buckle tensioner squib may be too high. On Model 215, this high resistance may be caused by a malfunction in the seat belt ETR connector/left seat separation point (X28/8) or the seat belt ETR connector/right seat separation point (X28/9). On Model 220, this high resistance may be caused by a malfunction in the driver's seat buckle ETR connector separation point (X28/34) or the passenger seat buckle ETR connector separation point (X28/35). The malfunctioning connectors must be replaced with a repair kit. Please follow the below procedure to repair.

- Cut electrical wires approximately 80 mm in front of connector.
- Carefully remove approximately 50 mm of fabric tape.
- Strip approximately 15 mm of insulation from the electrical wires.
- Slide solder connector onto electrical wires.
- Twist bared electrical wires with wire ends from repair kit.

f) Position solder connection in center of twisted wires and shrink with heat gun (solder).

g) Check solder connections.

h) Wrap fabric tape around electrical wires on both sides.

i) Remove old connector from bracket and install new connector.
