Shift mechanism does not move out of P

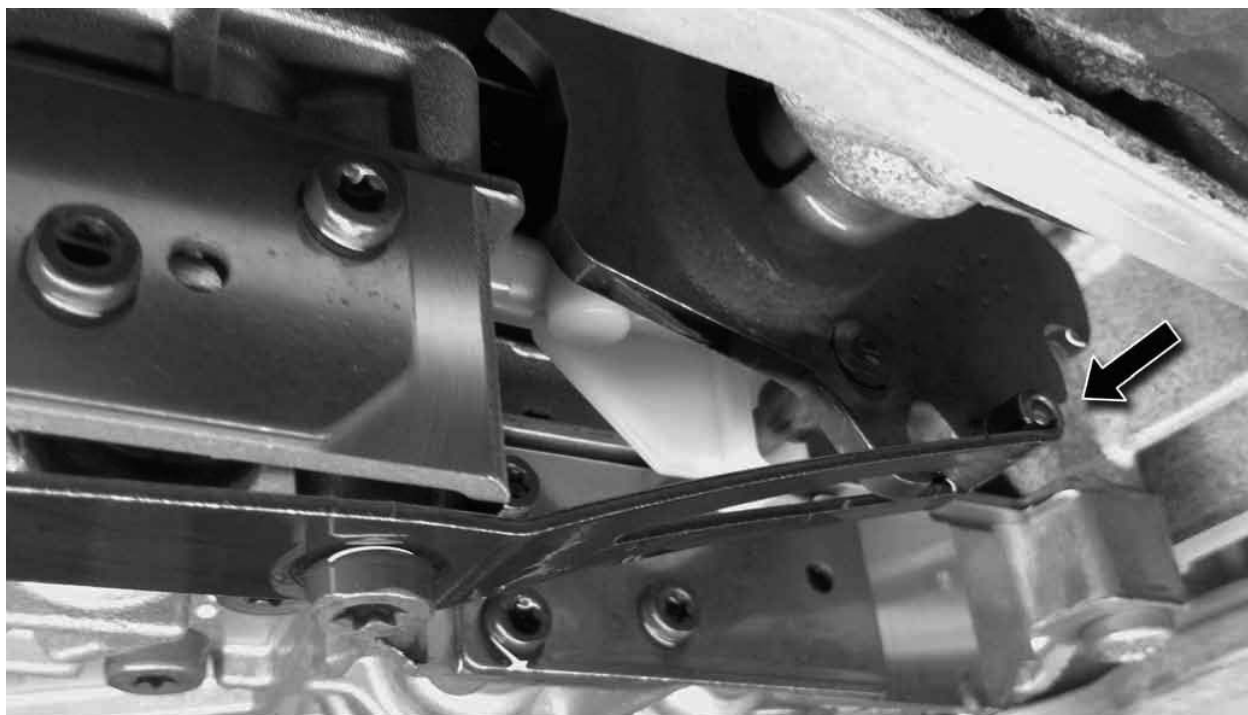
P27.19:2642-00

Correctly engaged selector valve in selection range detent plate

You will find a possible remedy in the chapter "DIRECT SELECT module". On vehicles with center shifter console and ESM, check whether the shift rod is hooked in/secured properly. On vehicles on which the EHS has been replaced, make sure that the selector valve is correctly mounted in the selection range detent plate.
