Code	Text	Status
2355-001	Check system 'Exhaust gas recirculation control'. The air mass is too small.

Model series/model designation 211.022

Automatic test of exhaust gas recirculation

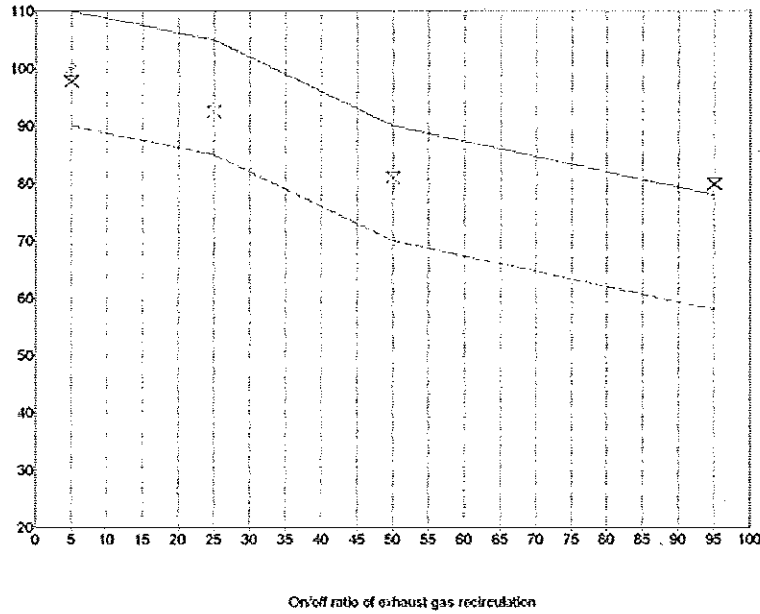
Evaluation of lambda values

Result of actuation	
Actuation	Lambda value: in percent, absolute
5	100 ; 5.548
25	93 ; 5.132
50	81 ; 4.496
95	80 ; 4.432
5	98 ; 5.424

Test completed
Result of test:
- One of the measurement values is outside the tolerance range.
- The test was not okay.
Continue with button F2

- Replace component Y27/9 (Left EGR positioner).

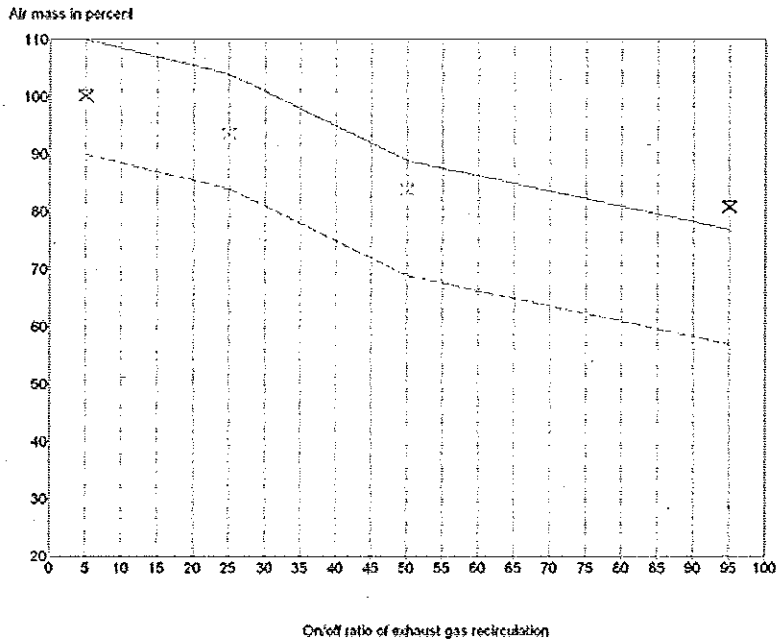
Evaluation of air mass

Result of actuation	
Actuation	Air mass value: in percent, absolute
5	100 ; 470.785
25	94 ; 440.735
50	84 ; 394.430
95	81 ; 380.820
5	100 ; 472.135
Chassis number	WDB01...
Date	21.09.2016
Time	17:51
Kilometer reading	32402 km
Engine speed	1400 U/min
Coolant temperature	83 °C
Oil temperature	90 °C
M16/5 (Throttle valve actuator)	5 %
M72 (Intake port shutoff actuator)	5 %
