DTB

Date: August 30, 2005
Order No.: P-B-80.20/34
Supersedes:
Group: 80

SUBJECT: Model 209.356/365/375/376/456/465/475/476 with option code 881
Model 211.026/056/065/070/076/082/083/087 with option code 881
Model 219.375/376 with option code 881
All Model Years
Remote Trunk Closing Non Functional

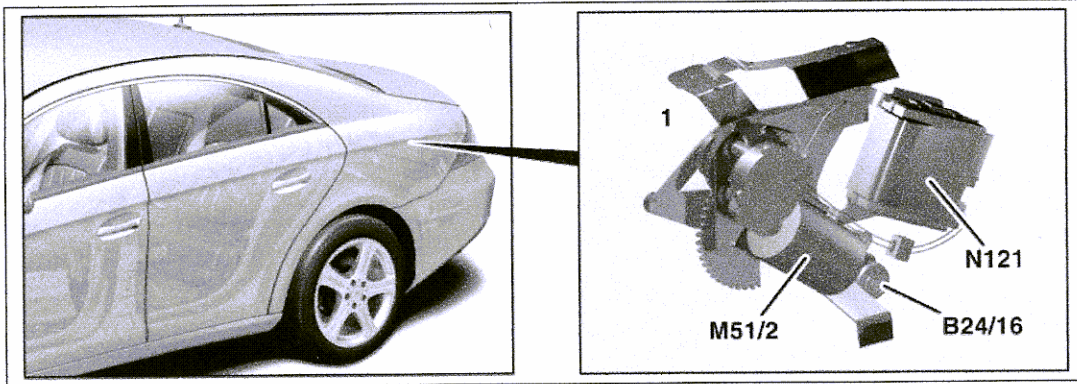
Figure 1

If you receive customer reports in the above model vehicles of the Remote Trunk Closing (option code 881) being non functional (not opening or closing), the potentiometer on the Trunk Lid Drive Unit may need to be replaced. Follow the procedure below to repair.

209.4xx = AR68.30-P-4601QA
3. Remove the plastic cover from the trunk lid drive unit.
4. Remove and replace potentiometer B24/16 (Figure 1).
5. Install removed trim paneling in reverse order.
