**DTB**

Date: March 4, 2009
Order No.: P-B-91.60/99e
Supersedes: P-B-91.60/99d dated June 12, 2007
Group: 91

**SUBJECT: Model 211.022/026/056/065/070/072/076/077/082/083/087/090/256/265/276/277/282/283/287
Model 219.372/375/376/377
SRS Light Illuminated**

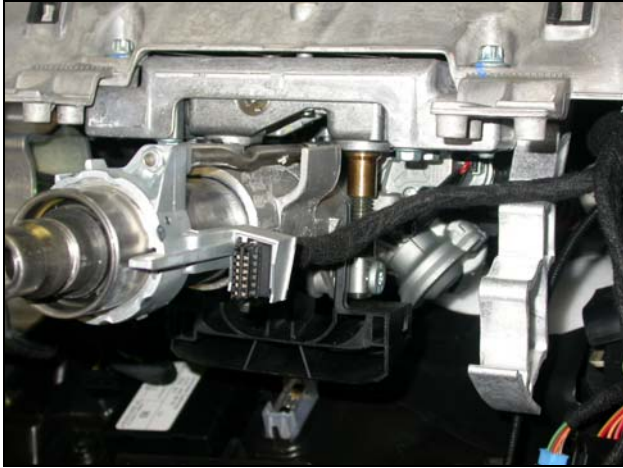
Figure 1 P-B-91.60/99
Harness routing version 1 (approx. length 220mm)

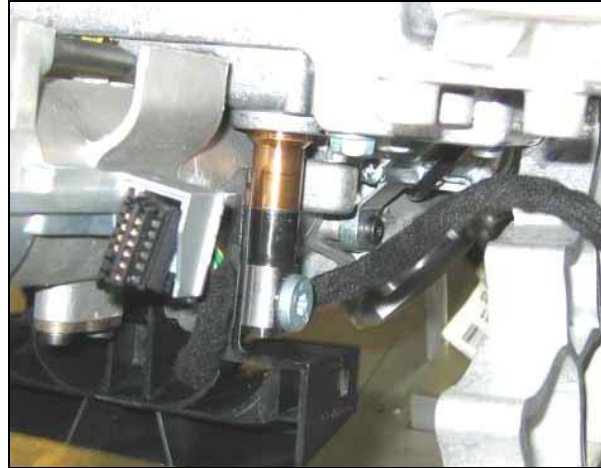
Figure 2 P-B-91.60/99
Harness routing version 2 (approx. length 330mm)

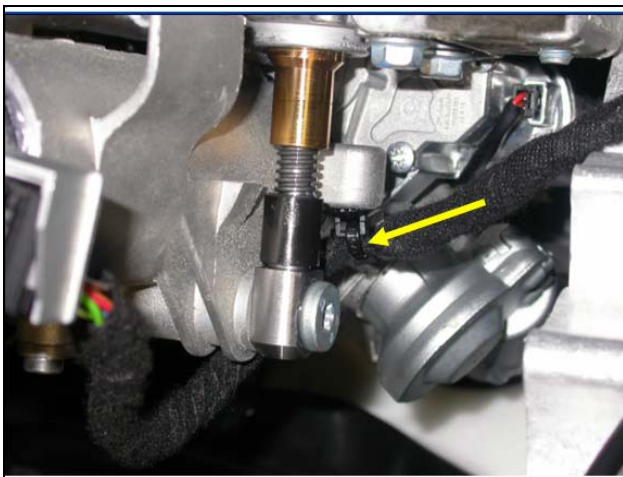
Figure 3 P-B-91.60/99c
219 Steering column cable tie location

3. Remove instrument panel bottom section on driver's side. Refer to WIS document AR68.10-P-1505T (211) or AR68.10-P-1505TX (219).
4. The 211 SCM harness routing has two versions (Figure 1 and 2).
5. On the 219, cut the cable tie securing the SCM harness to the steering column (Figure 3).
4. Unclip SCM connector from jacket tube by pushing on lock tabs (Figure 4).

21. Use the original harness routing and clip the SCM connector back on the jacket tube. Form a loop in the excess harness and secure it on the right side of the aluminum profile (Figure 9).
22. On the 219 use a cable tie to secure the harness to the cable anchor on the steering column (Figure 3).

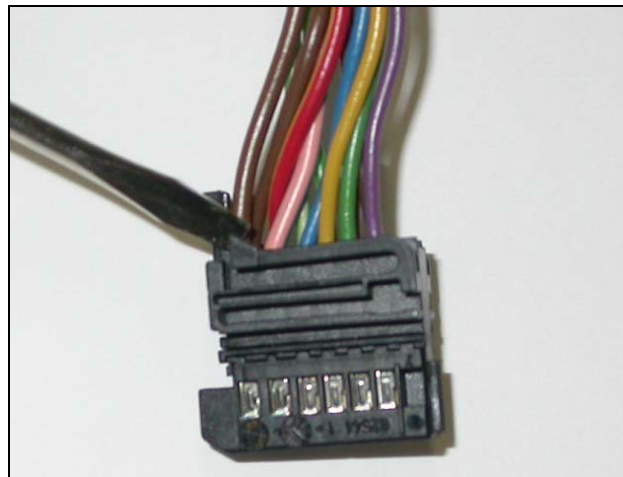
Figure 4 P-B-91.60/99
Push lock tab on N80 connector to release from bracket.
One tab on each side of connector.

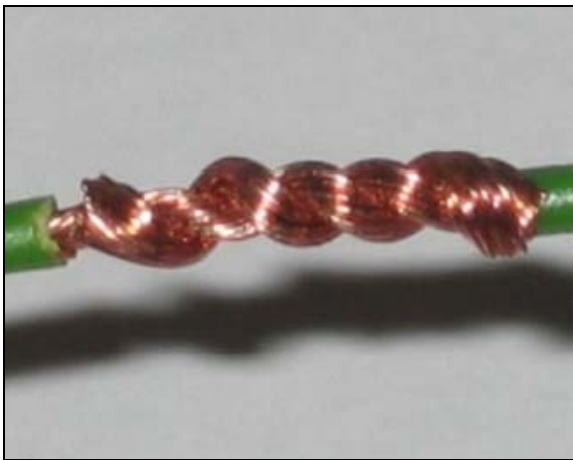
Figure 5 P-B-91.60/99c
Wires braided

16. Slip the solder connector (A002 546 13 41) onto the cut wire. Strip approximately 15 mm of insulation from the repair harness wire and the SCM harness wire. Braid the 15mm stripped ends of the repair wire and SCM harness wire, see (Figure 5). Solder the wires in accordance with the specified repair method in WIS document AR54.18-P-0100-06A (Figure 6).

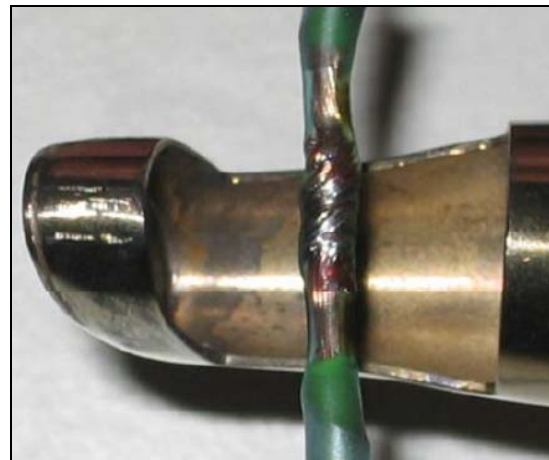
Figure 6 P-B-91.60/99c
Heat solder connector with Hot Air Gun
WE58.40Z1007-03A set to 400° C until soldering ring has dissolved

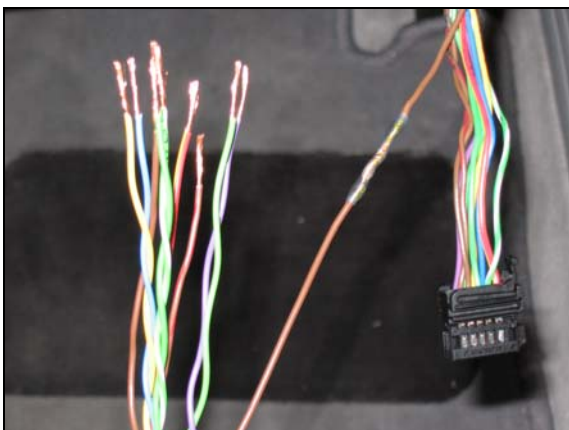
Figure 7 P-B-91.60/99c
The brown wire (0.5 BN) connected to terminal 8
(Repair as of MY 05)

- Using a Digital Multi Meter (DMM), locate the brown wire (0.5 BN) connected to terminal 8 of the SCM connector of the repair harness.
- Locate the brown wire (0.5 BN) connected to terminal 8 of the SCM connector of the vehicle harness and cut it at the connector.
- Slip the solder connector (A002 546 13 41) onto the cut wire. Strip approximately 15 mm of insulation from the repair harness wire and the SCM harness wire. Braid the 15mm stripped ends of the repair wire and SCM harness wire (Figure 5). Solder the wires in accordance with the specified repair method in WIS document AR54.18-P-0100-06A (Figure 6 and 7).
- Repeat steps 8 to 10 for the brown wires (0.5 BN) at pin 12 and (0.75 BN) at pin 1.

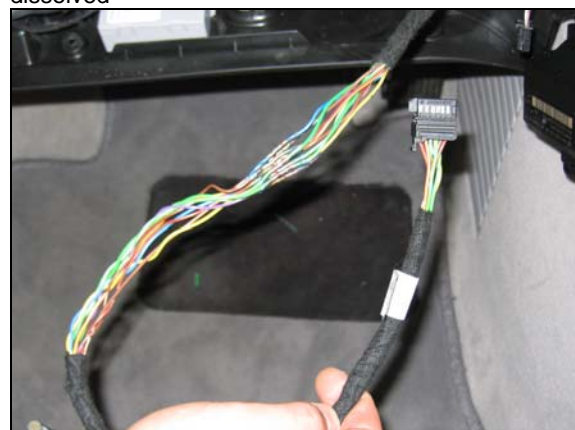
Figure 8 P-B-91.60/99c
Repair harness spliced to vehicle harness
(Repair as of MY 05)

- Repeat steps 8 to 10 for the green wires (0.5 GN) at pin 5 and 11.
- Cut remaining wires at the SCM connector and follow step (10) for remaining wires. The repaired harness will be significantly longer than the original harness (Figure 8).

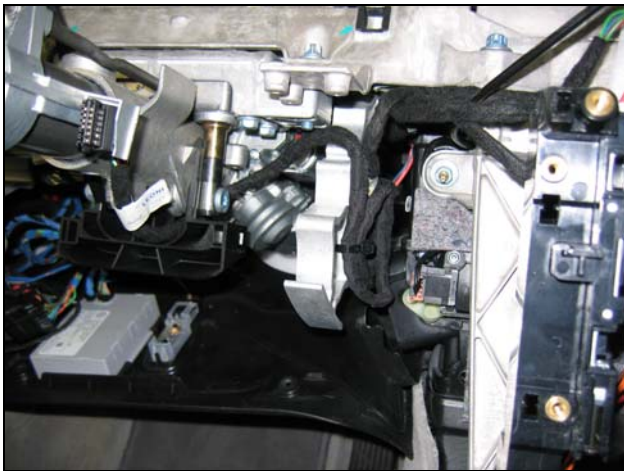
Figure 9

Excess harness secured to right of the aluminum profile (Repair as of MY 05)

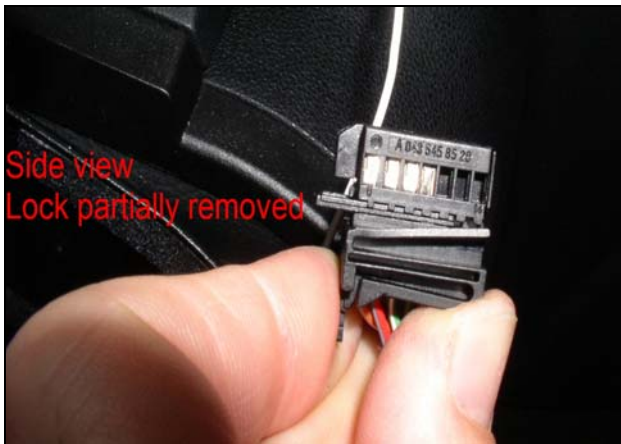
Figure 10 P-B-91.60/99c
Slide lock out of connector to remove/install terminals
(Repair up to MY 04)

27. Remove the lock on the SCM socket connector (Figure 10). Depress the lock tab on the terminal and remove one cut wire terminal at a time. Install the appropriate repaired wire into the correct position in the socket connector and form a loop in each wire (Figure 11). Gather the loops of repaired wires that include all the solder connectors and insulate with fabric tape. If present, the wires for the steering wheel heater are not included in the loop for the repair wires.

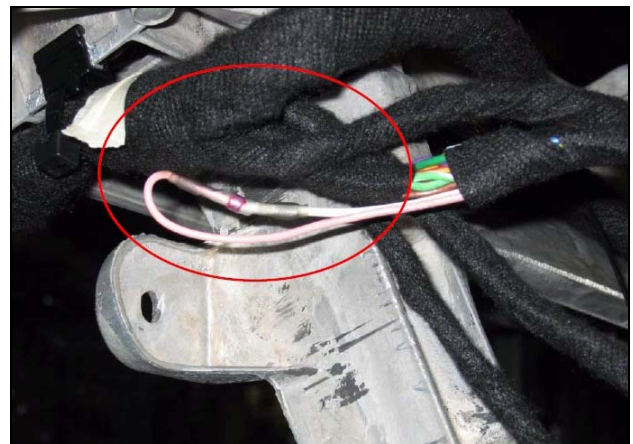
Figure 11 P-B-91.60/99c
Repair wire loop. Repeat for all, except steering wheel
heater wires. (Repair up to MY 04)

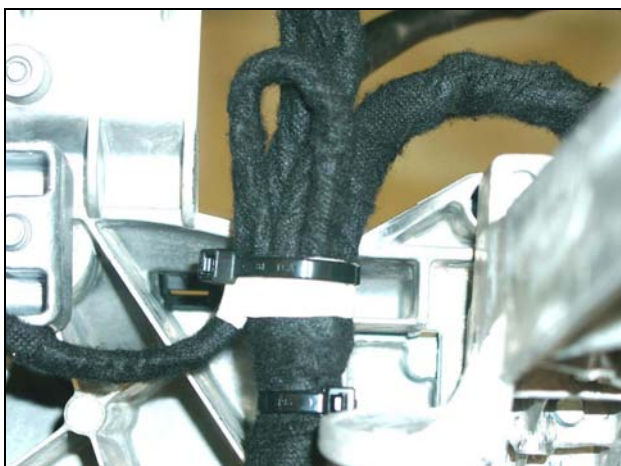
Figure 12 P-B-91.60/99c
Repair loop cable tied to cockpit harness (Repair up to MY 04)

28. Use the original harness routing and clip the SCM connector back on the jacket tube. Position the loop formed in Step 24 under the cockpit harness and secure with a cable tie (Figure 12).
