DTB

Date: February 1, 2008
Order No.: P-B-82.64/607
Supersedes:
Group: 82

SUBJECT: Model 171.454/456/473, as of MY 2005
Model 211.026/056/065/070/076/082/083/087/256/265/276/282/283/287, as of MY 2003
Model 219.372/375/377/376, as of MY 2006
Equipped with Option Code 819
CD Changer Cannot Be Operated / CDs Not Drawn In or Ejected, Jumps, Skips or Sets Over Temperature Fault Codes

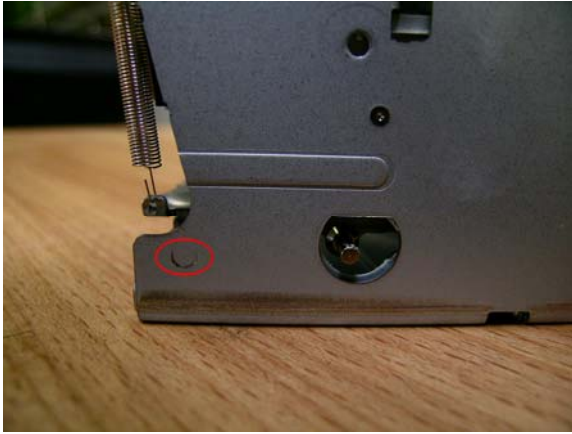
If you receive customer reports in the above model vehicles of the Compact Disc Changer (CDC) having any of the below conditions, these may be caused by either one or both bolts which fasten the CDC to the mounting frame being long or there being a software error in the CDC.

Figure 1 P-B-82.64/607
Shows physical damage to the internal drive

To resolve, check for physical damage at the bolting point of the changer (Examples – Figures 1, 2 and 3). If it is evident that the fastening/mounting bolts are too long, replace the mounting bolts size **M4x6** as listed in the parts information section.

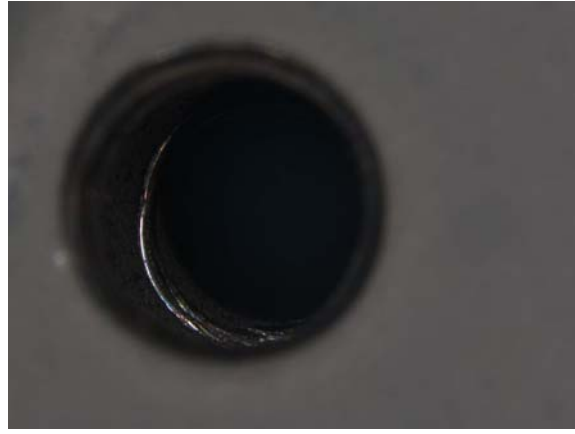
Figure 2 P-B-82.64/607
Close-up of threaded hole with physical damage

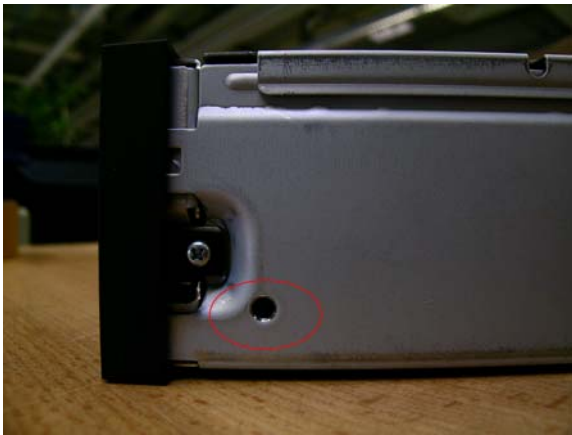
Figure 3 – Bolt is too long P-B-82.64/607
