Service Campaign Bulletin

Campaign No. 2005020003
April 2005

SUBJECT: **MODELS 163, 202, 208 210 WITH ENGINES 112,
MODELS 129, 163, 202, 208 210 215, 220 WITH ENGINES 113,
MODEL YEARS 1998 – 2000;
MODEL 170 WITH ENGINE 112, MODEL YEAR 2001
INSPECT, IF NECESSARY REPLACE HARMONIC BALANCER PULLEY**

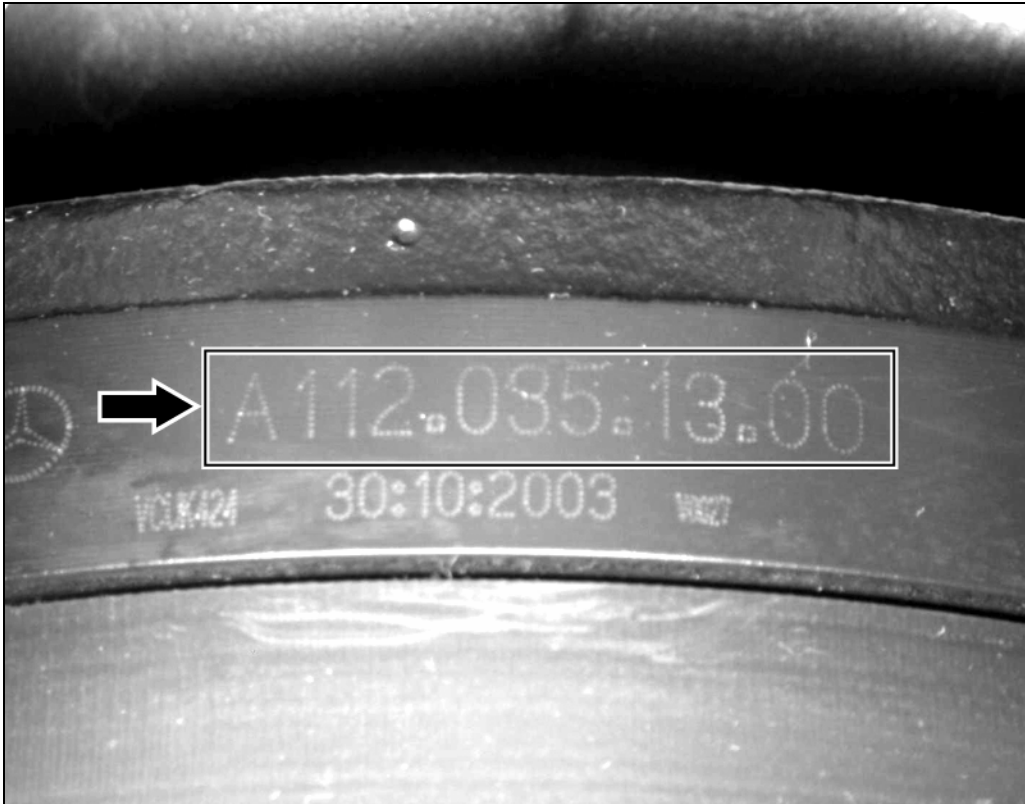
Figure 1

1. Turn crankshaft in direction of normal rotation until the part number (arrow, Figure 1) of the harmonic balancer pulley is visible.
2. If the harmonic balancer pulley has one of the part numbers listed below, it must be replaced (for replacement procedure refer to next step):

ONLY these 2 part numbers (below) require replacement.

- A112 035 00 00
 - A112 035 06 00
3. Replacement procedures for harmonic balancer pulley:
 - Engines 112 and 113 with viscous engine fan (non AMG models) refer to subject B.
 - Engines 112 and 113 with electric engine fan (non AMG models) refer to subject C.
