**DTB**

Date: January 9, 2008  
Order No.: P-B-42.10/90  
Supersedes:  
Group: 42

**SUBJECT: All Model 211 Vehicles  
“Brake Wear! Visit Workshop” Displayed in Instrument Cluster**

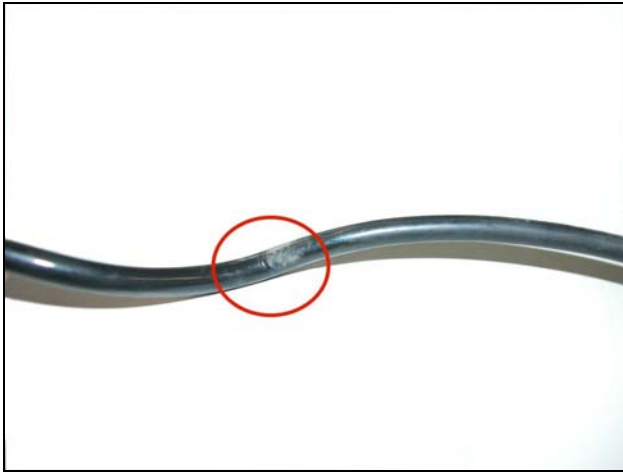
- Figure 1 and 2 – kinked / crushed section of rear brake wear sensor harness
  - Figure 3 and 4 – Location of above kinked / crushed section (right rear axle)

6. Check for continuity for the entire circuit from the SAM to the brake wear sensor.
7. If it is not possible to determine the sensor responsible for the erroneous fault or the above test steps do not resolve the issue, check both sensor's wiring harness over the **complete run** (from the respective wheel up to the driver's side SAM) for kinks / crushed sections / chafing marks. Even slight external damage can lead to a fault which occurs sporadically. Review the images below for examples and locations for possible areas of damage.
