Date: May 2007
Order No.: P-B-68.10/53
Supersedes:
Group: 68

SUBJECT: MODEL 211
Noises at the Instrument Panel

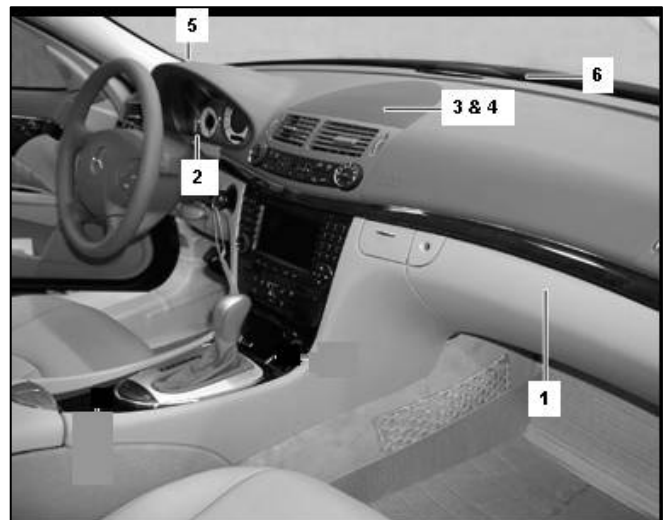
Figure 1

- A. Rattling noises at glove compartment lid (1, Figure 1)
- B. Noises in the area of the instrument cluster frame (2, Figure 1)
- C. Buzzing noises in the area of the centerfill (3, Figure 1)
- D. Buzzing noises in the area of the centerfill (4, Figure 1)
- E. Creaking/knocking noises in the area of the A-pillar (5, Figure 1)
- F. Rattling noise in the area of instrument panel, center/windshield (6, Figure 1)

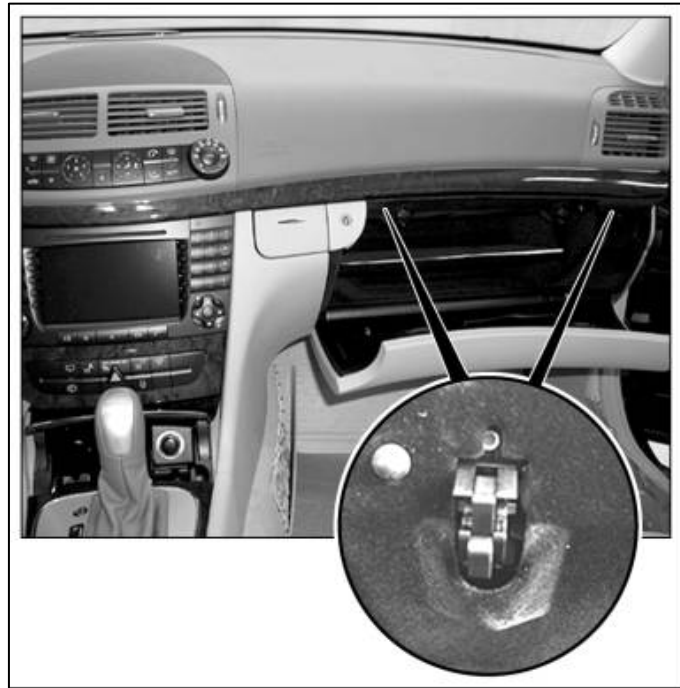
Figure 2

A. Rattling noises at glove compartment lid

The preload of the glove compartment lid may be set too weak, and rattling of the cover in the striker occurs as a result.

1. Adjust glove compartment lid.
(See WIS-document AR68.10-P-1300T)

i **Note:** Increase preload of cover by adjusting the striker (loosen and adjust striker – Figure 2).

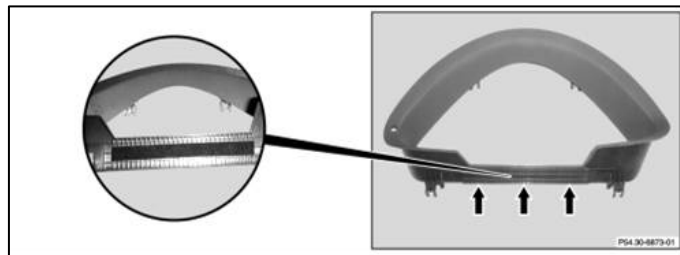
Figure 3

B. Noises in the area of the instrument cluster frame

The instrument cluster frame may rub on the instrument cluster when driving. This complaint occurs under conditions such as rough road surfaces.

1. Remove instrument cluster. (See WIS-document AR54.30-P-6015T)

2. Stick felt strip (material thickness: 1 mm) at the bottom of the ribs of the instrument cluster frame (Figure 3).

3. Install instrument cluster. (See WIS-document AR54.30-P-6015T)

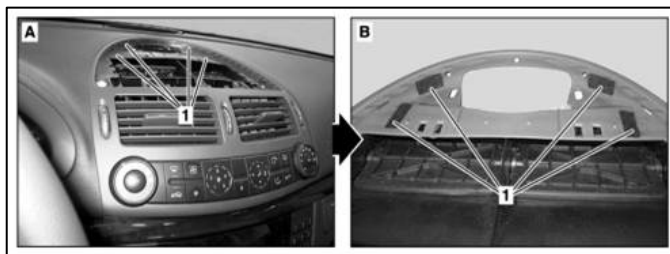
Figure 4

C. Buzzing noises in the area of the centerfill

Buzzing noises in the area of the centerfill may occur when driving. This is caused by there being too much play in the centerfill cover.

1. Remove cover for speaker. (See WIS-document AR68.10-P-1050T)
2. Apply felt (material thickness: 1 mm) in order to brace the grill. (1, Figure 4)
3. Install cover for speaker. MODEL 211.0 /2 up to 31.5.04 (See WIS-document AR68.10-P-1050T)

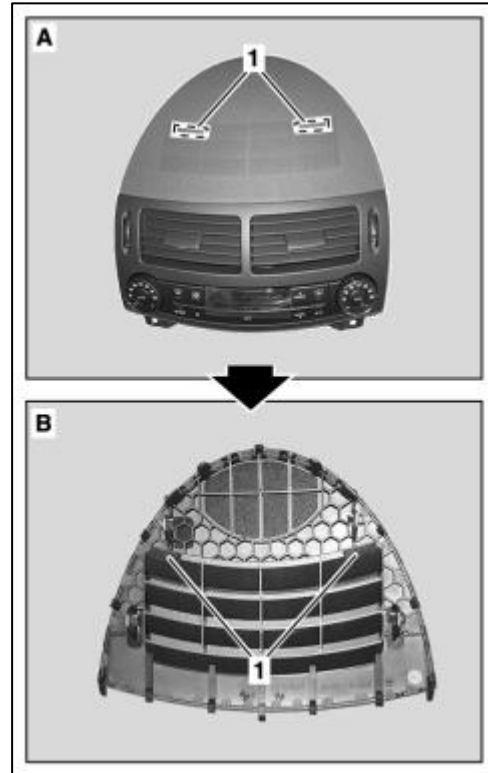
Figure 5

D. Buzzing noises in the area of the centerfill

Buzzing noises in the area of the centerfill may occur when driving. This is caused by there being too much play in the centerfill cover.

1. Remove cover for speaker. (See WIS-document AR68.10-P-1050TA)
2. Apply felt (material thickness: 1 mm) and replace the grill. (1, Figure 5)
3. Install cover for speaker. (See WIS-document AR68.10-P-1050TA)

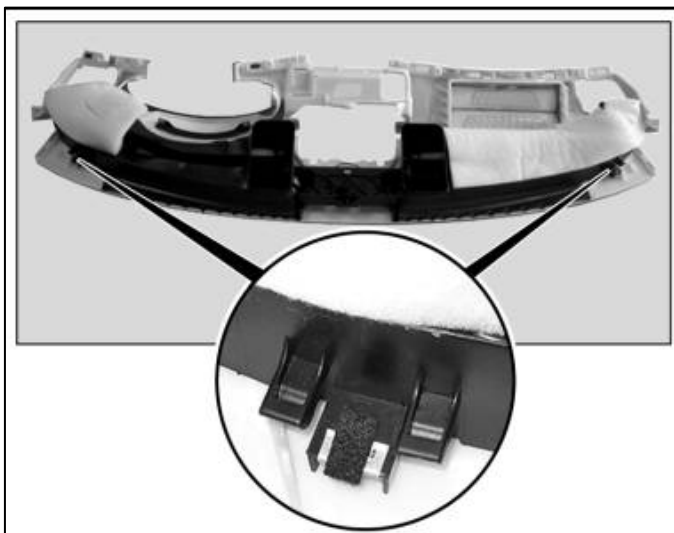
Figure 6

E. Noises in the area of the A-pillar

Creaking and knocking noises in the area of the instrument panel near the A-pillar may occur when driving. Creaking noises may occur due to the instrument panel clips rubbing on the crossmember under the windshield. Knocking noises may occur due to the clips contacting the air duct.

1. Remove top section of instrument panel.
(See WIS-document AR68.10-P-1020T)
2. Cover clips on left and right with felt (material thickness: 1 mm).

i **Note:** The felt should cover the spring shackle of the clip (Figure 6).

4. Install upper section of instrument panel.
(See WIS-document AR68.10-P-1020T)

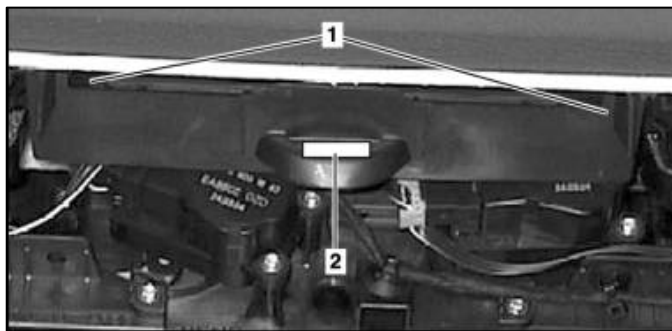
Figure 7

F. Noises in the area of the instrument panel, center to windshield

Rattling noises in the area near the center of the instrument panel or the windshield occur due to the instrument panel contacting the crossmember under the wind deflector and causing rattling noises on rough roads when driving.

1. Remove top section of instrument panel.
(See WIS-document AR68.10-P-1020T)

2. Apply felt (material thickness: 3 mm) onto retaining tab (2, Figure 7).

4. Install upper section of instrument panel.
(See WIS-document AR68.10-P-1020T)
