**DTB**

Date: February 6, 2009  
Order No.: P-B-82.85/678  
Supersedes:  
Group: 82

**SUBJECT: Model 211.022/056/072/077/087/090/277/287, Model Year 2009  
Model 219.372/377, Model Year 2009  
No Audio or Low Volume/Bass from Right-Side Speaker Group When Using Auxiliary  
Audio Device - Aux**

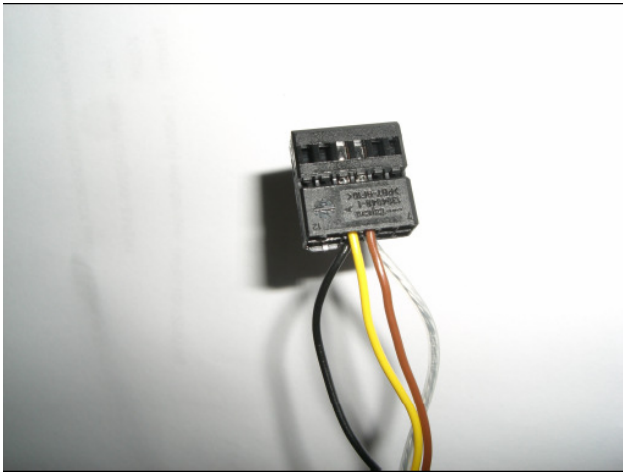
If you receive customer reports in the above model vehicles of the Auxiliary (Aux) Audio Device having no audio, volume too low/weak or low bass sound all from the right side speaker group, this may be caused by incorrect factory installation of the wiring harness connecting the head unit and the Aux Jack located in the glove box. To remedy, inspect the pinout assignments of the Head Unit Aux connector (JC) and if necessary, change the pin-out assignment (Figure1) in the connector housing on the head unit as described below in the pin assignment table and Figure 2.

Figure 1  
Incorrect (old) pin assignment

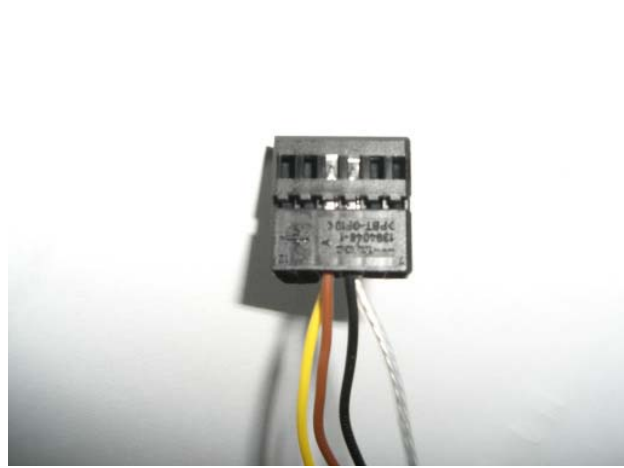
Figure 2  
Correct (new) pin assignment

**i** **Note:** The only pins that change assignment are: 4, 9 and 10. Pin 3 remains unchanged and the rest of the pinouts are unused.

| <b>Old pinout/Color</b> | <b>Function</b> | <b>NEW Pinout</b> |
|---|---|---|
| 4 / Black | Aux 1 Left | To PIN 9 |
| 9 / Brown | Ground | To PIN 10 |
| 10 / Yellow | Aux 1 RIGHT | To PIN 4 |
