Mercedes-Benz

Campaign No. 2014120006, January 2015

SUBJECT: **Models 212 Model Year 2015**
Replace Second Row Double Seat Belt Buckle

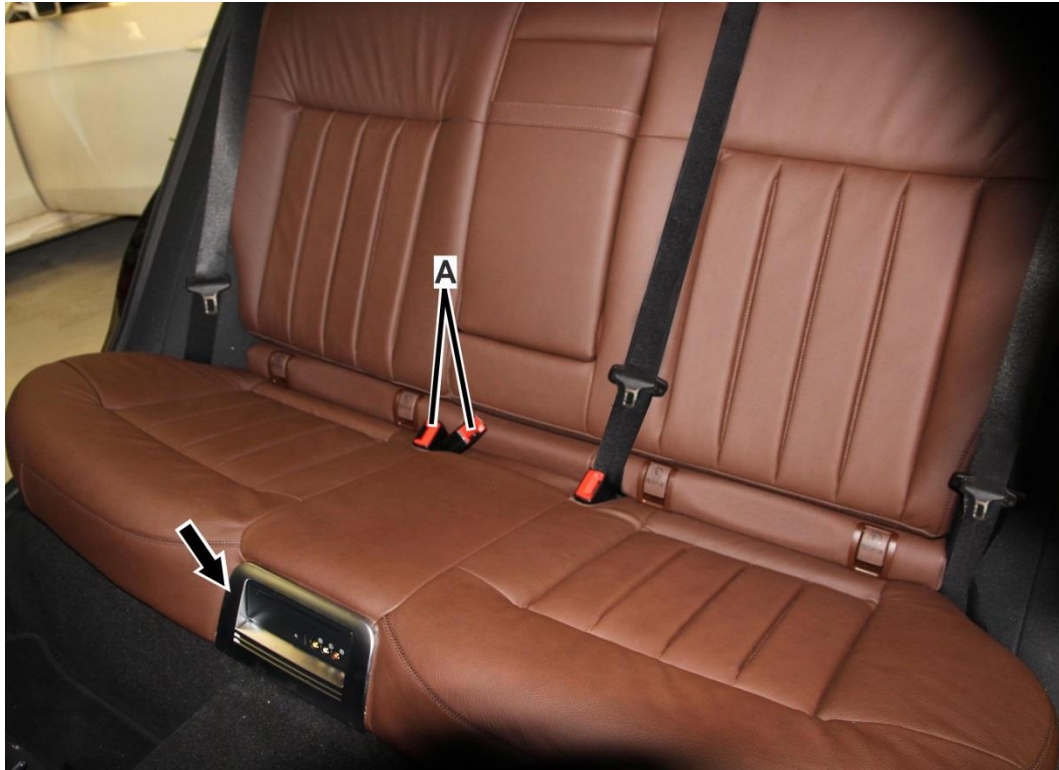
**Figure 1****i Note** (regarding above WIS instructions)

Daimler AG (DAG), the manufacturer of Mercedes-Benz vehicles, has determined that on certain Model Year 2015 E-Class vehicles the double seat belt buckle in the second row may not have been manufactured according to specifications. Subject vehicles are equipped with seat belt load limiters on all seats except for the rear middle passenger seat. Even in the event of a severe frontal crash, the seat belt load limiter will ensure that the belt load magnitude reached at the right rear passenger seat remains at a non-critical level for an affected double seat belt buckle. However, in the event of a severe frontal crash for the rear middle passenger seat, an affected double seat belt buckle may fail under such loading. This could increase the risk of injury for buckled middle seat passengers under these circumstances. An authorized Mercedes-Benz dealer will therefore replace the second row double seat belt buckle.

1. Replace double seat belt buckle (A, Figure 1) for right rear seat belt; refer to WIS: AR91.40-P-1516EW and perform steps 1, 3, 7.

- Disconnection of seat belt buckle switches does not apply to this campaign.
 - Removal of circlip on seat belt buckle mounting bolt does not apply to this campaign.
 - For vehicles with rear entertainment system, the paneling (arrow) on the DVD player must be removed prior to removing the rear seat; refer to WIS: AR82.60-P-7505-01EW.
2. Reassemble in reverse order.
