TO: Mercedes-Benz Dealer Principals, General Managers, Sales Managers, Service Managers, Parts Managers, Service Directors	FROM: Thomas Brunner, Department Manager, Vehicle Compliance and Analysis, Engineering Services
RE: Service Campaign 2017030011 Various Models MY 2005 - 2014 Replace Driver-side and/or Passenger-side Airbag	DATE: March 17, 2017

Campaign No. :		<h2>Replace Driver and Passenger Airbag(L4L)</h2>
2017030011		
<p>This is to notify you of the launch of a Service Campaign to replace the airbags on 540 MY05-14 vehicles included in the Takata recall and currently in dealer inventory under the Takata stop sale. See the chart on the first page.</p> <ul style="list-style-type: none"> • Driver-side airbag only: C-Class (203), SLK(171), E-Class sedan (212) • Driver and passenger airbags: C-Class (204), E-Class Coupe/Cabrio (207), SLS(197), GLK(X204) • Passenger-side only: C(204) <p>Please review the Service Campaign information below. The campaign will be launched on March 17, 2017 and all affected VINs will be flagged in VMI under Service Campaign 2017030011. The "pending" flag will be removed and cars will be taken off retail hold once the airbags are replaced. NOTE: Deal

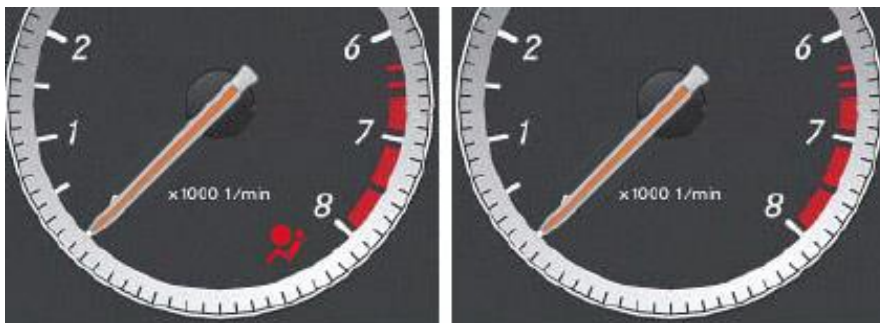
Figure 2 (shown on model 171)

Start engine and check whether Supplemental Restraint System (SRS) indicator lamp (Figure 2) goes out after a few seconds.

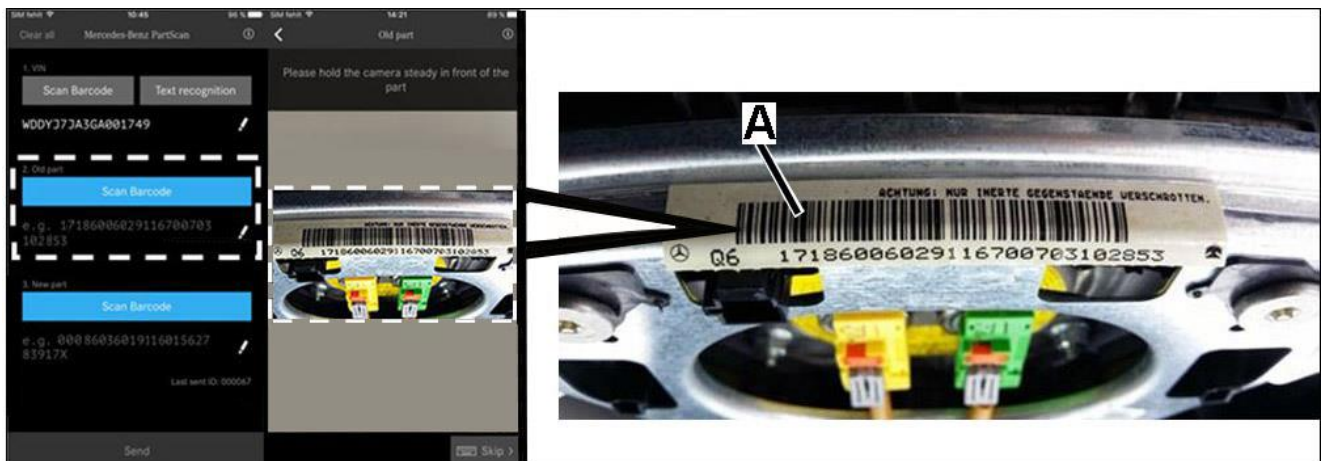
Figure 3 (Shown on model 203)

- Scan airbag bar code (A, Figure 3) from "old" airbag immediately after removing it from steering wheel by pressing "Scan Barcode" button (Figure 3).

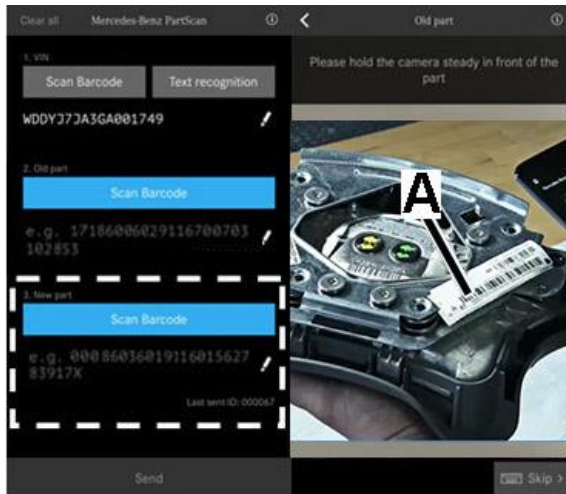
Figure 4 (Shown on model 203)

- Scan airbag bar code from “new” airbag immediately after packaging “old” airbag.

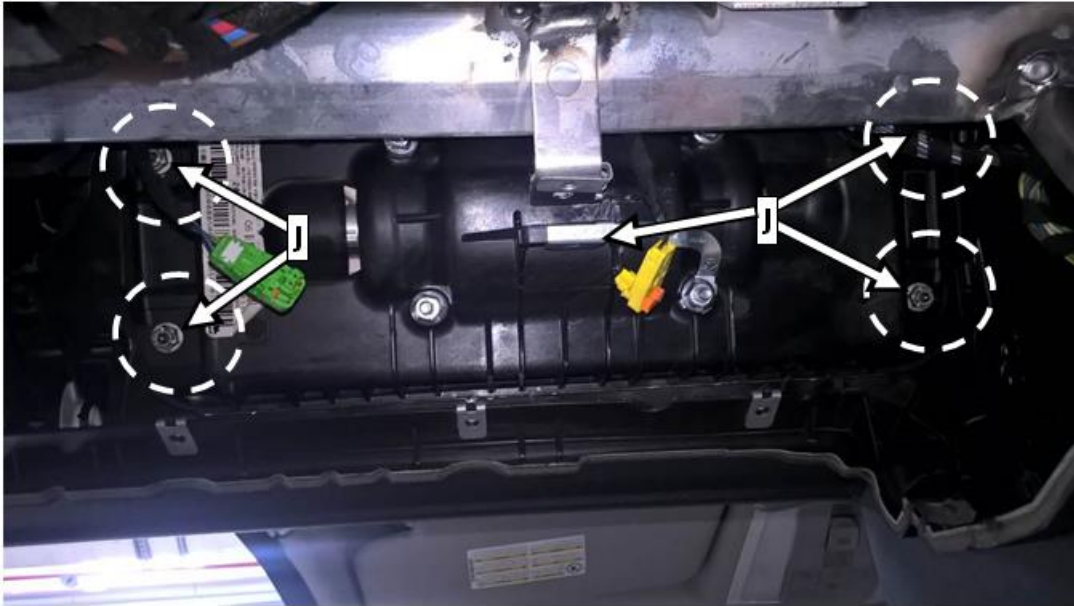
Figure 15

13. Remove front passenger airbag mounting nuts (J, Figure 15).

- Be sure to install new airbag mounting nuts (J, Figure 15) when installing “new” airbag to instrument panel.
- Torque airbag mounting nuts (J) to: **Nm** 5 Nm when installing “new” airbag to instrument panel.

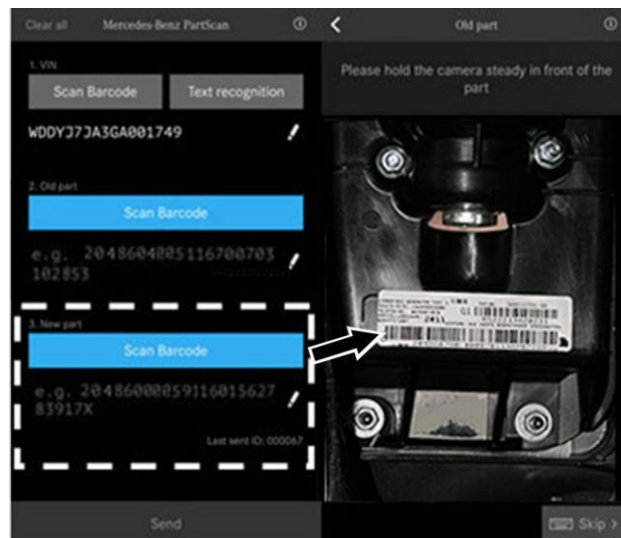
Figure 16

16 Scan airbag bar code (arrow, Figure 16) from “old” airbag immediately after removing it from dashboard by pressing “Scan Barcode” button (Figure 16).

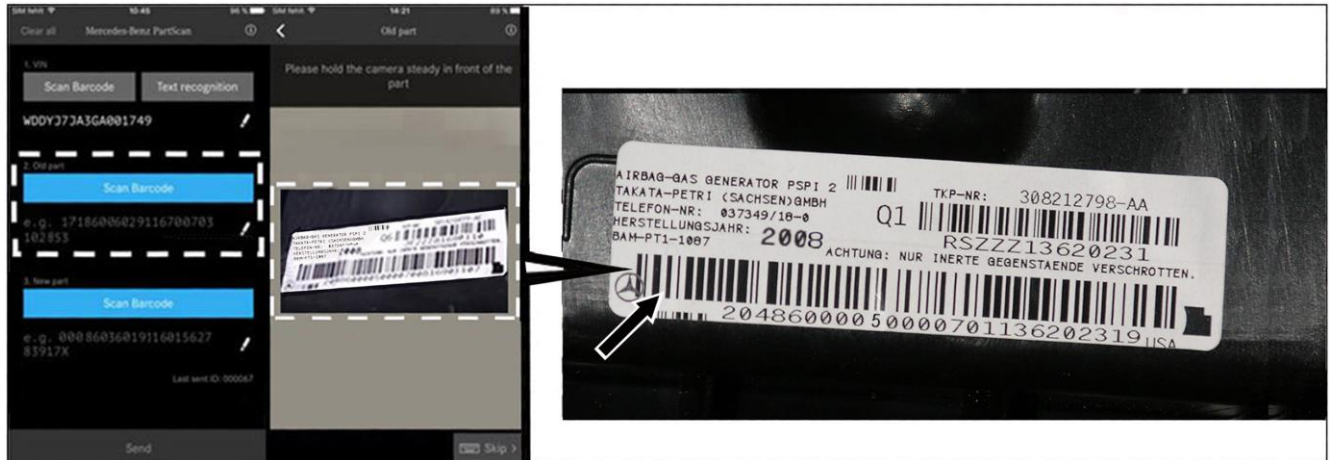
Figure 17

17. Scan airbag bar code from “new” airbag immediately after packaging “old” airbag
