TO: Mercedes-Benz Dealer Principals, General Managers, Sales Managers, Service Managers, Parts Managers	FROM: Thomas Brunner, Department Manager, Vehicle Compliance and Analysis, Engineering Services
RE: Service Campaign 2016090006 Model 204 (C-Class) MY 2008 - 2009 Replace Driver-side and Passenger-side Airbag	DATE: January 6, 2017

Campaign No. 2016090006, **January** 2016

SUBJECT: **Model 204**
Model Years 2008 and 2009
Replace Driver-Side and Front Passenger Air Bag

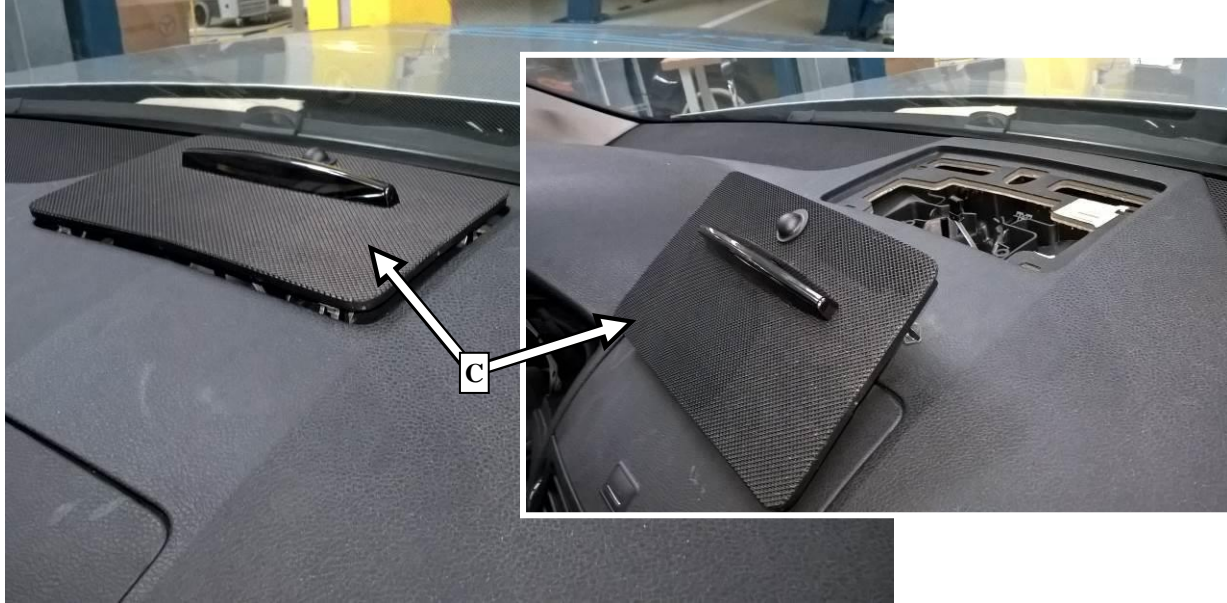
Figure 12

If equipped with sound system, also remove speaker under cover (C).

8. Unclip cover (C, Figure 12) on top of instrument panel and remove.

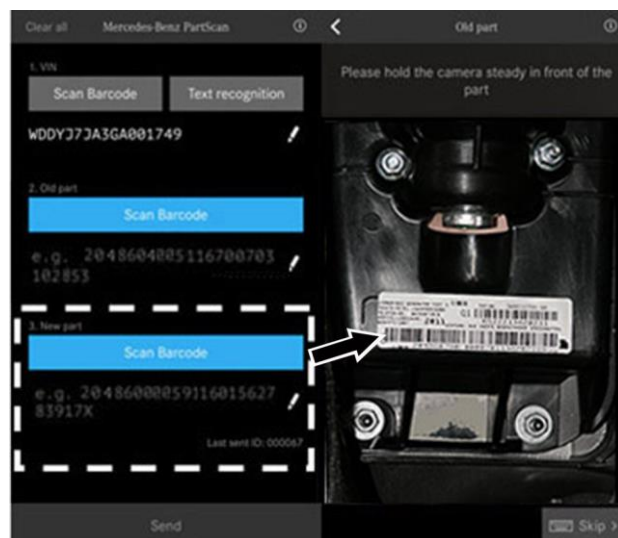
Figure 16

- Ensure that smart phone is held parallel to bar code label (arrow, Figure 16) when scanning airbag bar code.
- It must be ensured that the lower barcode (arrow) is scanned.
- The airbag part number can also be entered manually if required.
- This step can be omitted **ONLY** if bar code is incomplete, illegible, or missing.

16 Scan airbag bar code (arrow, Figure 16) from “old” airbag immediately after removing it from dashboard by pressing “Scan Barcode” button (Figure 16).
