John Dahlquist June 19, 2014 Version 3

With direct injection system for engines 157, 276, 278 (for example) the spark plug indexing is very critical as indicated in the picture and the warning information in WIS when replacing spark plugs.

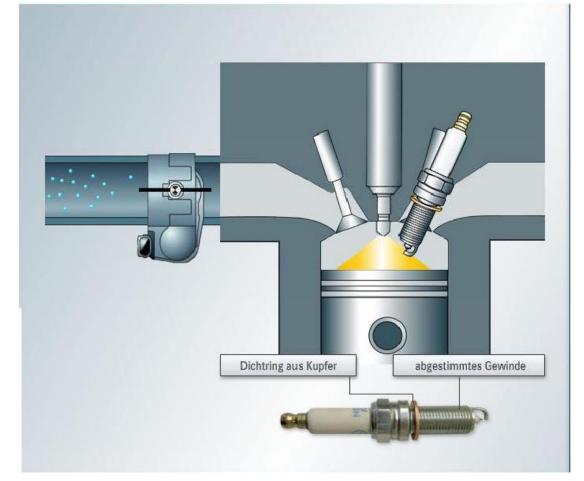
- Special spark plug
- Open side of electrode facing the injector
- Specific plug thread length
- Close-fitting requirement
- Specified torque must be observed

Installation: It is essential to adhere to the tightening torque as it influences the position of the spark plug electrodes in the cylinder.

An incorrect tightening torque causes misfires which can lead to damage to the engine and catalytic converter damage

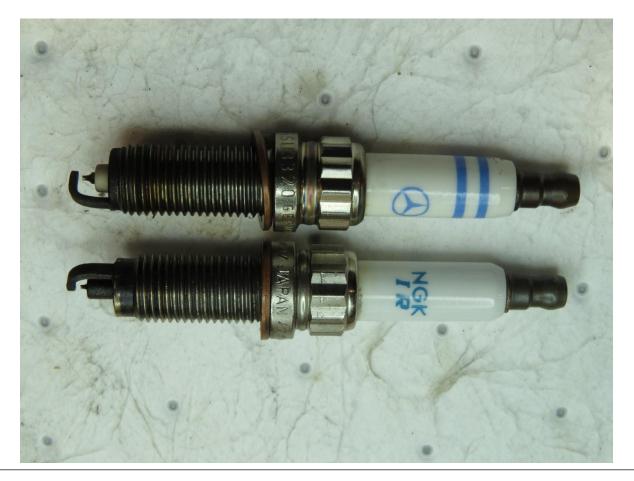
In the picture, an NGK unapproved spark plug is compared to a Mercedes approved spark plug. The NGK plug does not have the correct thread length for proper indexing and it isn't the correct heat range.

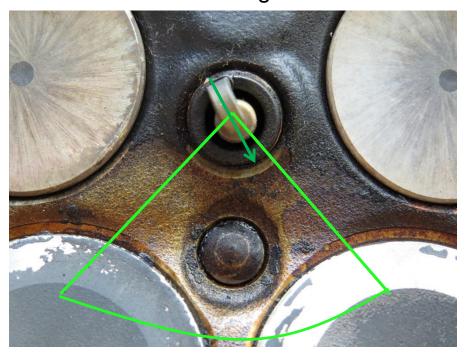
MB Plug

Below shows the indexing of the MB plug and the NGK plug when torqued at 23 Nm.

Note: For our direct injection engines, the indexing is up to 45 degrees of either side of the injector center.

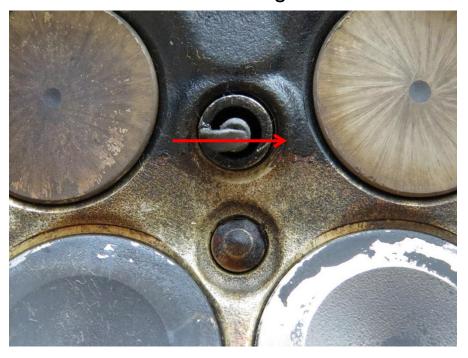
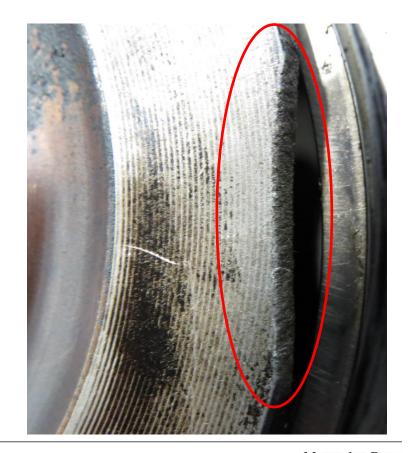
NGK Plug

In this case, the incorrect spark plug caused major engine damage (melted piston) that lead to a complete engine replacement. This is not a warrantable defect.
