# Service Campaign Bulletin

Campaign No. 2012070002, September 2012

SUBJECT: **Models 164, 171, 203, 204, 207, 209, 211, 212, 216, 219, 221, 230, 251, 463**  
**Engines 272 and 273**  
**Model Years 2005 - 2011**  
**Retrofit Adapter Wiring Harness on Camshaft Adjustment Solenoids**

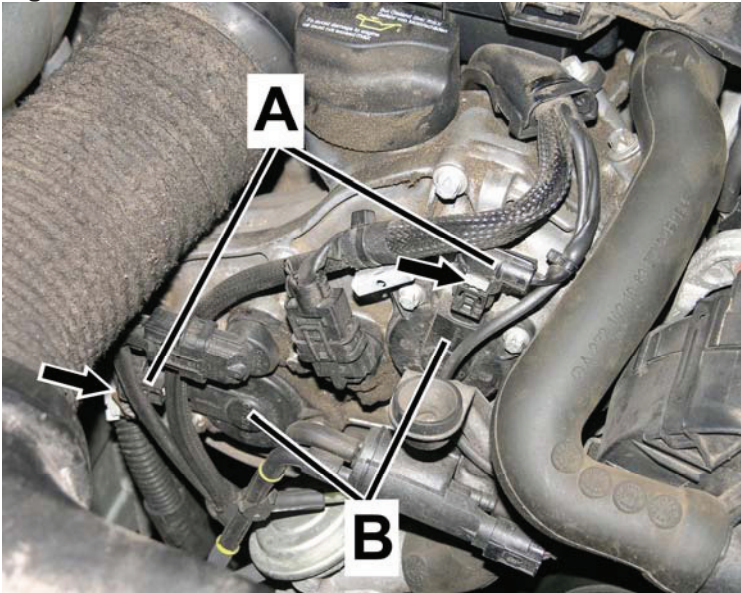
Figure 2

**Note:** Shown on engine 272

1. Remove top engine cover to get access to camshaft adjustment solenoids as required.
2. Disconnect camshaft adjustment solenoids from engine harness connectors (A, Figures 1 and 2):
  - Carefully unlock engine harness connectors (A) by squeezing and **partially** pulling out locking tabs (arrows) using pocket screw driver.
  - Disconnect camshaft adjustment solenoid connectors (A) from camshaft solenoids (B).

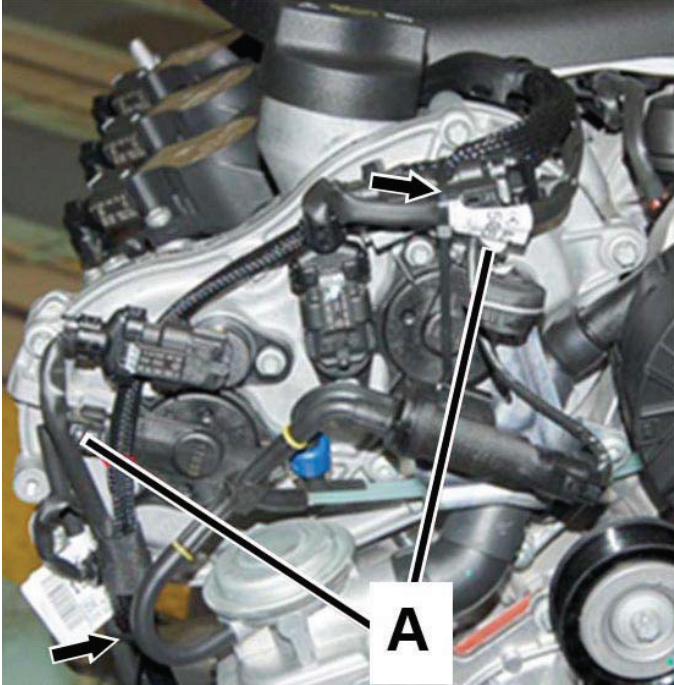
Figure 3

Ensure harness adapters are properly secured using cable ties (arrows, Figures 3 and 4) to prevent wire chafing and/or damage from hot engine parts, (e.g. oil cooler [B]).

3. Connect adapter harnesses (A, Figures 3 and 4):
  - Connect adapter harnesses (A) between connector on camshaft adjustment solenoid and engine harness.
  - Push locking tabs (arrows, Figures 1 and 2) into connectors to secure (total of 8 locking tabs).
4. Secure adapter harnesses with cable ties.
