Recall Campaign Bulletin

Campaign No. 2010100002, October 2010

SUBJECT: **Models 204, 207, 212 Model Year 2010, Model 207.4 Model Year 2011
Check Power Steering Line Connection Fitting**

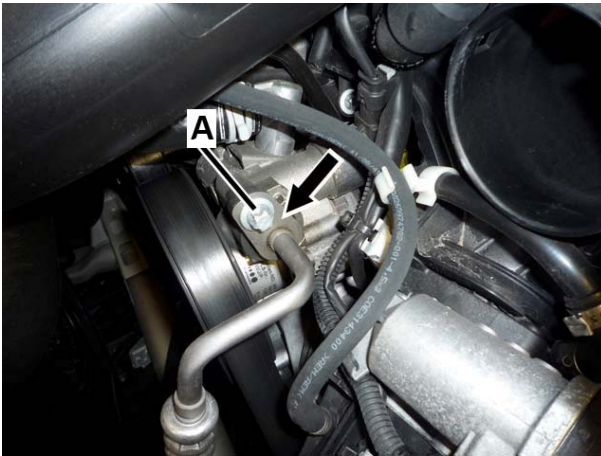
Figure 3

4. Check for leaks at the power steering line connection fitting (arrow, Figure 3) to the power steering pump.

2. Disconnect power steering high pressure line fitting (arrow, Figure 3) from the pump:
 - Place a shop rag below the power steering pump line fitting (arrow, Figure 3).
 - Remove bolt (A)
 - Disconnect power steering high pressure line fitting (arrow, Figure 3) from power steering pump.
3. Put socket wrench bit (special tool) onto connection fitting (arrow, Figure 4) and check whether it can be turned **by hand** (without any tools).

Replacement of O-ring on power steering line itself (arrow, Figure 3) is not required.
