Electric seat fore/aft adjustment nonfunctional

Topic number	LI91.10-P-054143
Version	3
Design group	91.10 Front seats
Date	07-10-2013
Validity	Model series 204, 207, 212 and 218 with fully electric seat adjustment
Reason for change	Added 204.0 and 204.9
Reason for block

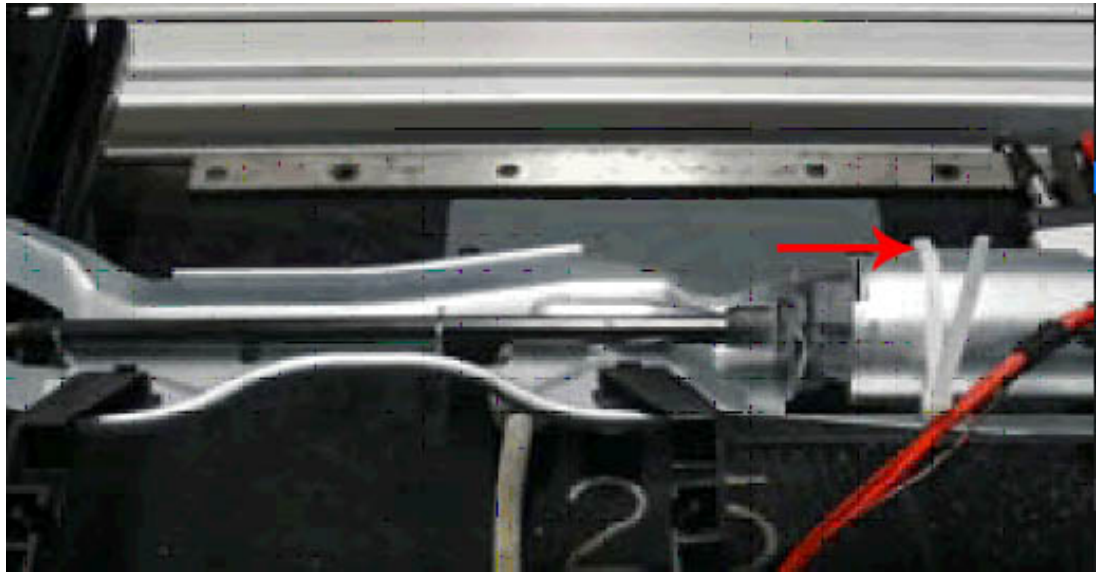
motor_reinforce.jpg:

For model 204.0 and 204.9 the entire seat frame must be replaced and seat motor should be reinforced:

The customer should be made aware that adjusting the seat with items underneath it can and will damage the seat. Replace affected seat frame (follow WIS document AR91.10-P-1450CW). To prevent this issue from occurring again, use a cable tie to secure the fore/aft motor to mounting bracket on both the new seat frame, as well as the other seat frame (as illustrated in the attached picture motor_reinforce.jpg).
