Mercedes-Benz

Campaign No. 2015050005, June 2015

SUBJECT: **Models 166 (ML), 204.9 (GLK), 212 (E-Class) Model Year 2015 with Engine 651 (4-Cylinder Diesel)**
Replace Timing Chain Tensioner Sealing Ring

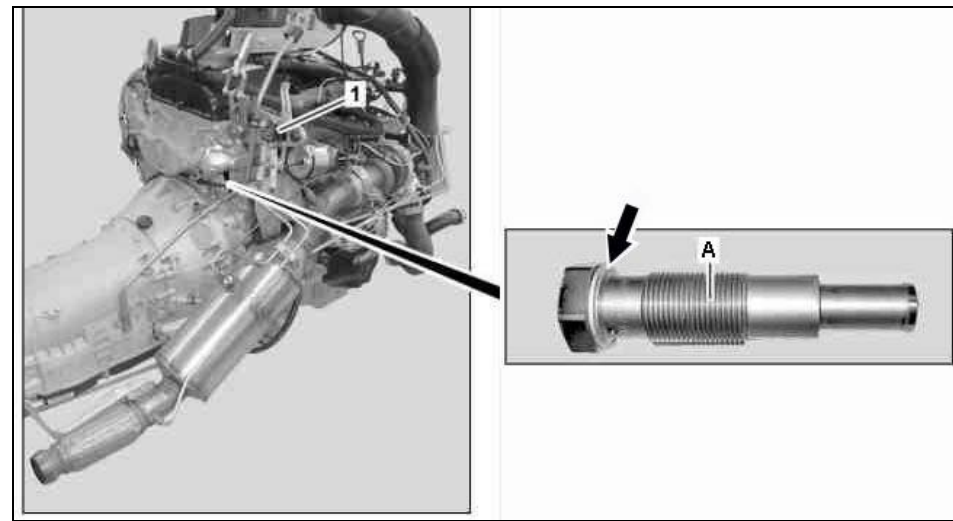
Figure 4

Daimler AG (DAG) has determined that on approximately 814 Model Year 2015 ML 250 BlueTEC, GLK 250 BlueTEC and E 250 BlueTEC vehicles, the chain tensioner gasket on the 4-cylinder diesel engine may have experienced variations in material tolerances during a certain production period. Such gaskets may exhibit an increased settling behavior, which could negatively influence the pretensioning force. Over time, this might lead to loosening of the chain tensioner, as well as an ineffective gasket seal for engine oil. As a consequence, leakage of engine oil onto the road might pose a threat to following traffic. Should the oil leakage reach a certain amount the engine might stall. Oil leakage in the presence of an ignition source could also increase the risk of a potential fire. An authorized Mercedes-Benz dealer will replace the chain tensioner sealing ring.

6. Replace timing chain tensioner sealing ring (arrow, Figure 4); refer to WIS: AR05.10-P-7800CD.

Do not replace timing chain tensioner, remove and reinstall only.
