Headlamps fogged

Topic number	LI82.10-P-063240
Version	7
Function group	82.10 Exterior lights
Date	06-15-2020
Validity	Model series 117, model series 176 with SA code: 631, 632 Model series 212 SA code: 640, 641, 642 X253, X156, model series 213 and 238 with SA code: 631, 632, 640, 641, 642 Model series 231 with SA code 640, 641, 642 Model series 177, 247 with SA code: 631, 632, 640, 641, 642
Reason for change	Assignment of part numbers for BR 177 and 247
Reason for block

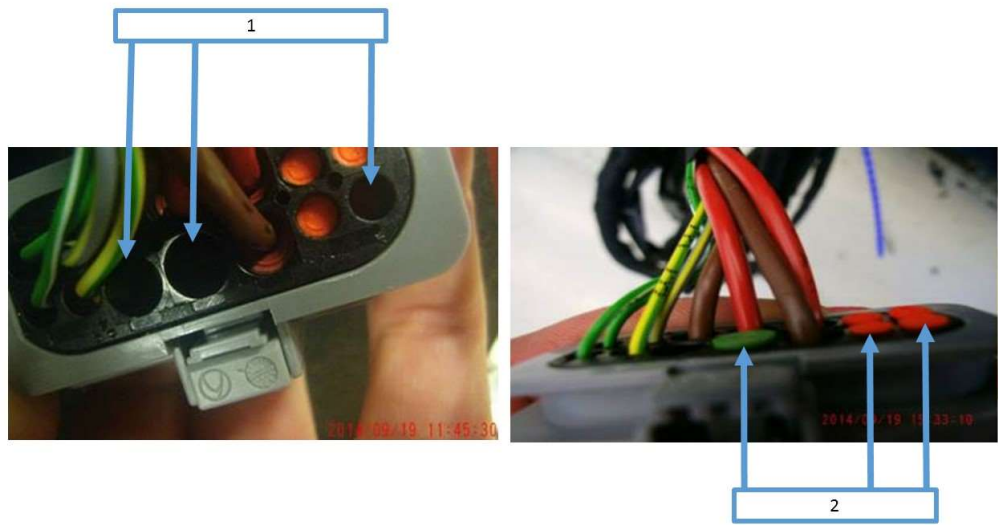
Bild 5.jpg:

1. The seals on the central connector must all be present [Picture 5 (1)] and correctly fitted [Picture 5 (2)].
2. The new transparent diaphragm must be correctly bonded [Picture 6].
3. Check headlamp housing for any external damage.
